Investigation report

Serious injury to a jumbo offsider during drilling work

May 2025

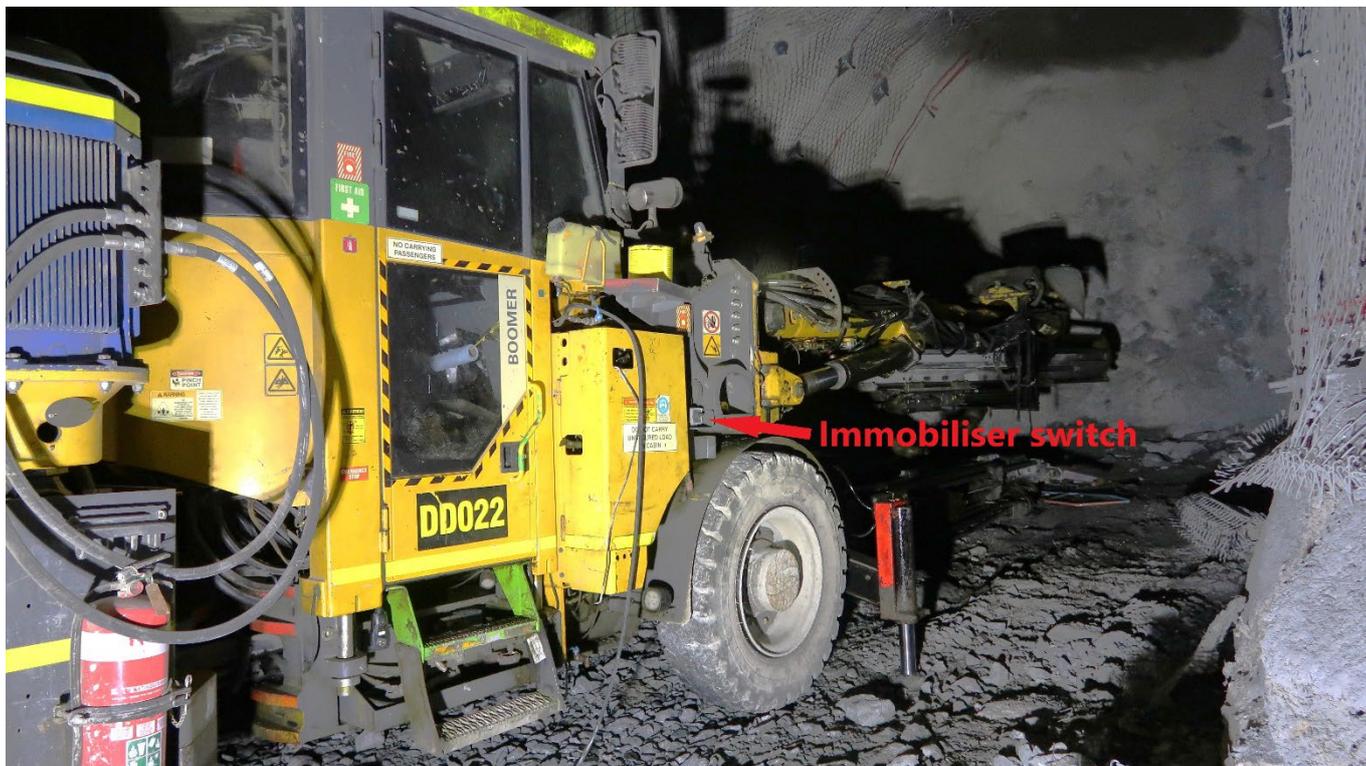
Shortly before the incident, the operator exited the jumbo while a lever in the operator's cabin of the jumbo remained engaged, which caused the right-hand boom to continuously rotate. Immobiliser switches (used to stop movement of the booms) were positioned on the front left and right sides of the jumbo.

Figure 1: Jumbo drill rig DD022 at the incident scene, with the location of one of the 2 immobiliser switches indicated in red

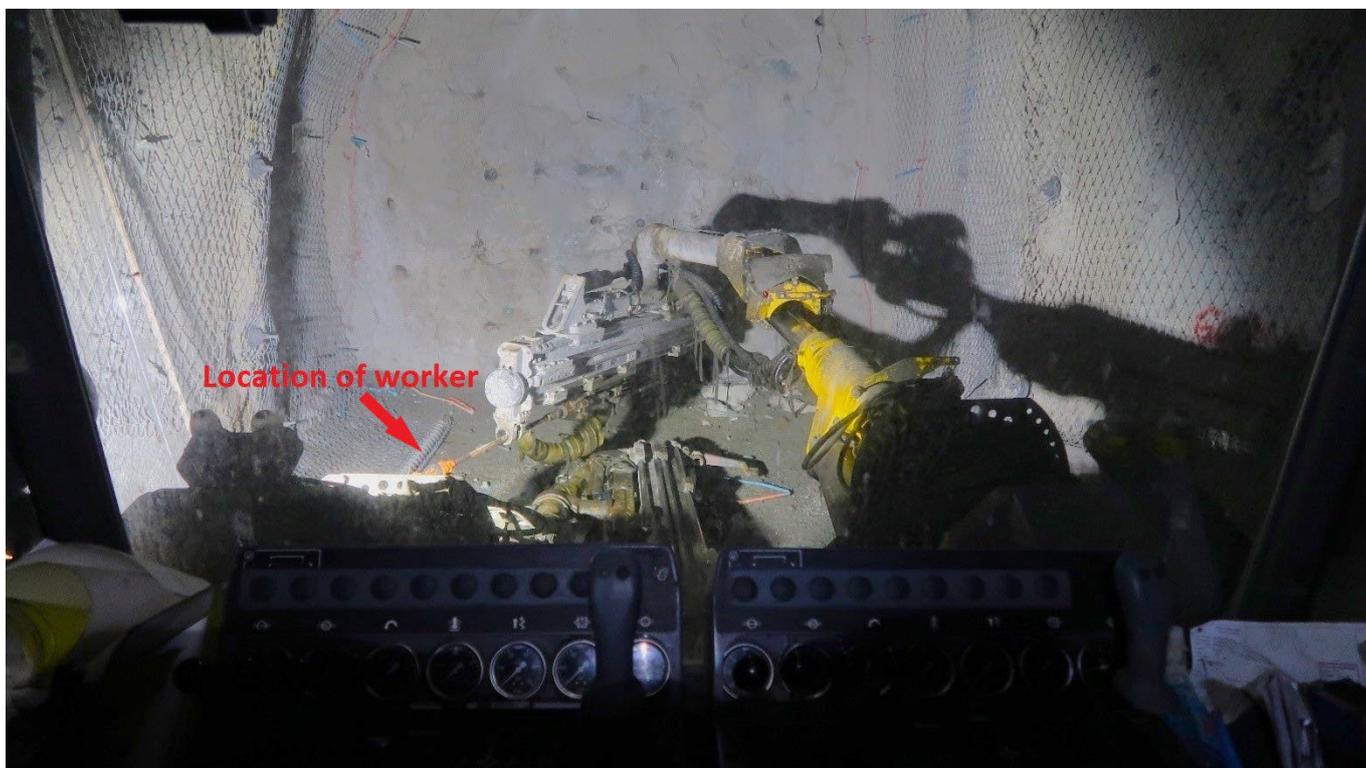
His left arm became entangled on the rotating drill steel resulting in traumatic amputation to his left arm below the elbow. An emergency response was activated resulting in the offsider being transported to the surface and airlifted to hospital. The offsider remained in hospital for over 5 weeks.

Figure 2: Incident scene viewed from the jumbo cabin with approximate location of offsider at the time of the incident, and a piece of his work shirt (predominantly orange in colour) entangled in the drill steel

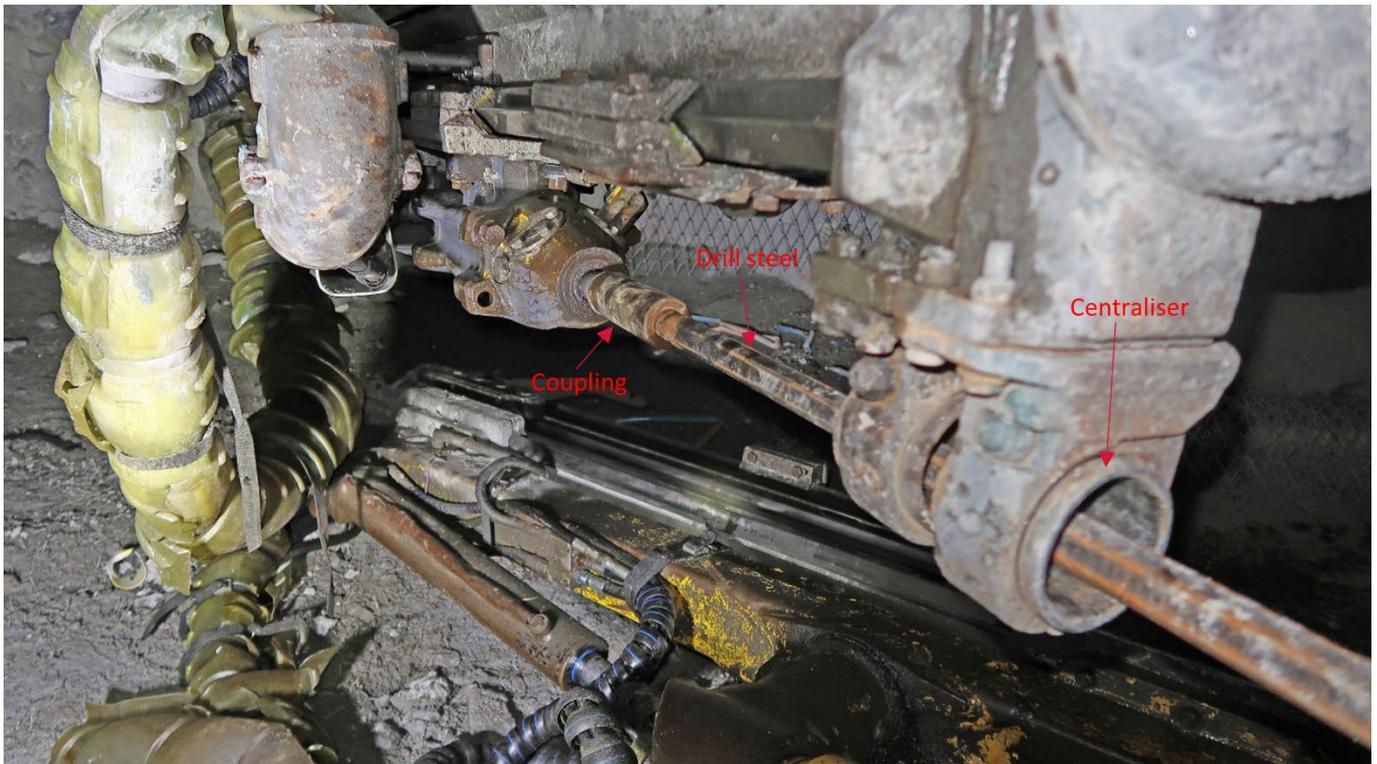
Without engaging the switch, the offsider approached the front of the jumbo to change a component on the right-hand boom, which was angled back towards the left side of the jumbo. The offsider inserted a 3.7 metre drill steel into the coupling of the right-hand boom as the coupling rotated.

Figure 3: Drill steel inserted in coupling on the right-hand boom
