Quarterly safety report

January to March 2025

Published by Resources Regulator

Title: Quarterly safety report – January to March 2025

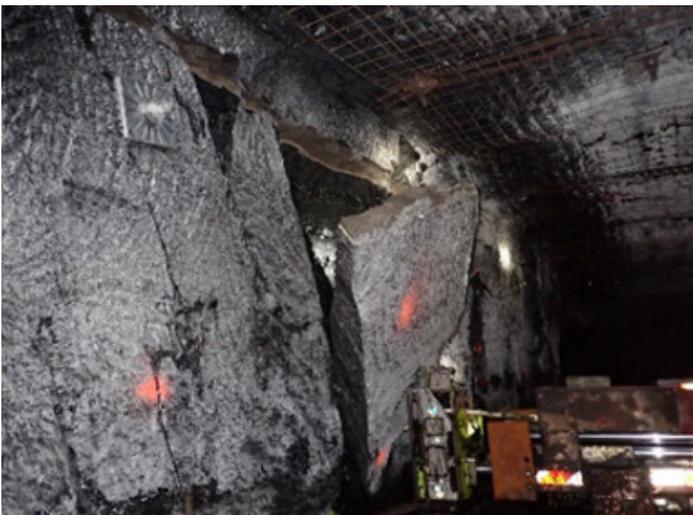
Dangerous incident | IncNot0048373 – Rib slump during support installation

Summary: An operator was injured when a rib slump occurred during rib support installation. Two operators were using an air track when installing secondary rib support. A hole was drilled in the rib and chemical was installed. The operator retracted the drill rig head plate off the rib to install a rib bolt. The rib slumped, and as the operator pulled his hand away, it was caught between the rig mast and the falling rib. The wedge of rib coal that fell was about 1500 mm high, 700 mm wide and 300 mm deep. Before the work started, there was no sign of any deformity and no visual sign of fracture or failure while the drilling was taking place.

Picture 1.
Rib slump in panel

Comments to industry: The potential for a fatal outcome from rib failure is well understood. While there may be no visible signs of potential rib failure, it is nonetheless imperative that consideration is given to this possibility. Any risks to operators should be mitigated by implementing appropriate controls. The method of bolting that affords the most protection to operators by minimising the risk of coming into contact with a slump or fall of rib should be used at all times.

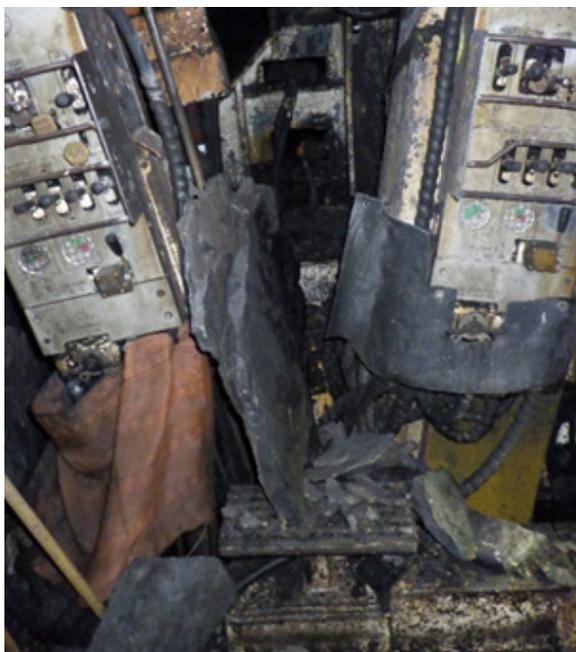
Summary: A continuous miner had completed a cut-out and was preparing to install mesh when a slab of stone 900 x 800 x 100 millimetres fell and hit the timber jacks before rolling back onto the platform of the miner. The operator took evasive action when he saw the stone falling and was uninjured. The slab fell when ramping up through an ironstone band in the roof. The worker was supporting the mesh by hand when the slab fell.

Picture 2.
Slab resting on continuous miner platform after incident

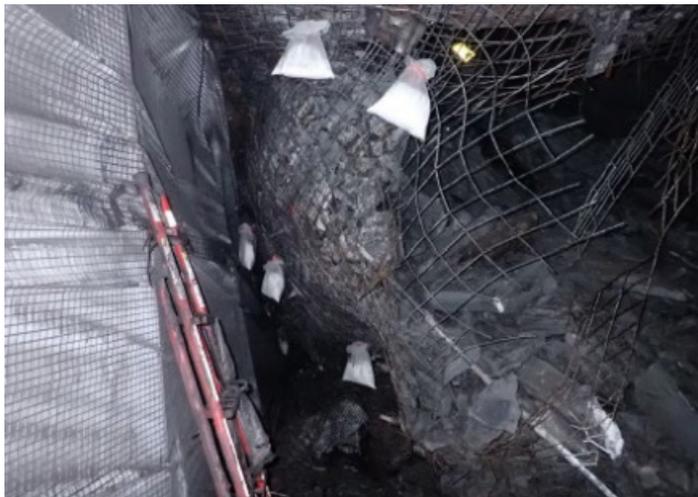
Summary: A shearer was cutting back into the tailgate for a second shear of shift when the continuous miner worker noticed what appeared to be a roof fall adjacent to the tailgate drive. The longwall mining supervisor was contacted, who inspected and identified a roof fall that was impeding access from the tailgate. The area was barricaded to prevent access.

Picture 3.
Roof failure impeding access

Comments to industry: This incident highlights that loading applied to an active tailgate roadway ground support increases immediately outbye the faceline as the face retreats and abutment loads are redistributed outbye. This increase in loading on the installed ground support, particularly if accompanied by the presence of a localised geological anomaly can result in a fall of ground. The improvement of geotechnical inputs into ground support design has significantly reduced such failures over the past decade, however strata failure remains a fundamental risk with localised geological anomalies potentially affecting the adequacy of the ground support as it was designed and installed. Ground support designs will ideally be able to tolerate localised changes that demand more load carrying ability from the installed ground support.

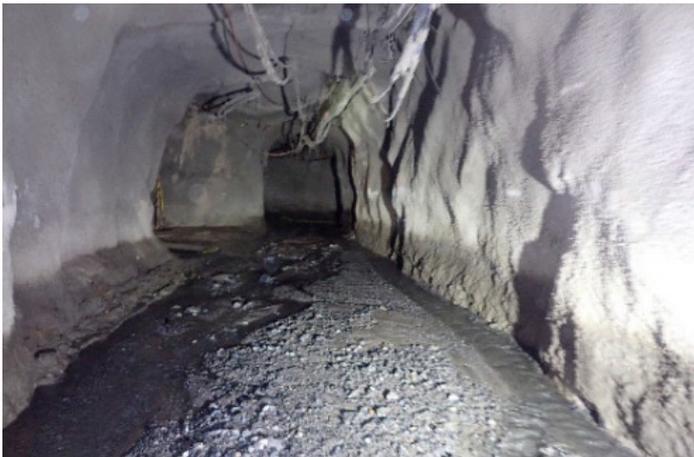
Dangerous incident | IncNot0048321 – Inrush of water from ramp to platform

Summary: There was an inrush of water from a 24-level ramp to a 25-level platform to below the knee level of a worker in the area. The water came from an old stopping area where excess dirt and material had been put in the drive and created a bund. Water had built up behind the bund over a period and when a fall of ground occurred into the water, it created a pressure wave that broke through the bund.

Picture 4.
Damp walls indicating the water level reached

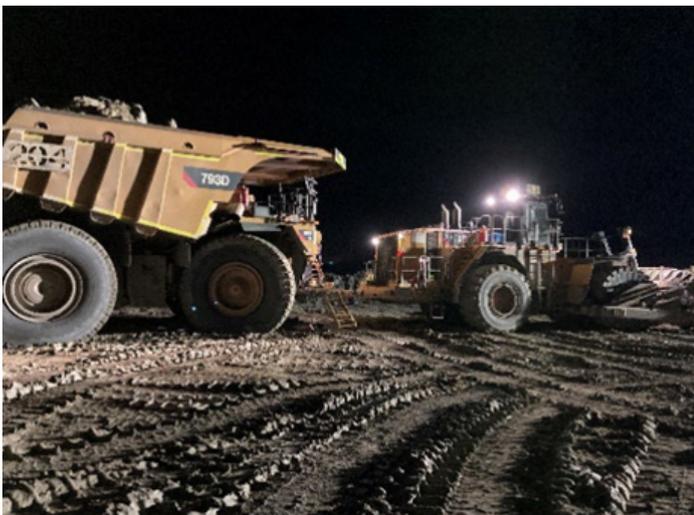
Dangerous incident | IncNot0048381 – Haul truck and wheel dozer collision

Summary: A wheel dozer was working on a dump when it reversed 30 metres and collided with the front of a stationary haul truck. The truck operator was waiting for direction from the wheel dozer operator. The wheel dozer operator did not look behind him while reversing.

Picture 5.
Collision scene between truck and dozer

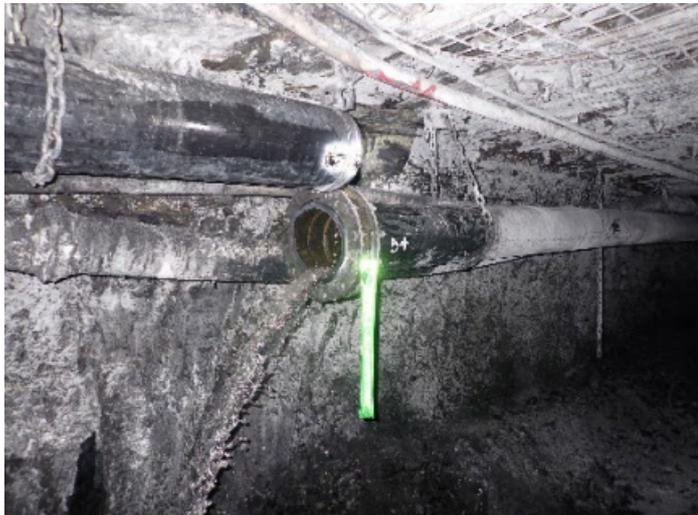
Summary: A loader was travelling out of a mine towing 2 longwall monorail cassettes. The rear monorail frame hit a 250 mm water-filled poly-pipe, causing the pipe to fracture. The poly-pipe was not pressurised above gravity-feed pressure. However, a high-tension cable (11kV) power line above the poly-pipe was also hit by the damaged pipe and caused cable sheath damage. Crews were evacuated from the mine. The trailing cassette wandered towards the ribline – making contact with the pipe flange, which in turn made contact with, and damaged, the cable.

Picture 6.
Fractured poly pipe

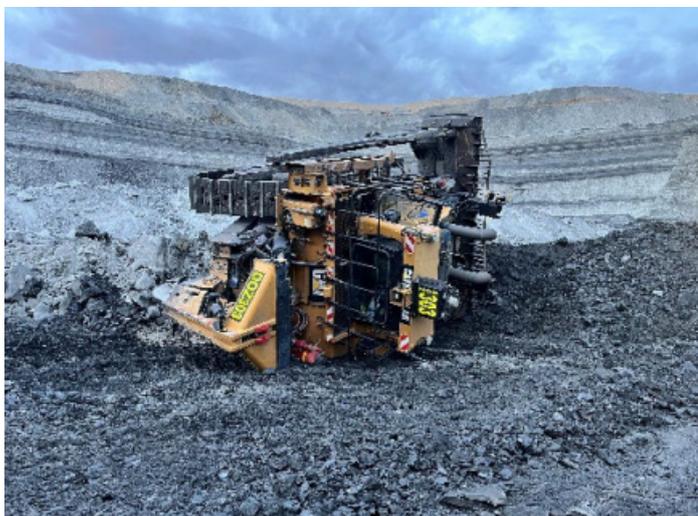
Summary: A dozer operator was completing floor clean-up at a dig area and after completing a push, he reversed at 45 degrees. The operator stopped, ready to begin another push when the dozer slowly started to tip onto the right-hand side. The operator said it felt like the bench the dozer was sitting on slumped.

Picture 7.
Tipped dozer at dig area

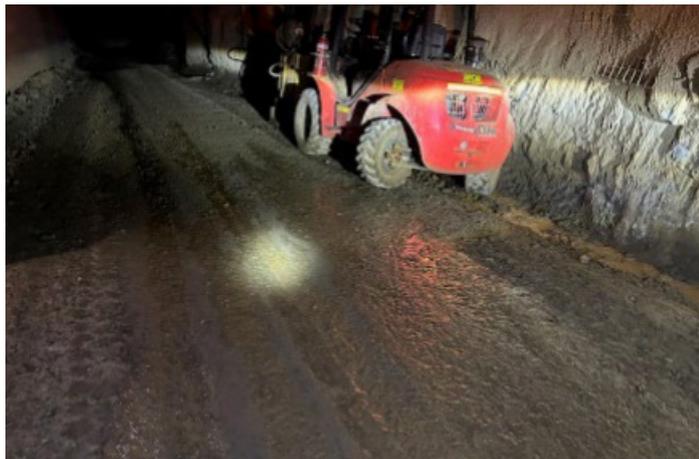
Summary: While carrying a load into a mine, a forklift truck failed to stop after the brakes were applied. The operator had to steer the forklift into a wall to bring it to a stop. The operator was not injured.

Picture 8.
Forklift truck against wall

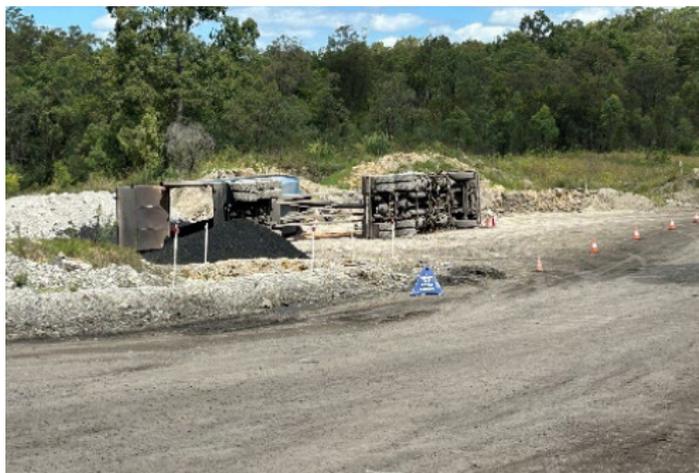
Summary: A prime mover with a single trailer was moving coal between a washery and a train-loading facility when an issue occurred with the reverse gear. The trailer was being tipped when the coal hung-up in the top part of the trailer and caused it to tip over on its side. In the process, the prime mover also rolled onto its side. The location selected to tip the load had a 5% cross slope. The cross slope was enough to cause instability in the truck as the load was being tipped, resulting in the truck tipping onto its side.

Picture 9.
Tipped mover and trailer

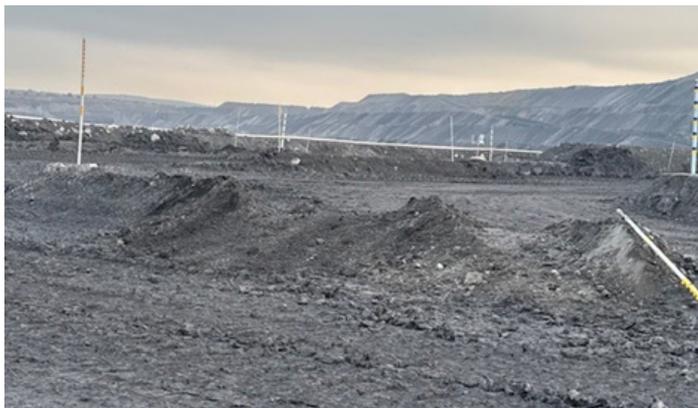
Summary: A haul truck operator approached a left-hand turn at an intersection at speed. The truck breached a centre bund and crossed onto the opposite side of the road. No other road users were in the immediate vicinity of the truck at the intersection, however a vehicle was 100-150 metres away and the occupants witnessed the incident.

Picture 10.
Bund damage after incident

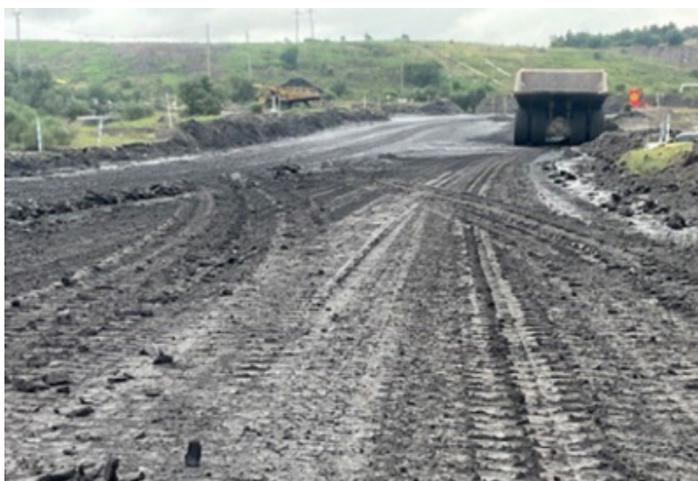
Summary: A new-to-industry trainee was operating a haul truck when the trainee felt a loss of traction. The operator attempted to correct the loss of traction but oversteered and crossed the centreline of the road before correcting the steering sharply and stopping against a windrow.

Picture 11.
Truck stopped at windrow after traction loss

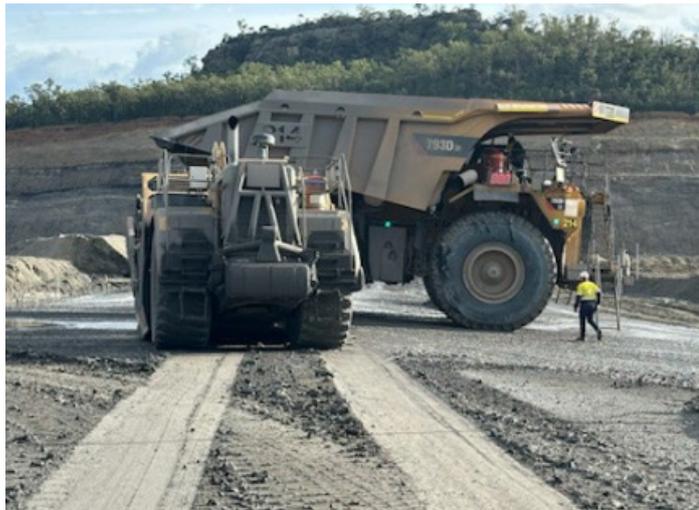
Summary: A scraper collided with a haul truck at the intersection of the main pit and a haul road. The scraper was operating under hierarchy conditions. The scraper slid approximately 57 metres before colliding with the haul truck.

Picture 12.
Scraper and haul truck with visible slide marks

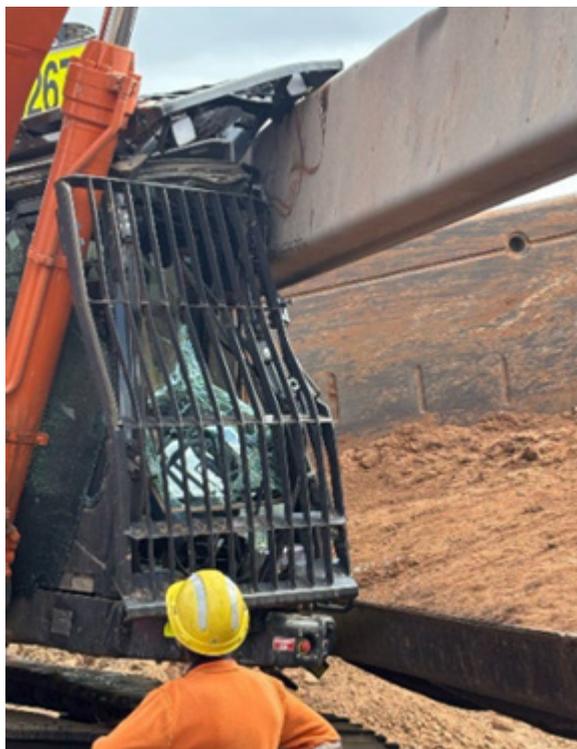
Summary: A rear dump truck and a 49-tonne excavator collided when the truck reversed into the cab of the excavator. The operator of the excavator was not injured but required assistance to egress from the machine. The truck had material hanging up in the tray that was going to be removed with the intervention of the excavator. Both vehicles were using different communication channels so positive communication was not established as the truck was reversing.

Picture 13.
Excavator cab collision damage

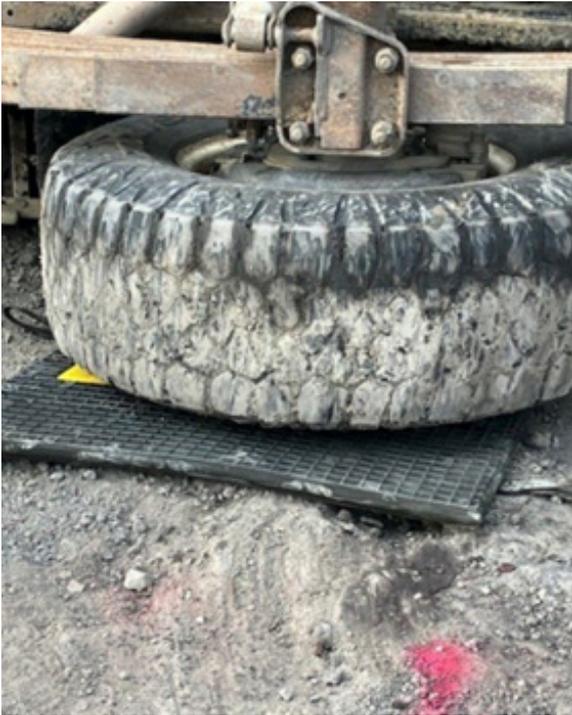
Summary: A light vehicle operator was travelling on a haul road when they lost control of the vehicle and rolled it onto its left side. The driver was the single occupant in the vehicle. The road was flat and straight and was watered to the mine's standard at the time. The vehicle had worn tyres, which contributed to the loss of traction.

Picture 14.
Worn tyre on rolled light vehicle

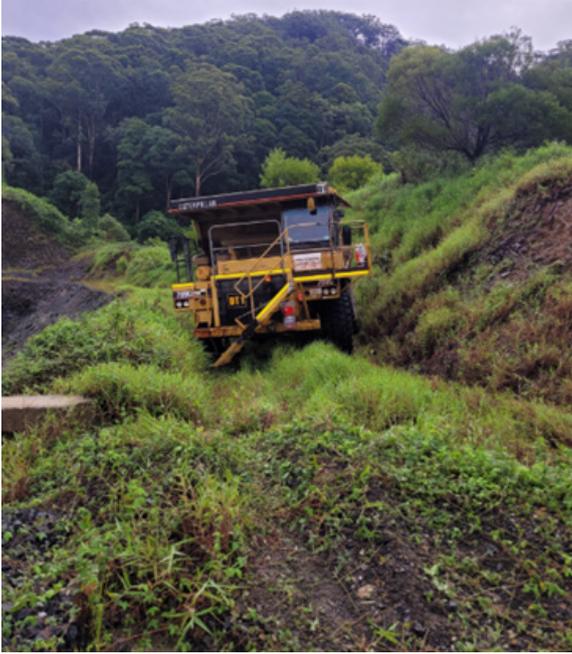
Summary: A haul truck lost power on a ramp and rolled 30 metres backwards before coming to rest on a bench. The operator had stopped on the ramp with the motor running, waiting for another task to be completed. When the task was completed, the operator put the truck in gear, released the handbrake and took his foot off the footbrake to accelerate. The engine cut out and the truck began rolling backward. The operator pumped the footbrake and pulled the retarder up and down multiple times with no result. He couldn't use the secondary retarder as he was trying to steer the truck. He managed to steer the truck over a water diversion bund and bring it to a halt.

Picture 15.
Stricken truck after incident

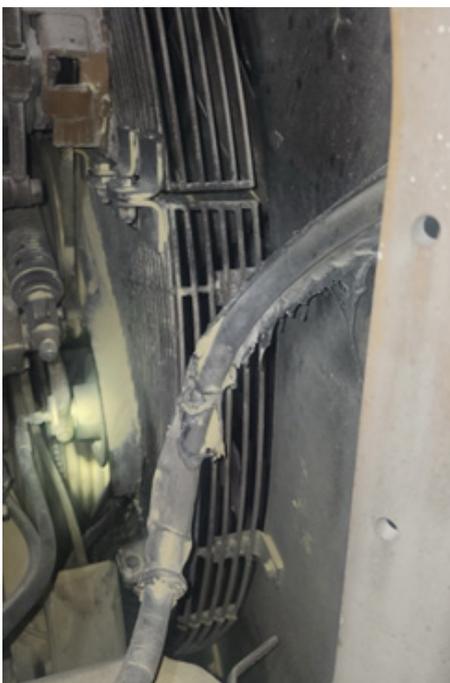
Dangerous incident | IncNot0048320 – Sprayed fluid ignited on hot machine parts

Summary: A fire occurred at the rear of a load haul dump (LHD) while operating underground. The operator noticed the fire and activated the fire suppression. He exited the machine and used a hand-held extinguisher to extinguish the fire. Smoke dissipated to return air with no impact elsewhere underground, and no withdrawal or refuge. A hose at the back of the LHD near the radiator cooling fan had burst and sprayed fluid onto hot machine parts.

Picture 16.
Hose damage at rear of dozer

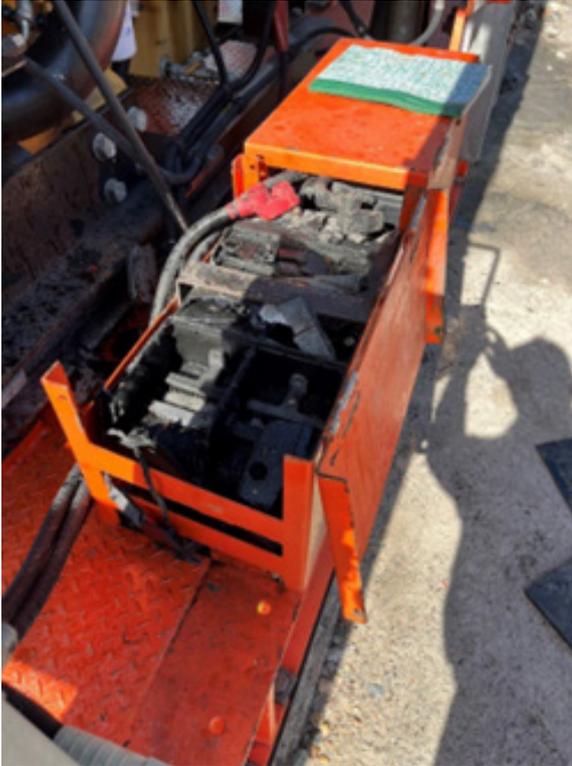
Summary: A battery on a surface skid pump pressurised and split the casing, releasing battery fluid in an uncontrolled manner. After an operator completed refuelling a dewatering skid pump, the operator started the diesel engine. During the starting process, the operator heard a loud bang as one of the 2 sealed lead acid batteries on the skid pressurised and split the battery casing causing plastic pieces of the battery to eject outward, along with battery fluid. The pressure release pushed open the unsecured hinged battery enclosure lid. An internal battery fault caused the battery fluid to vaporise while the engine started and drew current, pressurising the battery casing and causing the plastic casing to fail.

Picture 17.
Battery enclosure minus unsecured lid

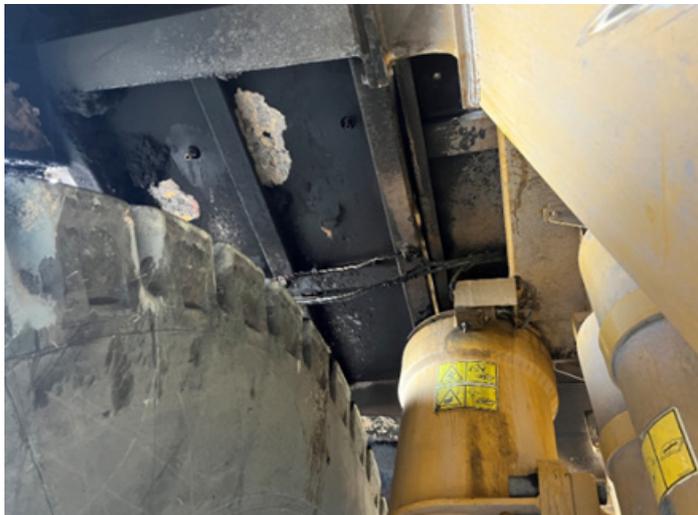
Summary: While driving up a ramp in an open cut pit, a truck operator noticed a failed turbo and reported it on the maintenance channel. As the truck ascended, flames erupted from the right-hand side, prompting the operator to call an emergency. Dispatch activated a site-wide emergency response. The operator stopped, exited the truck via the stairway, but went back to retrieve his hard hat and exited the burning truck again. The operator did not shut down the truck, and fire suppression was not triggered. Engine oil from the failed turbo ignited on the exhaust, spreading to the right-hand fender's sound suppression material. A mining supervisor activated the emergency stop and fire suppression from the front bumper. A water cart attended the scene and extinguished the fire.

Picture 18.
Fire location underneath right-hand fender

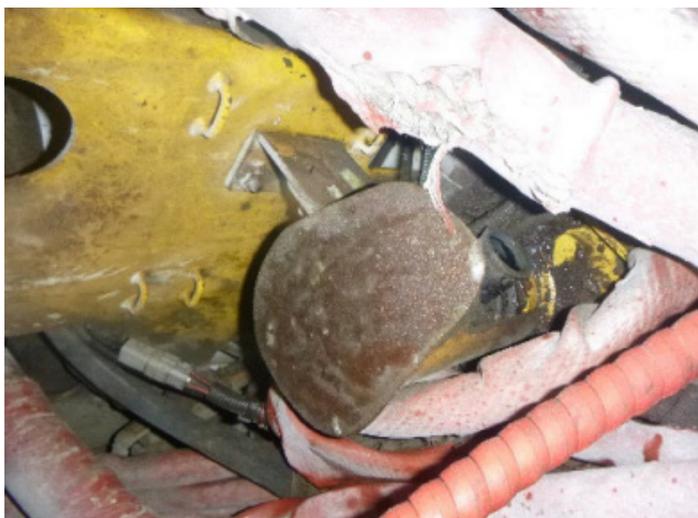
Summary: A fire occurred on an underground haul truck as it was being refuelled. A breather hose came loose from a pipe, resulting in atomised diesel interacting with a hot surface.

Picture 19.
Loose breather hose on haul truck

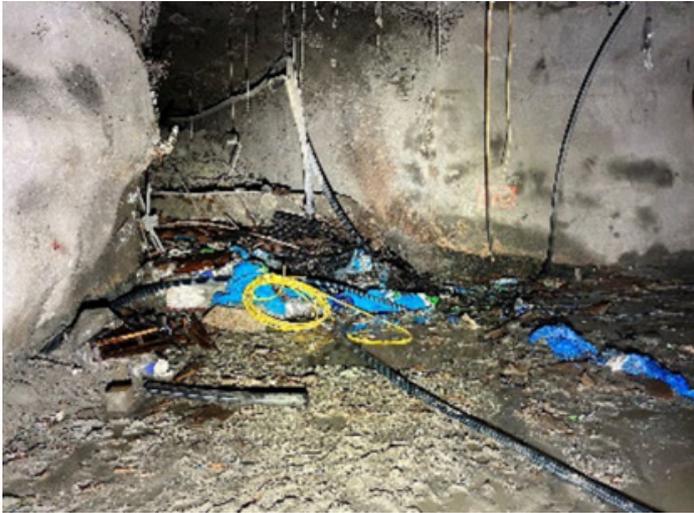
Summary: A pile of pallets, vent bag, and poly pipe caught fire underground with no apparent ignition source. An operator pulled into the level, smelled smoke and realised that smoke was coming out of the drive. The shift supervisor initiated evacuation back to the refuge chambers for all underground workers. Workers in the refuge chambers on levels below the fire were evacuated after the fire was extinguished. Workers spent between 2.5 and 5 hours in refuge.

Picture 20.
Fire damaged detritus underground

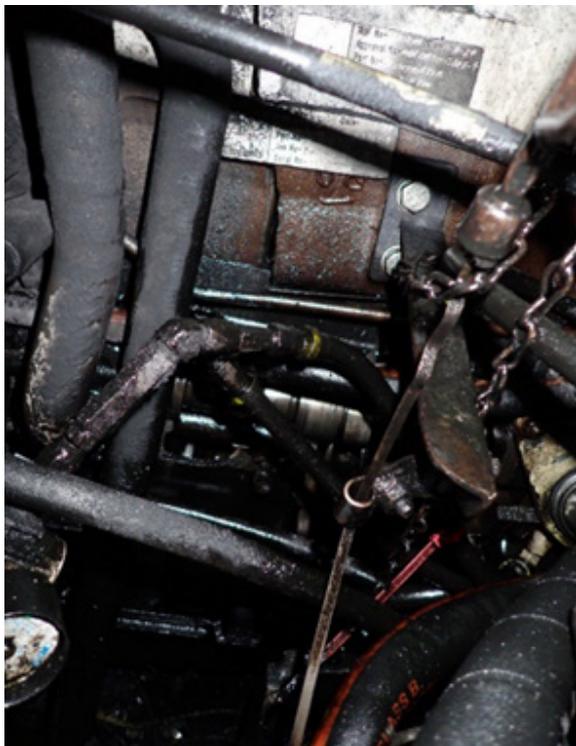
Summary: A load haul dump machine (LHD), fitted with an explosion-protected diesel engine, was picked up from pit bottom in an underground coal mine. After driving a short distance, the LHD operator heard a ticking noise from the diesel engine. The operator stopped and returned towards pit bottom for maintenance to check the machine. After driving 3-4 pillars, the operator heard a loud bang and the LHD stopped. The top end of the explosion-protected diesel engine systems (ExDES) had catastrophically failed with a hole blown in the side of the diesel engine and internal engine components being exposed to the mine atmosphere. The machine was quarantined with a root cause investigation being conducted by the mine and the original equipment manufacturer.

Picture 21.
Catastrophic failure of diesel engine
