Weekly incident summary

Week ending 16 May 2025

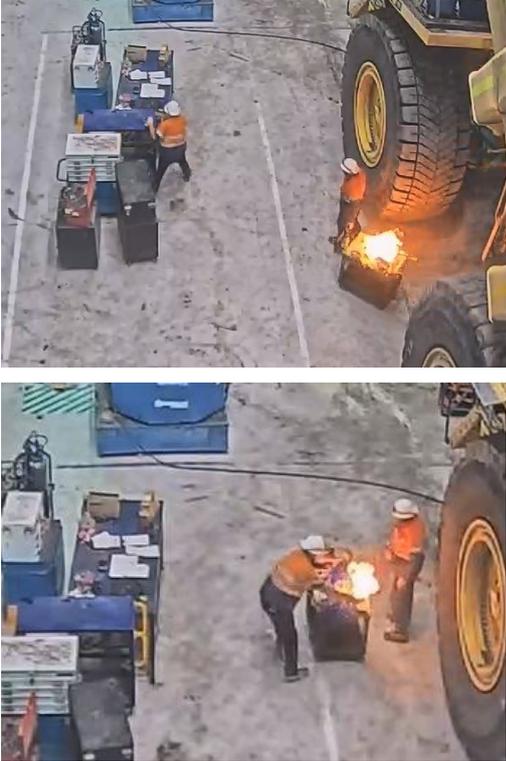
| Incident type | Summary | Comments to industry |
|---|---|---|
| Dangerous incident IncNot0049082 Open cut coal mine Fire or explosion | <p>A boilermaker was using a grinder while working on the chassis rails of a dump truck. The sparks from the grinder ignited a trolley-mounted tray containing brake-cleaning fluid that was beneath the truck. One worker moved the trolley clear of the truck and 2 workers attempted to smother the fire with cloths. Unfortunately, this only added fuel to the fire.</p> <p>The trolley was wheeled outside the workshop and tipped over, allowing the burning liquid to spread across the ground.</p> <p>Another worker used a dry chemical powder extinguisher to put out the fire. Nobody was injured during the incident, although workers were exposed to</p> | <p>Workers are reminded that they have duty under the Work Health and Safety Act to comply with all reasonable instructions, policies and procedures that mines have in place.</p> <p>Mine operators must have processes in place to ensure that the controls identified within site procedures and permits are implemented.</p> <p>Workers must be trained regularly about how to respond in an emergency such as a fire. Workers should be aware of the location of emergency equipment and mine operators should conduct regular emergency management training.</p> <p>Work procedures should not allow for flammable liquids to be in the vicinity of hot work.</p> |

| Incident type | Summary | Comments to industry |
|---|---|---|
| | <p>smoke, extinguishing medium and the fire.</p> | |
