Weekly incident summary

Week ending 2 May 2025

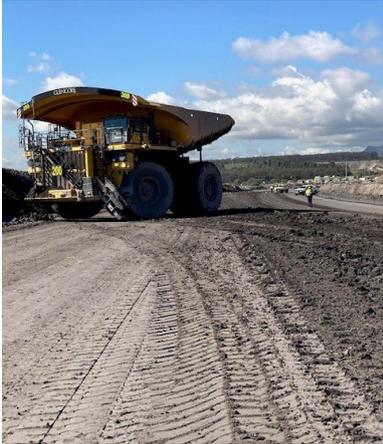
Incident type	Summary	Comms to industry
Dangerous Incident IncNot0049004 Open cut coal mine Roads or other vehicle operating areas	<p>While travelling on a wet section of road, an empty haul truck lost traction as a mobile manufacturing unit (MMU) was passing on the opposite side.</p> <p>The haul truck slid along the road and crossed the centre line before ending up at 180 degrees from the intended direction of travel.</p> <p>The haul truck missed colliding with the MMU by about 8-9 metres.</p>	<p>Workers must operate vehicles at a speed that is appropriate to the prevailing conditions.</p> <p>Mine operators should ensure that, after rain events and when operating in wet weather conditions, adequate systems are in place (including statutory inspections) to check road conditions and communicate these conditions to the workforce.</p> <p>When developing control measures to manage the risks of operating vehicles, mine operators must consider</p>

<p>mobile plant operating characteristics including stopping distances, manoeuvrability, and speeds for both loaded and unloaded vehicles.</p>
<p>Dangerous Incident IncNot0049015 Industrial minerals Choose an item.</p>	<p>Two fitters finished a job in an elevated work platform (EWP) and were about to travel back to the park area while still in the basket.</p> <p>The workers tried to retract the outriggers but they failed to work, so they attempted to elevate the basket to free up the hydraulics. The basket, which was about 5 m off the ground, then tipped forward. The EWP safety system activated, and the workers safely lowered to ground.</p> <p>The EWP was a hired unit.</p>

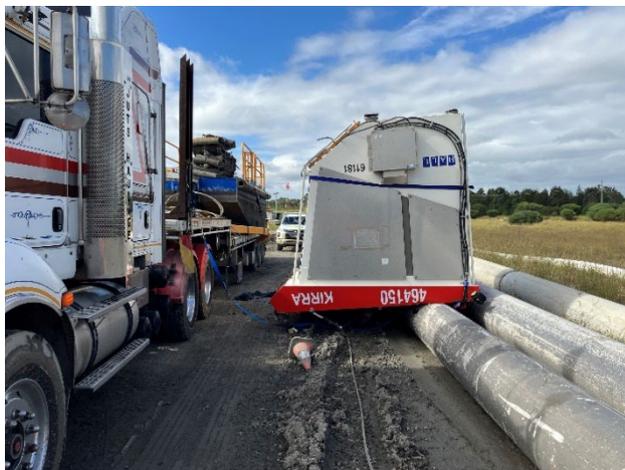
<p>Dangerous Incident IncNot0049024 Open cut coal mine Choose an item.</p>	<p>Three workers were securing a dredge cab onto a truck trailer using straps when the cab gradually rolled off the trailer and fell to the ground.</p> <p>One worker was tightening a strap at the time the cab began to topple and had to take evasive action. The cab weighs about 2 tonnes.</p>	<p>Mine operators must have systems in place for loading, securing and transporting plant and associated components of plant.</p> <p>Workers must be trained and deemed competent prior to participating in the loading and securing of plant.</p> <p>Operators must identify the risk of loads shifting, especially when there is steel on steel contact and where there is the potential for a load to shift or topple if straps are overtightened.</p>
