# Weekly incident summary

## Week ending 18 July 2025

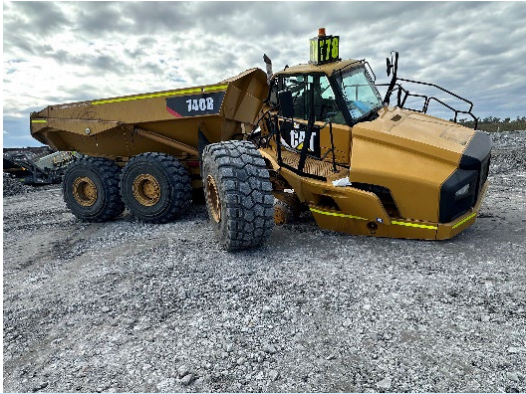
| Incident type | Summary | Recommendations to industry |
|---|---|---|
| Dangerous incident<br>IncNot0049471<br>Open cut coal mine | <p>The wheel of an articulated dump truck dislodged from the wheel assembly while in operation, causing the cab to come to rest on the ground.</p> <p>The dump truck had completed its ninth load for the day and was unloaded when the incident occurred.</p> <p>The wheel nuts became loose and eventually stripped the thread on the wheel studs, causing the wheel to become dislodged from the assembly.</p> <p>The machine was recently purchased at an auction by the contracting company.</p> | <p>Before use at a site, plant should be assessed against the mine's introduction to site process.</p> <p>Introduction to site should include:</p> <ul style="list-style-type: none"><li>• checking the mobile plant to the mine's engineering standards and their mechanical engineering control plan</li><li>• checking the functionality of all safety critical systems</li><li>• checking the plant has been maintained and is in a fit-for-purpose condition to enter the mine site.</li></ul> <p>All plant should have pre-start inspection undertaken by a trained and competent person to ensure the plant is safe to operate.</p> |

| Incident type | Summary | Recommendations to industry |
|---|---|---|
| | | <p>Refer to <u>MDG 15 Mobile and transportable plant for use on mines and petroleum sites for further guidance.</u></p> |

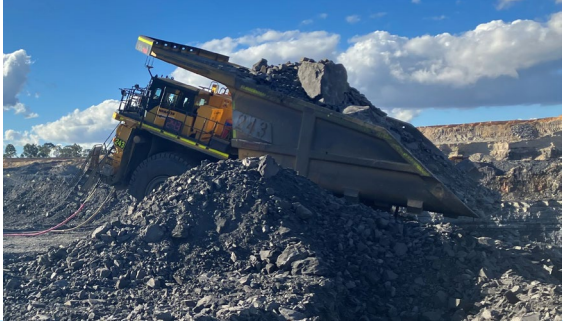
| Incident type | Summary | Recommendations to industry |
|---|---|---|
| <p>Dangerous incident<br/>IncNot0049472<br/>Open cut coal mine<br/>Ground or strata failure</p> | <p>While backing up to tip a load, the windrow slumped causing a dump to drop down at the rear.</p> <p>Preliminary investigation suggests that soft material at the toe of the dump caused the windrow to fail.</p> | <p>When designing a dump, ground stability should be a primary consideration.</p> <p>Material consistency, wet conditions and dipping ground stability should be considered.</p> <p>Inspections should verify dump integrity. Areas that do not meet the standard should be demarcated, communicated and remediated to meet the standard.</p> |

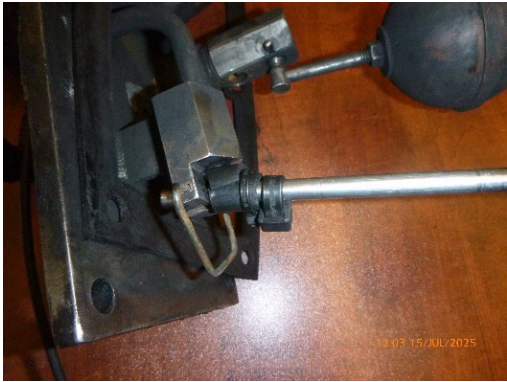
| Incident type | Summary | Recommendations to industry |
|---|---|---|
| <p>High potential Incident<br/>IncNot0049440<br/>Underground coal mine</p> | <p>A mine loader was unable to be restarted after shutting down.</p> <p>The low water shutdown float was modified with a piece of rubber hose attached to the float arm to seal off the air pressure for the safety circuit.</p> <p>The float was retained with a safety clip and not the recommended stainless steel split pin.</p> | <p>Alterations to design-registered plant is not permitted unless authorised.</p> <p>The low water shutdown float is a critical control of the diesel engine system that ensures a water barrier is present to prevent propagation of flames or sparks from the diesel engine system.</p> <p>Mine operators must have controls in place to ensure work carried out on explosion-protected diesel engine systems (ExDES) is authorised and carried out by people who are trained and competent for that work.</p> <p>Fitters who are required to work on ExDES should be trained on the specific requirements for maintenance and repair of ExDES to ensure that engine maintenance is</p> |

| Incident type | Summary | Recommendations to industry |
|---|---|---|
| | | carried out in such a manner as to maintain the explosion-protection properties and engine system reliability.<br><br>Maintenance work orders are to be reviewed upon completion with additional work orders raised for any emerging or not completed work. |
