Investigation report

Investigation into a serious drill rig incident at Ashton Coal Mine on 12 August 2012

Report prepared by the NSW Mine Safety Investigation Unit

July 2014

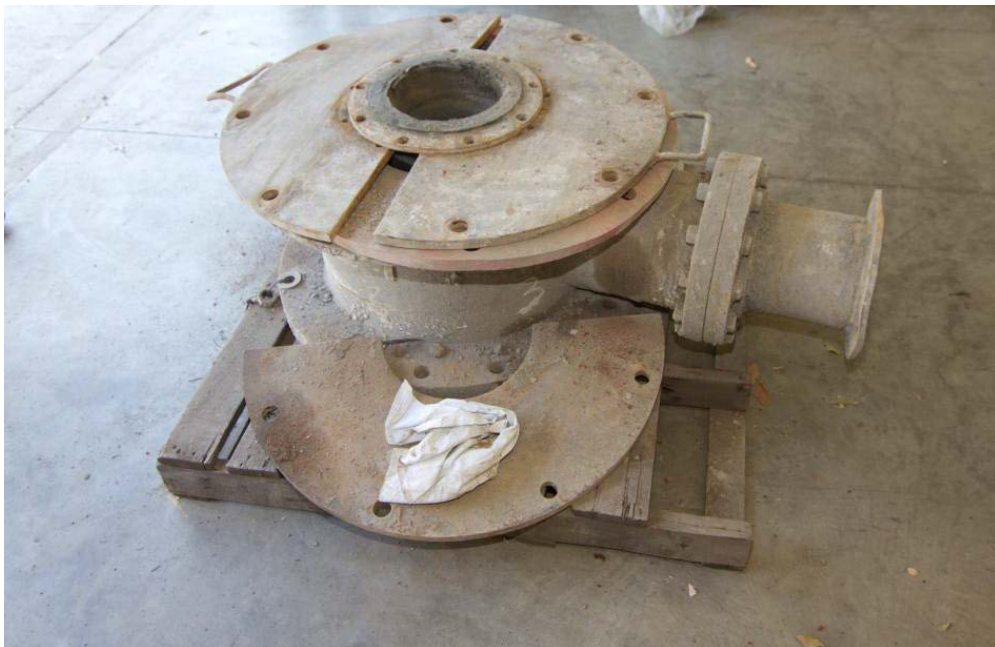
Silver City Drilling used a single surface casing (diameter 600mm) at both borehole locations. Above the casing sat a diverter box with a rubber seal (Washington seal), pictured below in figure 2, which allowed the drill pipe to travel through and maintain rotation. The diverter box was designed to divert the cuttings into the air discharge line which would expel the cuttings into a purpose built sump. When drilling was completed a secondary casing (406mm) was to be installed for the purposes of dewatering the mine.

Figure 2. Diverter box that was installed at Borehole 4

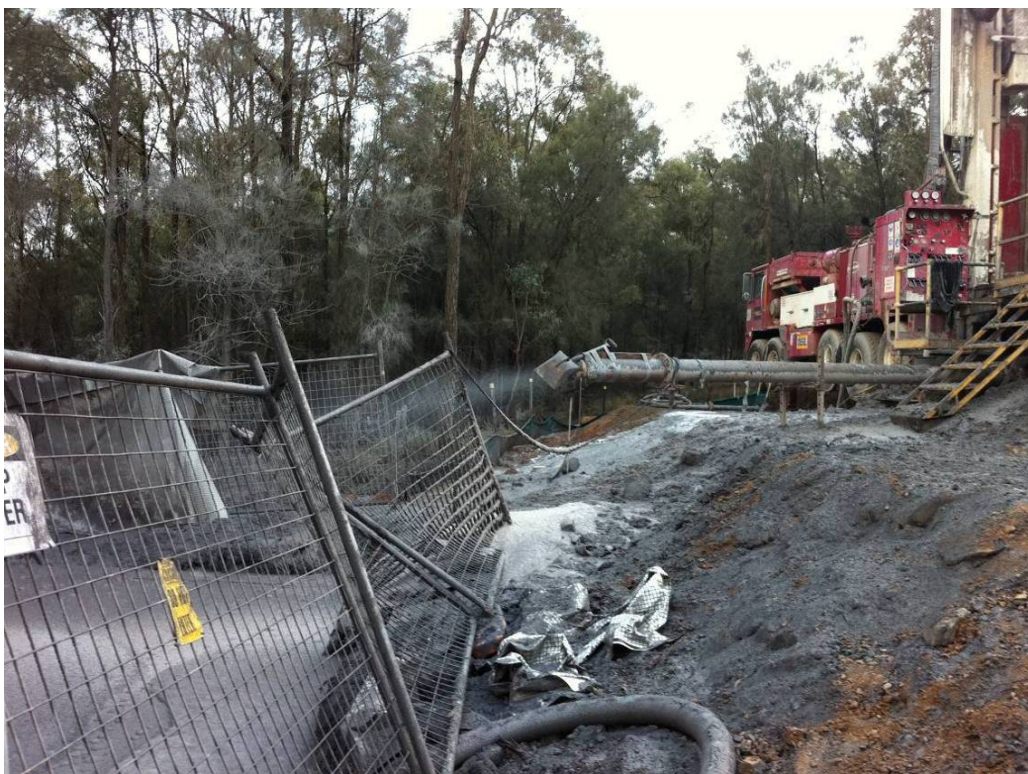
Drilling operations at the new Borehole 3 site proceeded, with only a few minor issues, until, a second environmental incident was reported to the contract holder, who directed Silver City Drilling to ensure that drill cuttings from the air discharge line be diverted to the sump, and not the surrounding environment. Figure 6 shows makeshift efforts to direct discharge from the drilling operation into the sump on the lower terrace. The photo shows a shovel taped to the end of the air discharge line with tape to divert the cuttings.

Figure 6. The second environmental incident location borehole 3.

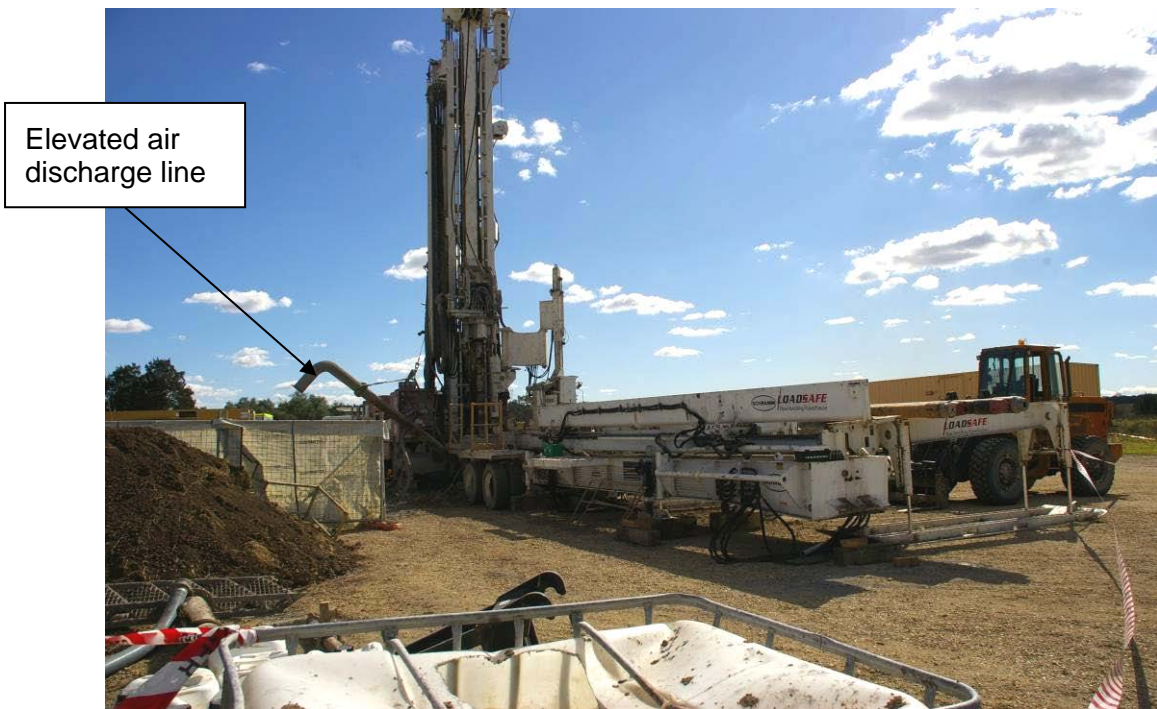
Figures 7 and 8 depict the Silver City Drilling drill rig at Borehole 4, post incident. The air discharge line was secured in an elevated position by emergency response personnel.

Figure 7. Silver City Drilling drill rig at Borehole 4 post incident.

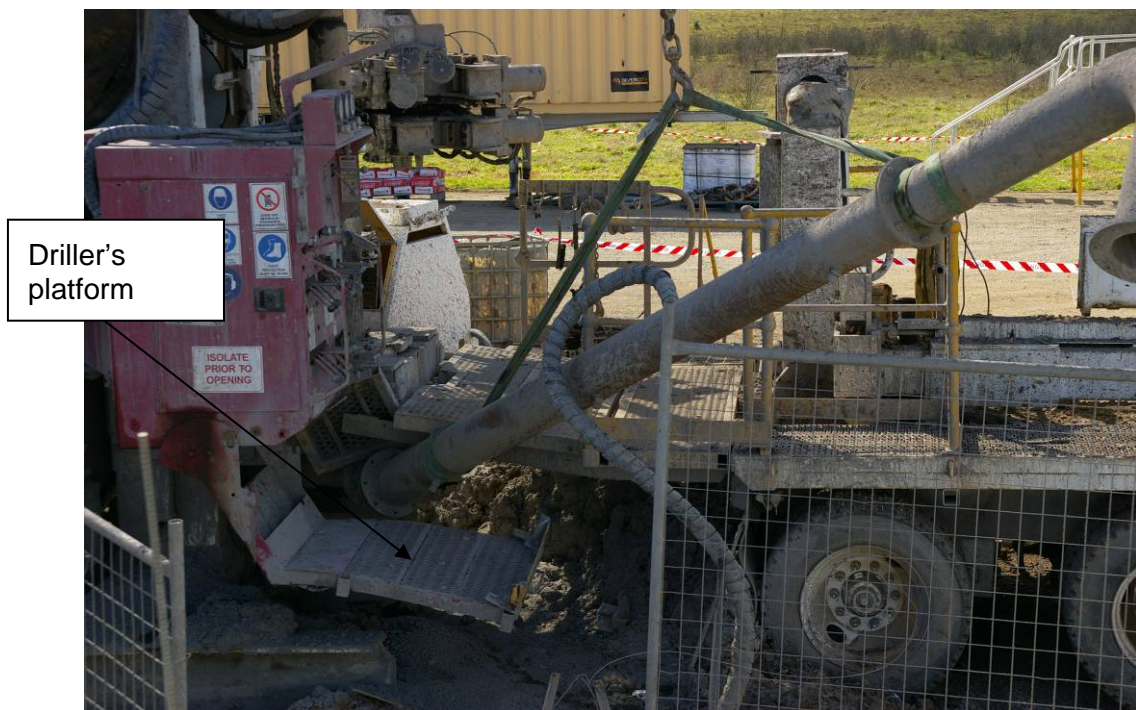
Figure 8. Drilling platform and elevated air discharge line.

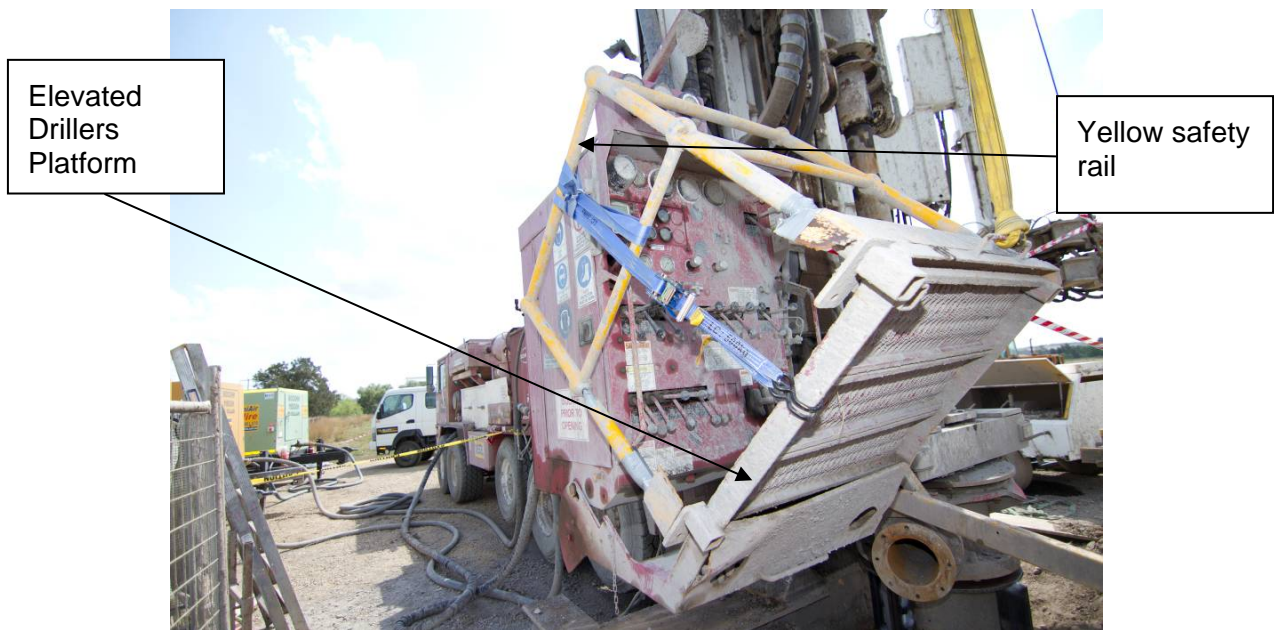
Figures 9 and 10 demonstrate the direction of travel the driller's platform was able to take and the likely trajectory that the air discharge line could have taken.

Figure 9. The driller's platform in a simulation designed to show the trajectory that was possible during the incident.

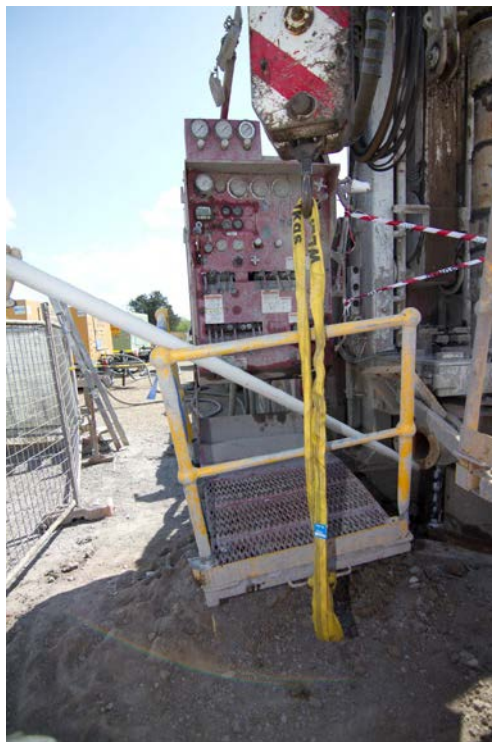
Figure 10. The likely final resting point of the driller's platform. The air discharge line is represented by a white polyethylene pipe.

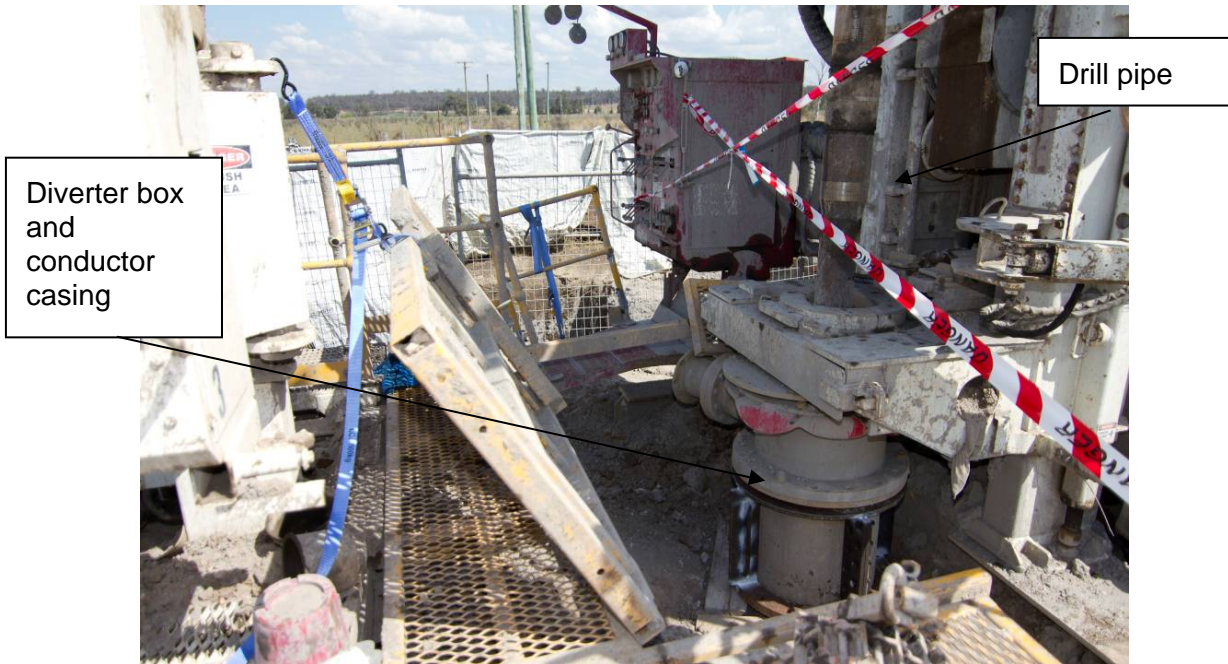
The casing is required to be bonded to consolidated ground, but grouting will generally not be effective in alluvial layers. It is generally considered necessary to bond the casing to solid strata, such as bedrock. Inadequate installation of the conductor casing in an alluvial area enabled water to enter the borehole from an alluvial aquifer. Just before the incident, Silver City Drilling estimated that the borehole was producing 15,000 to 20,000 litres of water every hour.

Figure 11 identifies the conductor casing and diverter box at the Borehole 4 incident site.

Figure 11. The conductor casing being supported by a steel bracket and the drill string.

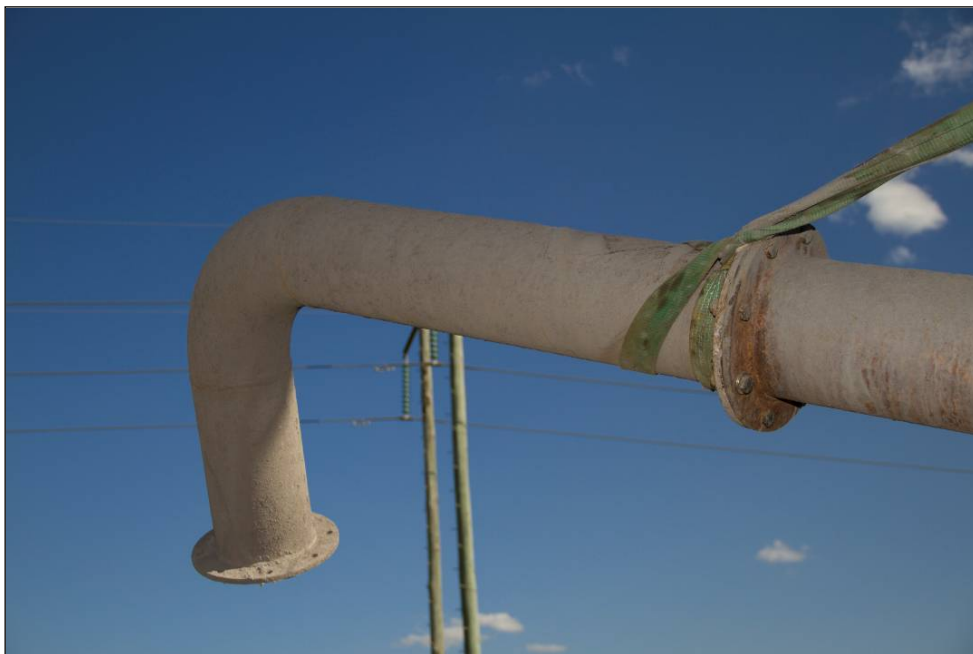
The addition of a 90 degree elbow to the end of the air discharge line is a key contributing factor in the incident that occurred at the Borehole 4 site. The air discharge line with the 90 degree elbow can be seen in figure 12.

Figure 12. 90 degree elbow on the end of the air discharge line.

This change to the air discharge line resulted in a shift of forces from horizontal to vertical.

The 90 degree elbow was installed by Silver City Drilling in response to concerns about the environmental problem that occurred on Borehole 3. A 90 degree elbow was available on site as a result of a previous job where it had been attached at the collar end of the blow out preventer (BOP). A BOP was not required on the Ashton Coal Operations job but remained on site until it could be transported back to the Silver City Drilling depot.

The installation of the 90 degree elbow on the air discharge line changed the directional forces from horizontal to vertical creating a lifting force on the air discharge line. The air discharge line securing system was inadequate to restrain the air discharge line. The risks involved with the system were not identified or adequately controlled.

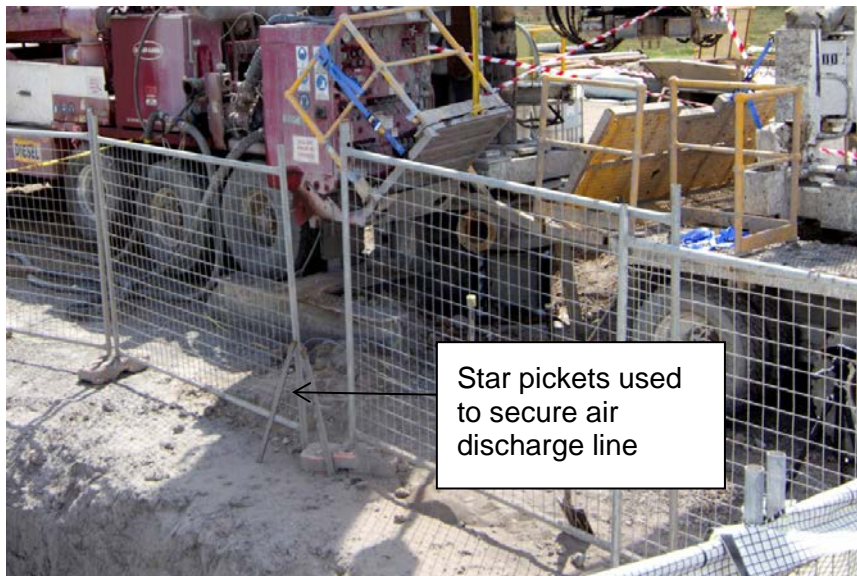
This anchoring system was ineffective and failed to prevent the air discharge line from lifting when the direction of force from the end of the air discharge line was changed from horizontal to vertical.

Figure 13. Borehole 4 scene depicting star pickets and fencing wire used as an air discharge line anchor.

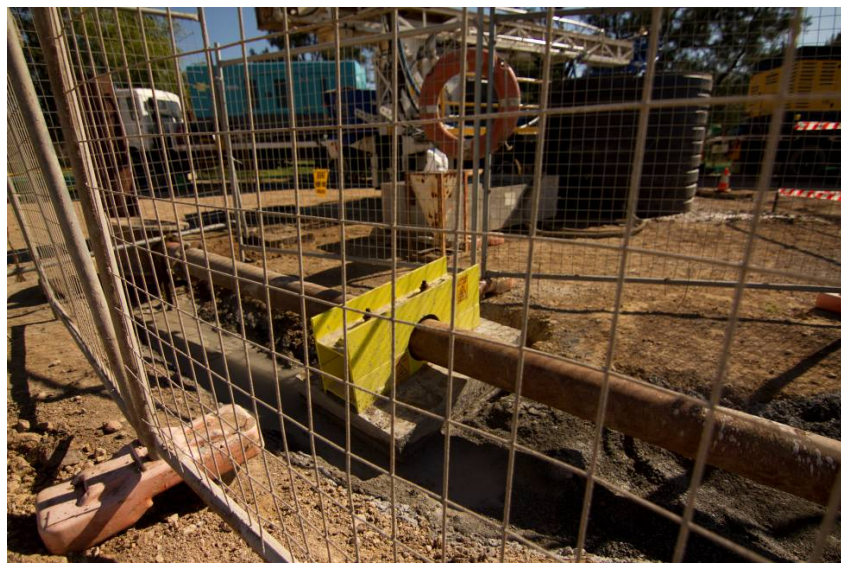
Figure 14. Air discharge line anchor required post incident.

The photograph below shows the air discharge line anchoring system that Ashton Coal Operations now requires prior to air drilling.

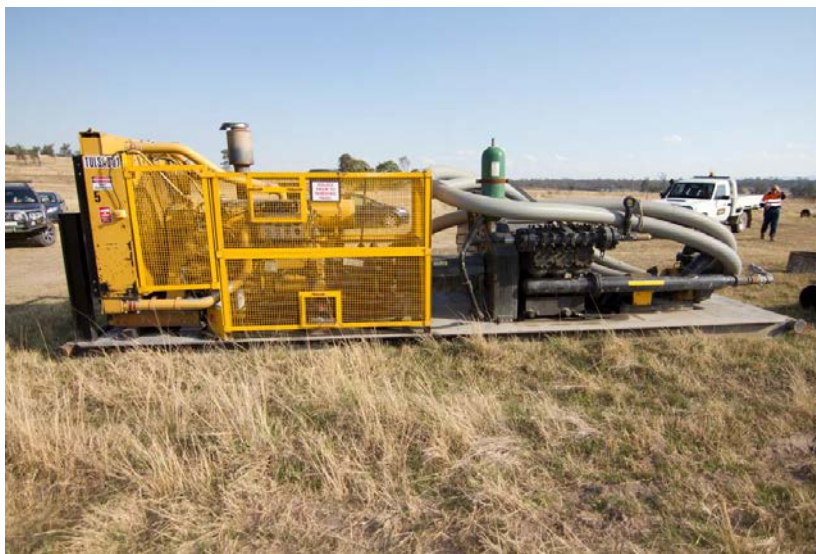
It would have been possible to convert to this form of drilling when the issue of excessive water was first raised. Silver City Drilling had the required equipment to undertake rotary mud drilling on site. The following picture identifies a Triplex mud pump that was on site at the time of the incident.

Figure 15. A Silver City Drilling Triplex mud pump on site at Ashton Coal Operations premises.

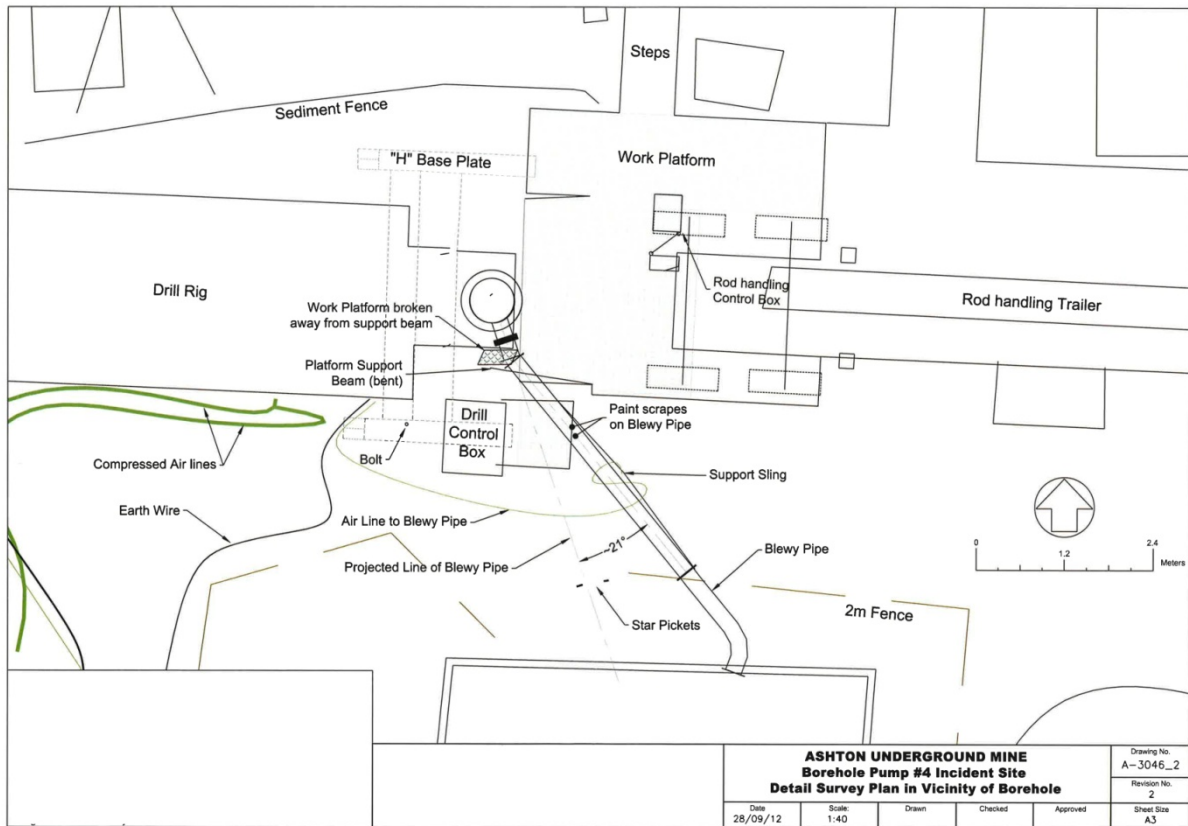
Figure 16. The Borehole 4 drill pad post incident.

The design of the drill pad, location of the sump and orientation of the drill rig required the air discharge line to travel under the driller's platform. An alternative drill pad design could have prevented the air discharge line from traversing under the driller's platform.

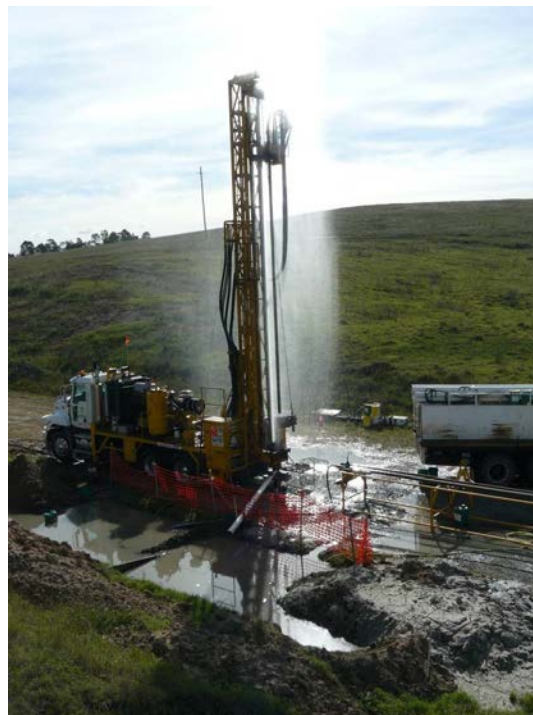
According to reports on those incidents, both exploration drill rigs appear to have intersected high pressure aquifers after drilling through broken ground later determined to be geologically significant. The resultant circumstances of drilling into an aquifer under pressure were an ejection of the core barrel and the release of fugitive water and gas from the well. These types of incidents are commonly referred to as a 'blow out'.

Figure 17. A 'blow out' incident on an exploration drill rig in the Hunter Valley.
