Summary Investigation Report

Serious injury involving longwall service
cassettes at the Beltana Mine on

21 August 2008

Report prepared for the Director General of the
Department of Industry and Investment by the
Investigation Unit, Thornton

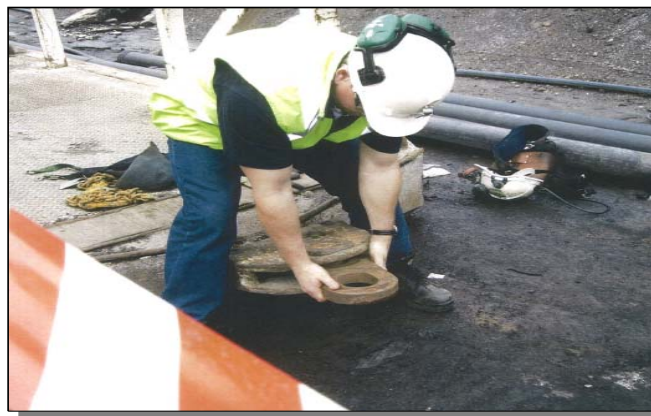
As Mr Thomas lent down to pick up the coupling he put his right leg on the ground next to the front of the coupling of SB2 as shown in the next photo. He lifted the 18 kg coupling and lug (a 9kg lift) to about horizontal position. As SB3 cassette was pushed closer (from the right of Mr Thomas' position) it swung clockwise toward the join area. SB3 continued to move past the coupling joint point and caught Mr Thomas' leg between the two cassette couplings. The crushing force of the impact caused several compound fractures to Mr Thomas' right lower leg.

Photo showing re-enactment of lifting the cassette coupling

- Scene preservation and restricted access to the site
- Upon withdrawal of the section 89 Notice by the Department's Inspector an assessment of joining longwall service cassettes was undertaken by the mine
- Beltana reviewed the longwall service cassette couplings and developed a system to support the coupling so people are no longer required to support it manually
- Beltana completed a job safety analysis (JSA) for the task of coupling the longwall service cassettes and made it available on the company intranet to all personnel and contractors.

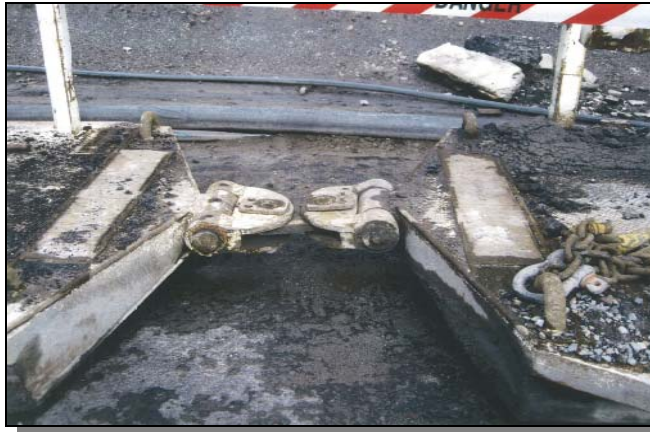
Photo showing cassettes with joined couplings

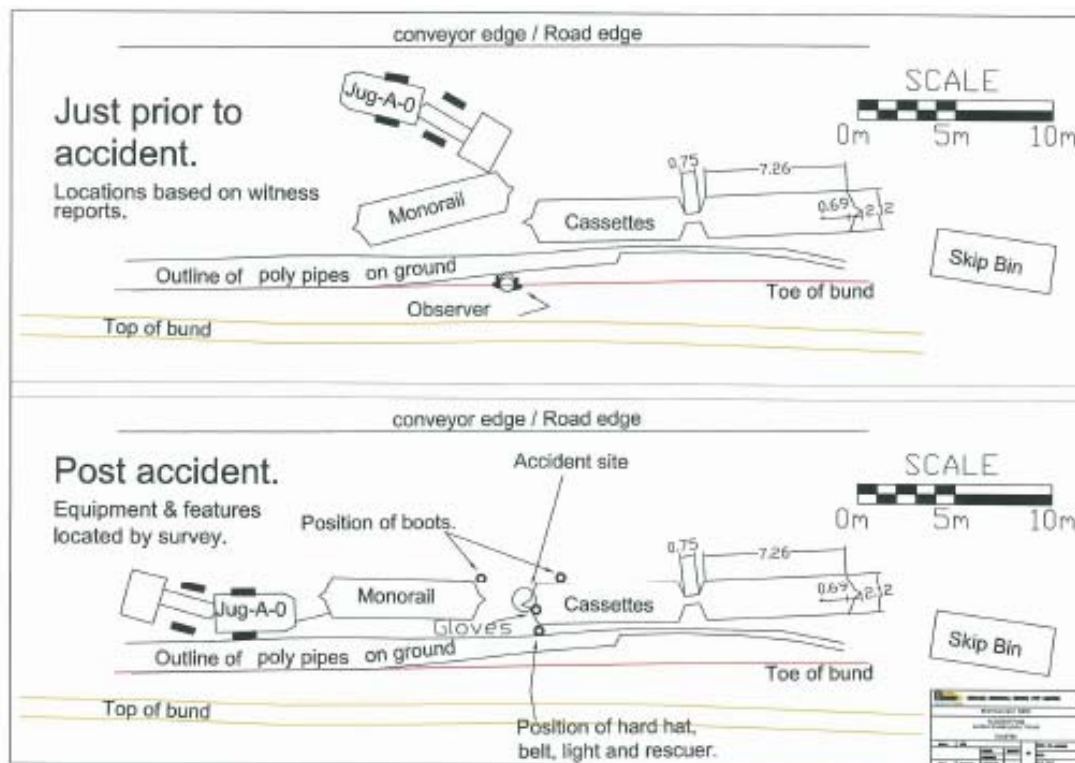
Plan of incident supplied by Beltana Highwall Mining
