Investigation Report

Elevated work platform incident resulting in injuries at the Bulga Open Cut Mine on 21 March 2006

Report prepared for the Director-General of the Department of Industry and Investment by the Investigation Unit, Thornton

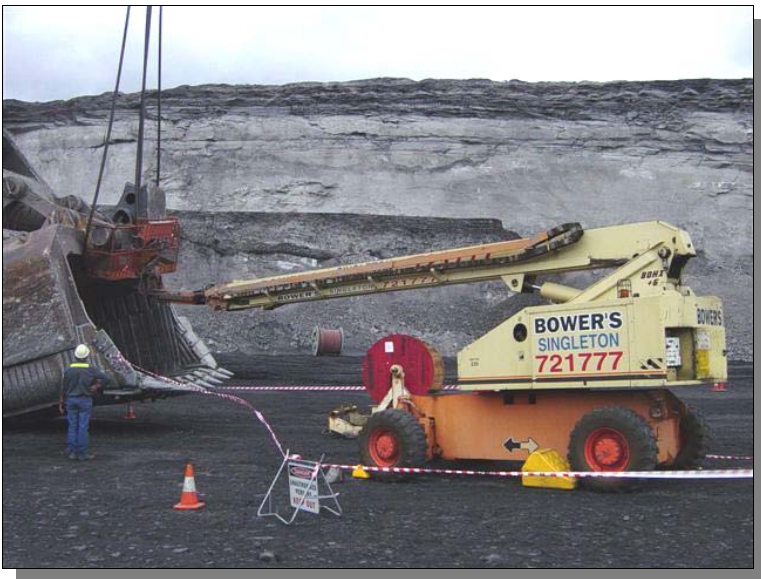
At about 12.15pm the fitter was holding a hoist rope when he turned around to reach the boom lift-lever which moves the man-basket up and down. At the same time his foot was on the ‘deadman’s pedal’. The EWP suddenly lurched forward into the bucket equalizer. The impact crushed the man-basket door, pinning the right foot of the fitter. After several attempts he was able to stop the EWP using the emergency stop button on the platform control panel.

Aerial lift and P&H 4100 shovel bucket

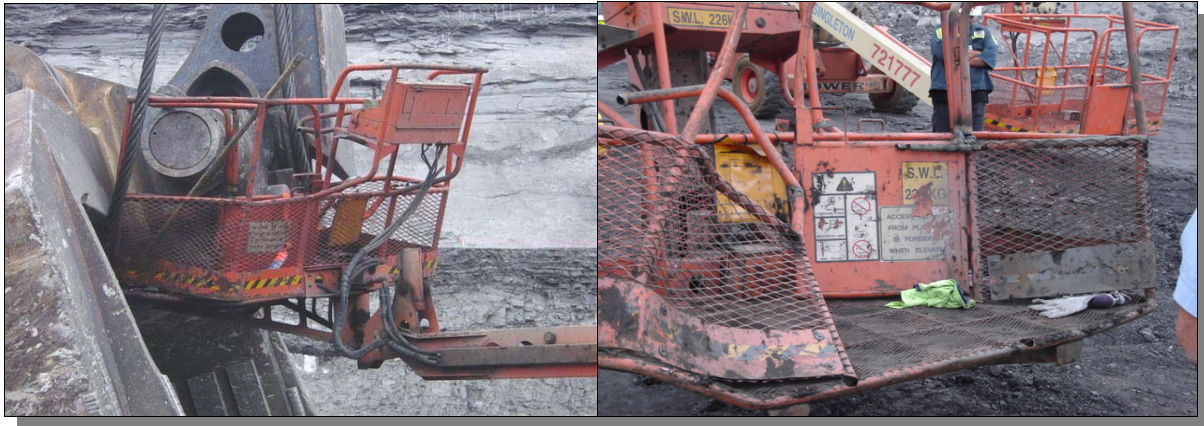
Man-basket, hoist ropes and equalizer

Man-basket showing damage to platform door

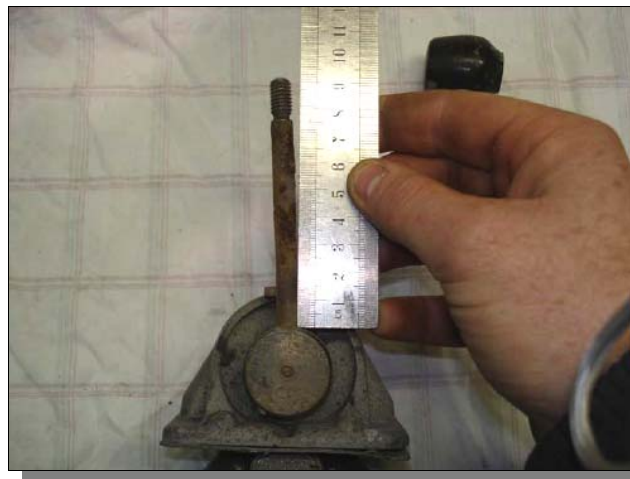
Examination of the EWP found that the drive controller slide lock mechanism was jammed in the up position. This was caused by the drive controller lever shaft being bent off centre. The jammed slide lock would not affect the operation of the drive control lever but it would prevent the control lever being locked in the neutral position to prevent inadvertent operation.

The bent centre shaft of the drive controller

Mr Baxter and the fitter, who operated the EWP, both inspected the machine before starting operations. Neither of them identified that the drive controller slide lock mechanism was jammed in the up position making it impossible to lock the drive controller in the neutral position.

The pre-deliver inspection conducted by Boom Logistic Ltd. also failed to identify this fault.

Notices issued A notice was issued to Bulga Coal under section 63(1) of the *Coal Mines Regulation Act 1982* imposing restrictions with regard to the EWP and requiring an independent assessment of its operations.

An improvement notice under section 91 of the *Occupational Health and Safety Act 2000*-was issued to Boom Logistics Ltd. regarding safety issues relating to the EWP.
