Published Investigation Report

Serious inrush incident at the Cadia East
Mine on 21 February 2010

Mine Safety Investigation Unit

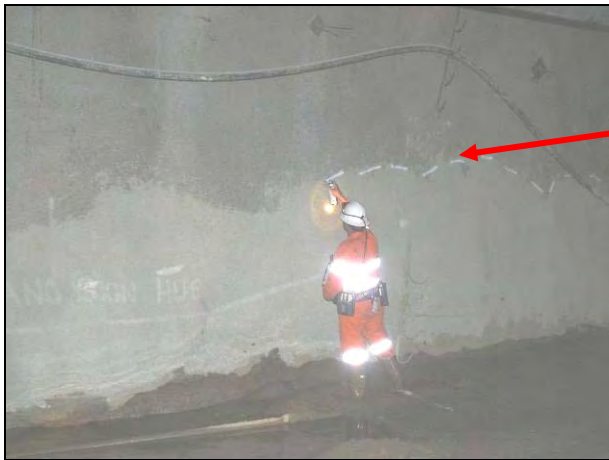
Photograph near base of VR5A shaft.

This photograph shows dried mud on the wall of the drive indicating the height the material reached as it flowed down the drive from the base of VR5A shaft.

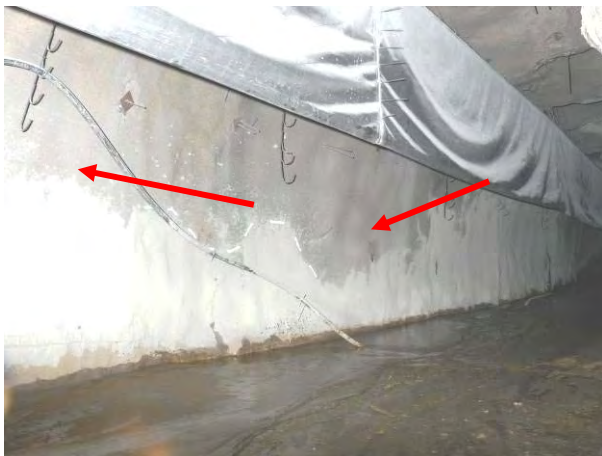
Photograph at base of VR5A shaft.

This photograph is the section of the drive at the base of VR5A shaft. It shows dried mud in a slumping pattern on the wall of the drive as it flowed from the base of VR5A shaft. It also shows dried mud on the ventilation bag at approximately 7m in height

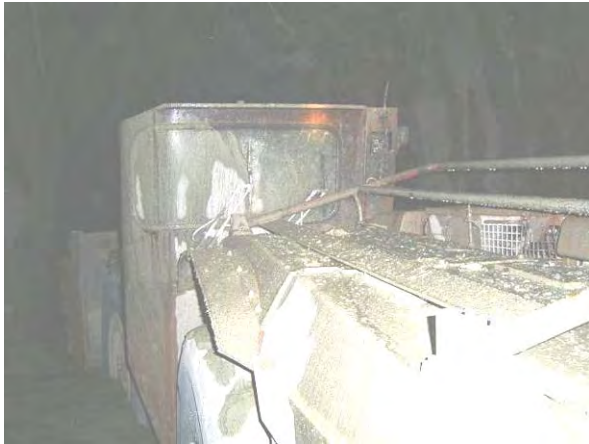
Photograph of the rear view of bogger (L001) that was pushed down the drive.

Note the mud material that had coated the bogger up to the cabin level.

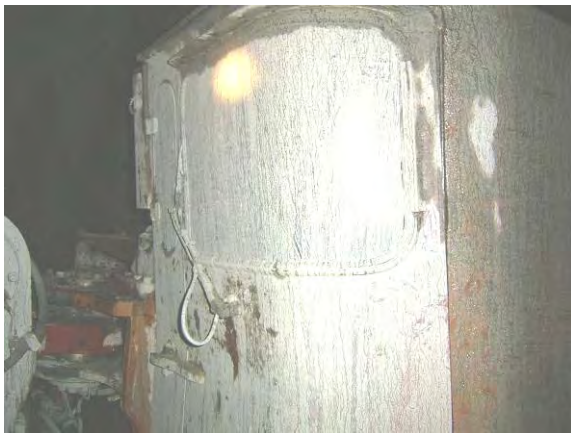
Photograph of the bogger (L001) that was pushed down the drive.

Note the mud material that had coated the front windscreen of the bogger.

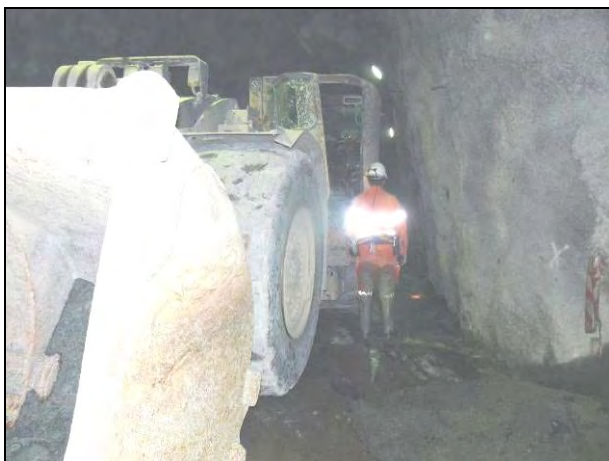
Photograph of the bogger (L001) that was pushed down the drive.

The bogger is parked in the underground workshop after the incident.

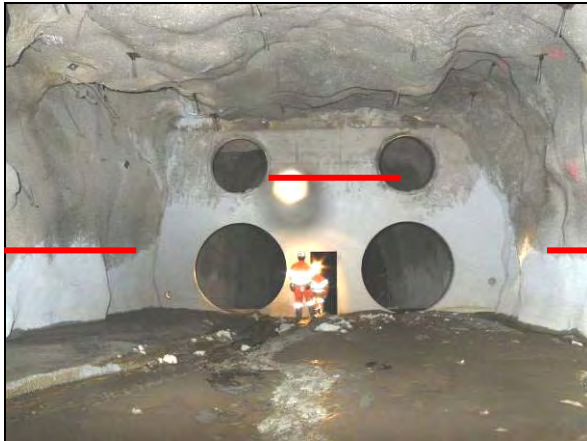
Photograph of ventilation wall approximately 350m from base of VR5A shaft.

Showing the height of the inrush material on the walls and the ventilation structure located approximately 350 metres from the VR5A shaft. The red lines are indicative of the height of the inrush material in comparison to the two persons standing at the doorway.

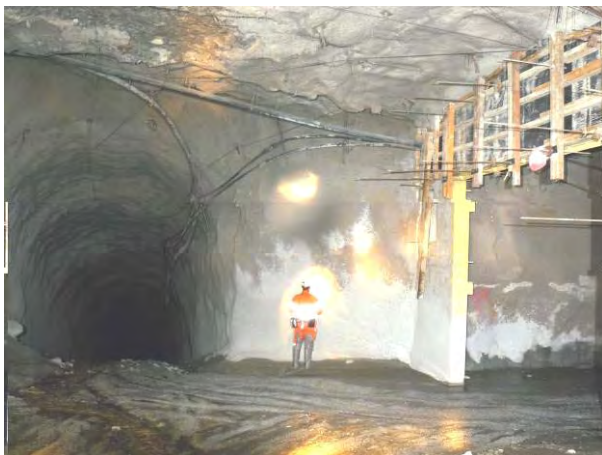
Photograph of roadway intersection 550m from base of VR5A shaft.

Showing the height of the inrush material on the wall beyond the ventilation structure.

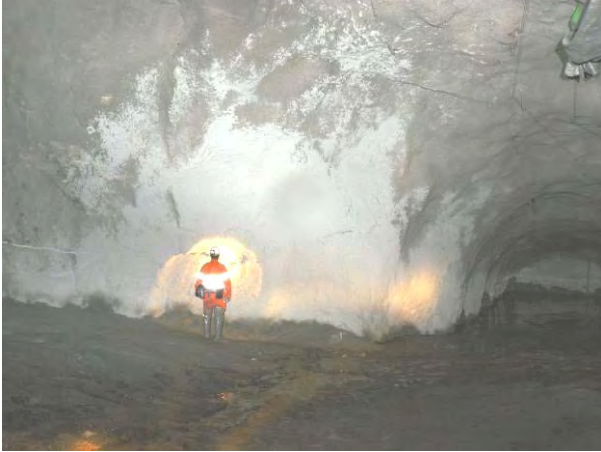
Photograph of ventilation wall at intersection near top of VR5B shaft – 760m from base of VR5A shaft.

Showing the height of the inrush material on the wall beyond the ventilation structure.

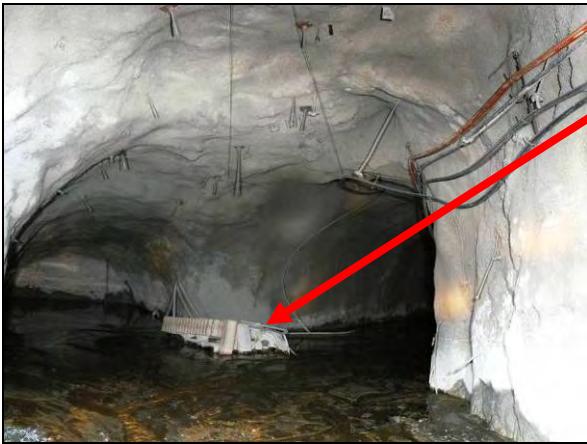
The inrush material travelled through the holes in the ventilation structure and continued along the VR5A ventilation drive. It washed a 6 tonne unmanned mini excavator that was close by to the structure 300 metres along the drive to within close proximity of the top of the open VR5B shaft approximately 100 metres below the level of the base of VR5A shaft. The following photograph is of the 6 tonne excavator covered in mud at rest in the vicinity of VR5B shaft.

Photograph of the mini excavator that was washed approximately 300 metres along the drive to top of VR5B shaft.

Excavator on its side with one track visible. The top of VR5B shaft is in the drive to the right of the buried excavator. See the following full photo of this model excavator.

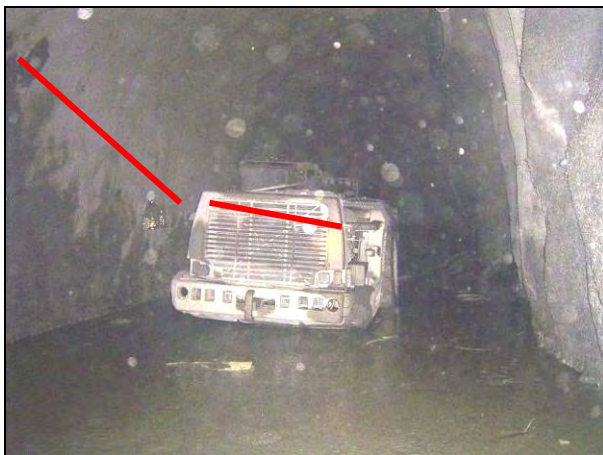
At the base of this shaft a second operator in a Bogger (L005) was exposed to the inrush. This machine was also struck by the wet material and subjected to a higher than normal wind velocity from VR5B shaft. On exit from his machine the operator found wet material to a depth of over 1m in the area.

Photograph of the second bogger (L005) that was operating in the area at the bottom of VR5B shaft.

The bogger is located in wet material near the base of VR5B shaft. The red lines indicate the height of the inrush material.

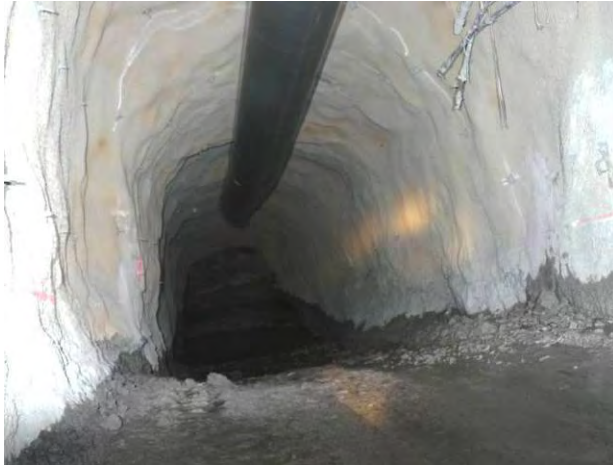
Photograph of sump at bottom of decline.

A jumbo drill crew were preparing their drill in readiness to move into this area to set up to drill.

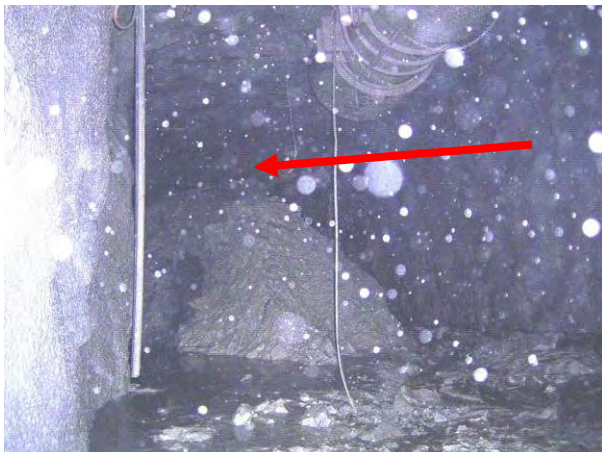
The inrush material washed away part of a temporary structure of piled up material and a brattice that was at the base of the VR5B shaft for controlling mine ventilation. This caused a change to the ventilation in the mine. It took air away from the main decline (main mine access drive) and a workshop.

Photograph of the area at the base of the VR5B ventilation shaft.

The red arrow points to where a brattice arrangement was located prior to the inrush at the base of the VR5B ventilation shaft.

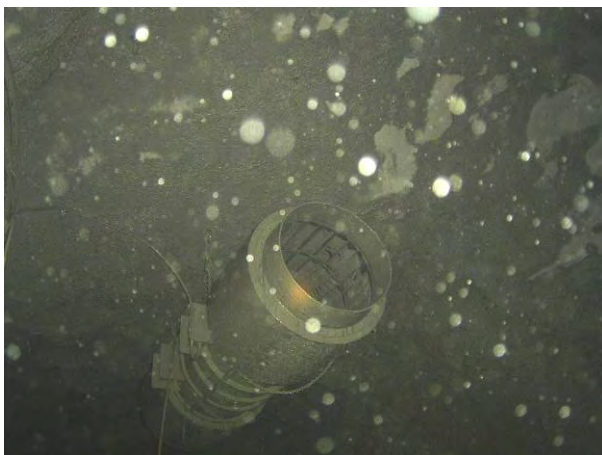
Photograph of the fan installed in the drive at the base of VR5B base of the VR5B ventilation shaft.

Note the splatter of the inrush material on and around the electrical ventilation fan.

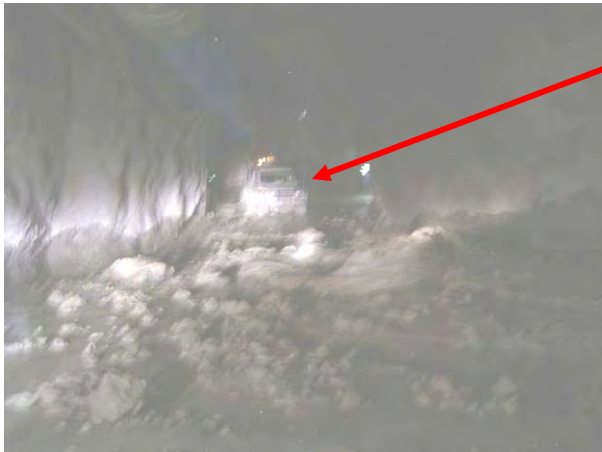
Photograph of the light vehicle bogged in the inrush material below VR5B shaft.

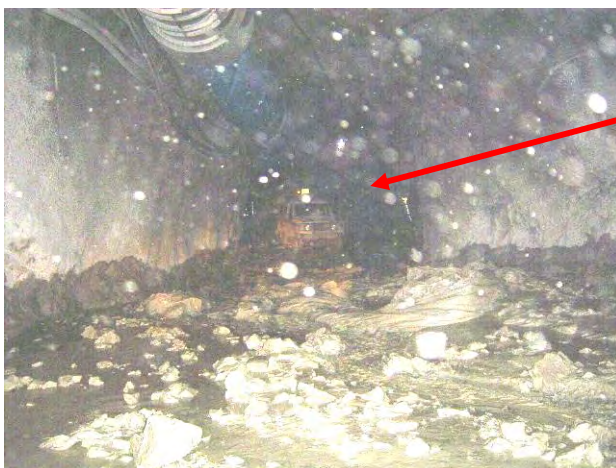
2nd Photograph of the light vehicle bogged in the inrush material below VR5B shaft.

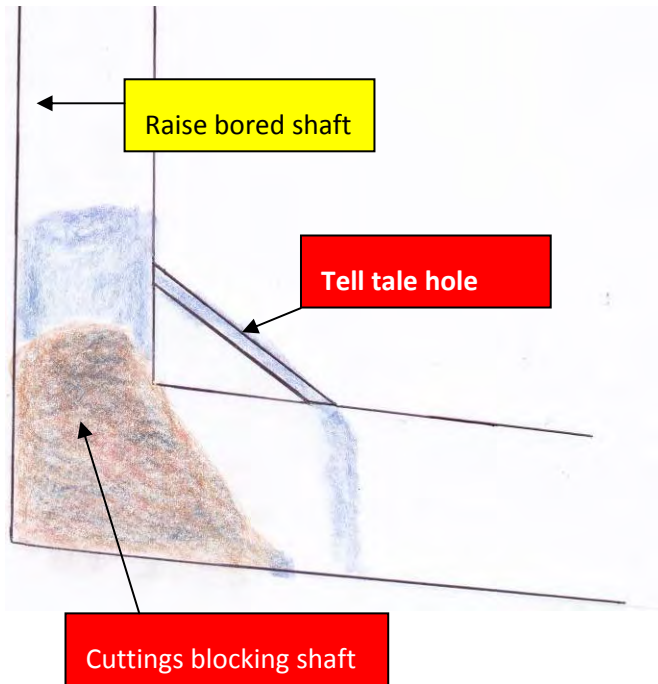
Diagram created by A Piggott.

Representation of a shaft blocked by the build up of cuttings at the bottom and water accumulating up the shaft.

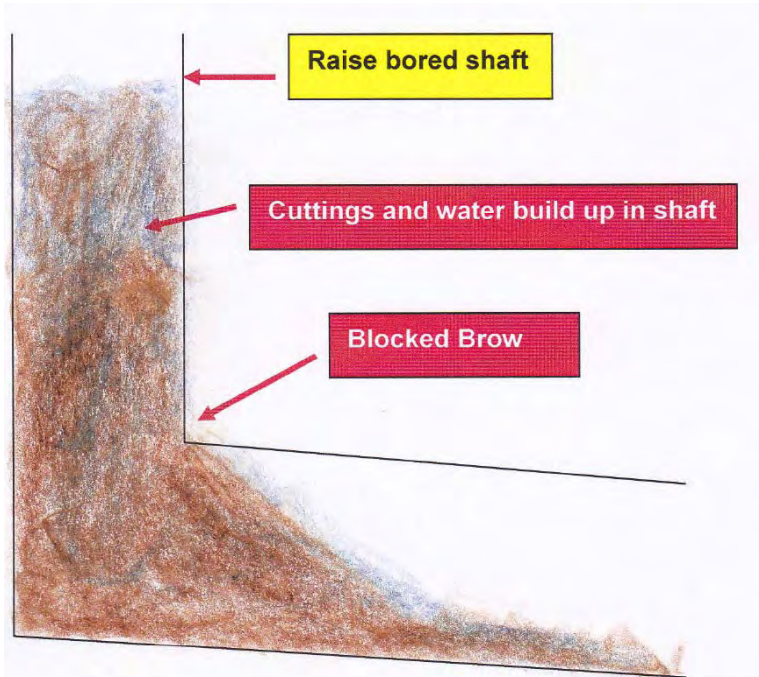
Diagram created by A Piggott.

The inrush was a result of an excessive build up of reamed cuttings choking the raise bore shaft at its base and the subsequent further build up of the unknown quantity of water and cuttings in the shaft bursting out from the bottom of the shaft.

Representation of the potential for cuttings and water to build up in a shaft when the brow of the hole at the bottom of the shaft becomes blocked.

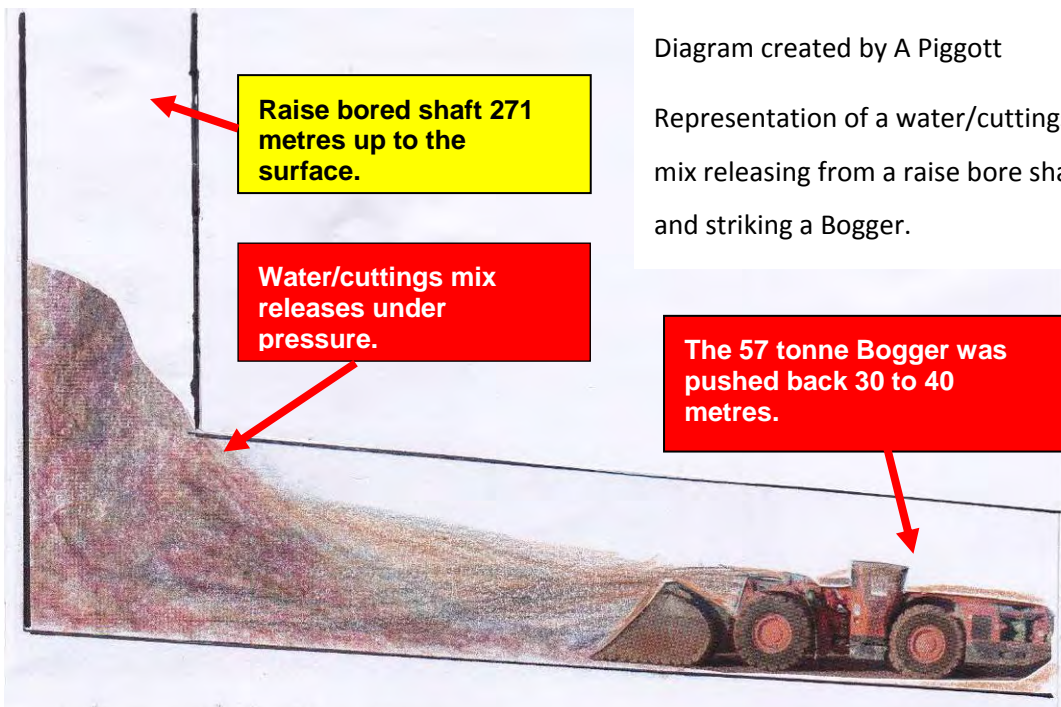
Diagram created by A Piggott

Representation of a water/cuttings mix releasing from a raise bore shaft and striking a Bogger.

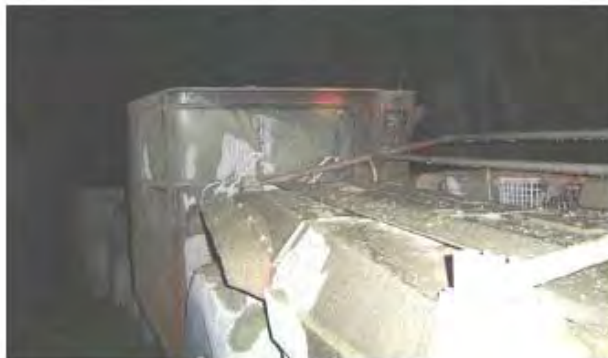
The photo shows the rear view of the bogger that was removing the wet cuttings from the base of the raisebore hole at the time of the inrush.

Note the inrush material visible on the machine up to the enclosed operator cabin.
