Investigation Report

Incident involving
Bruce Slessor

Cadia Valley Operations
South Waste Dump Extension

24 August 2008

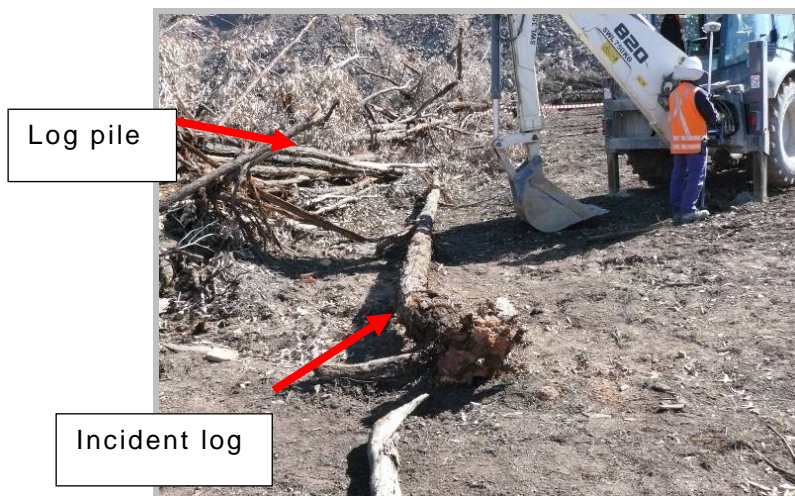
This photo shows the root ball of the incident log on the ground in front of the backhoe and the timber pile.

Person in the photo taking measurements post the incident

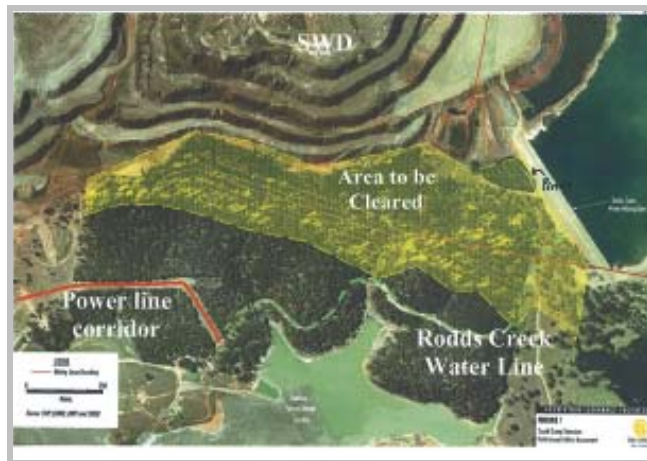
This diagram shows the area cleared in May 2008 below the South Waste Dump and Rodds Creek Dam.

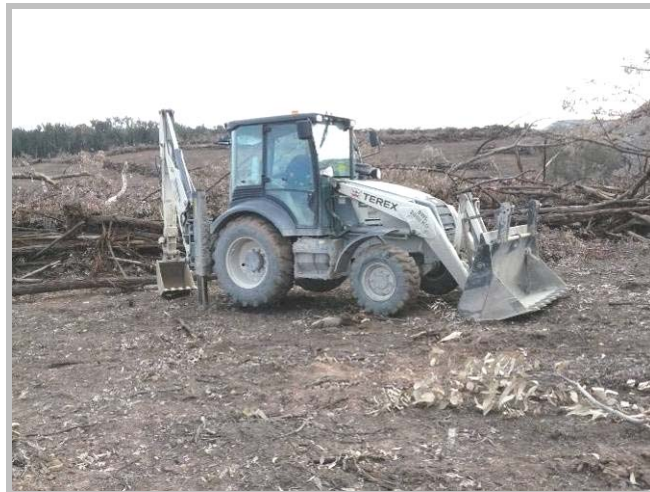
The photo shows the backhoe position in relation to the pile of wood.

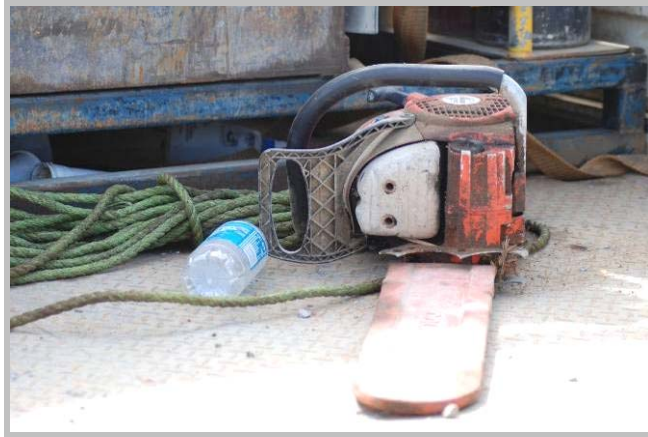
The photo shows a green rope and a chainsaw found in the tray of a CVO vehicle allegedly used by Mr Slessor.

At the time when the photo was taken the vehicle had been relocated from the incident scene to the CVO main office.

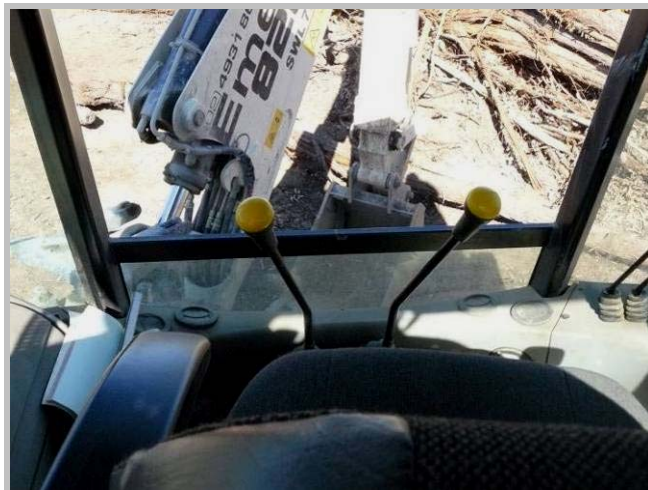
The photo shows the view from the backhoe seat position showing the relation of the log pile, the backhoe bucket and the incident log on the ground.

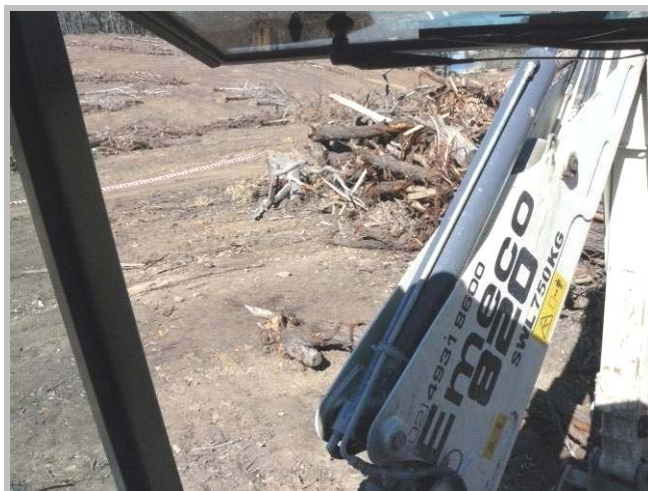
The photo shows the left hand side view from inside the backhoe cabin.

The incident log stump end is visible on the ground.

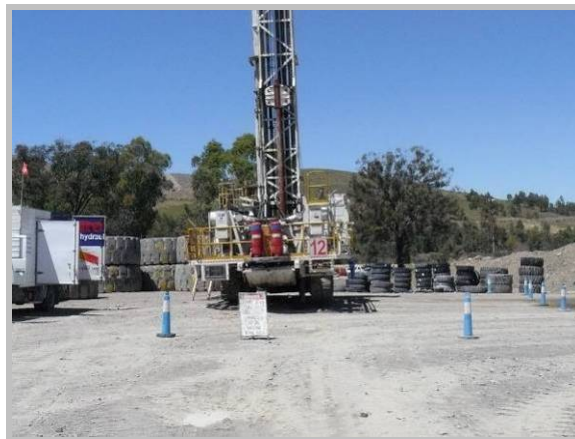
The photo shows a machine under maintenance control with blue coloured cones and radio notification signage board in place.

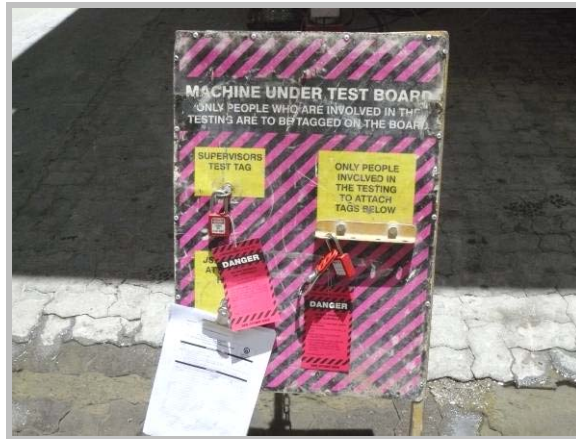
The photo shows the notice board placed for a maintenance task.

Attached were machine isolation lock and tag and personnel sign on documentation.
