**NSW
Resources
Regulator**

CAUSAL INVESTIGATION REPORT

COLLAPSE OF SHAFT COLLAR

North Wambo Underground Mine

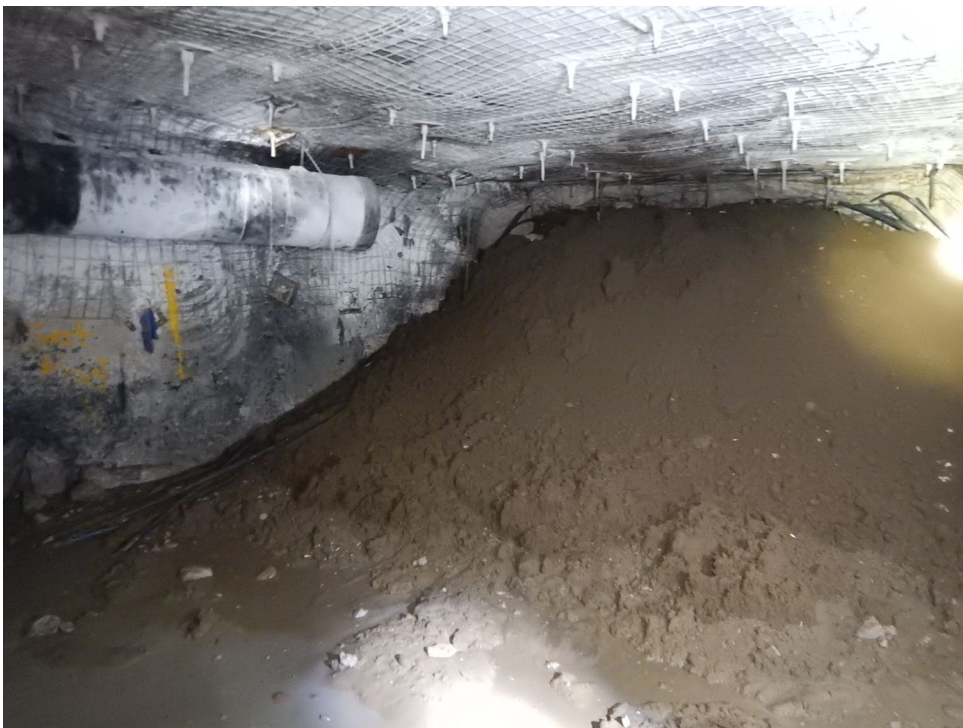
Figure 1 The bulkhead seal location after the catastrophic failure

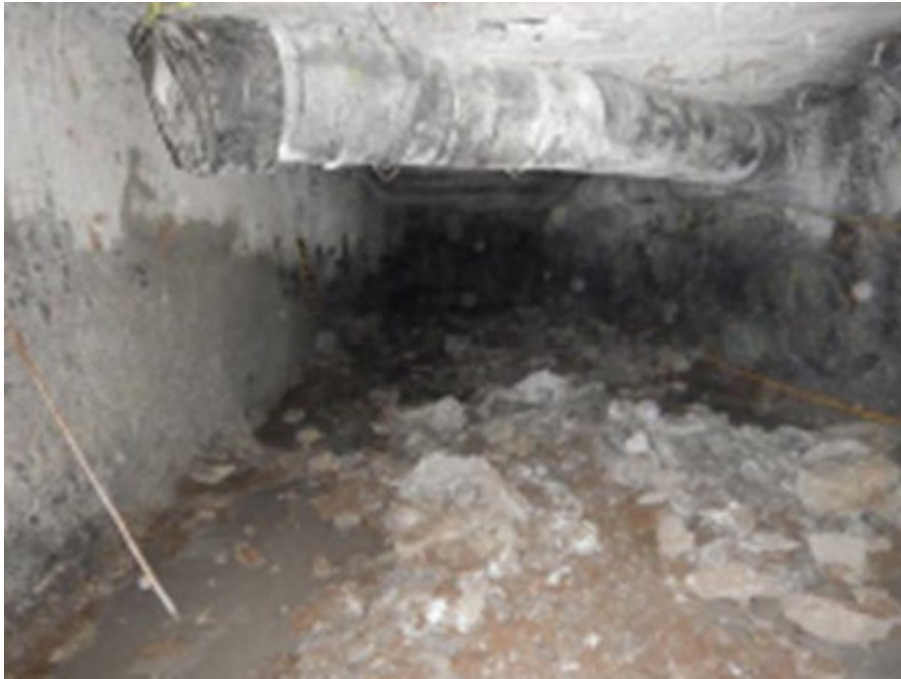
Figure 2 Looking inbye from the bulkhead seal site following the catastrophic failure

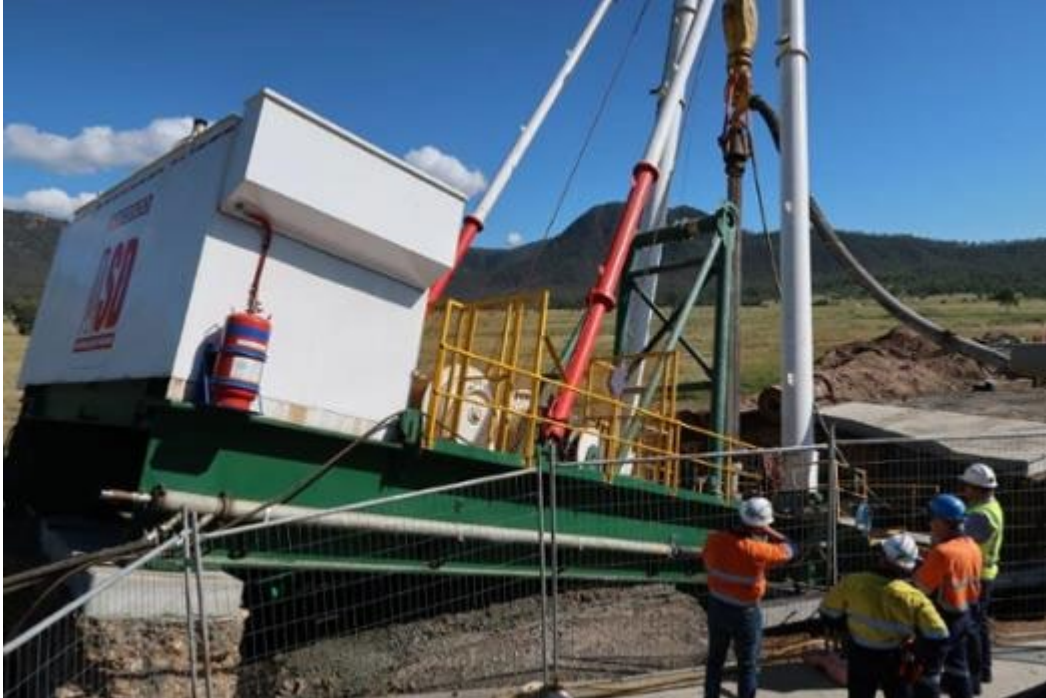
Within minutes of the drilling mud escaping from the shaft, the alluvial materials close to the surface began to collapse into the shaft void, due to the rapid loss of confinement pressure. A sinkhole rapidly developed and the drill rig personnel moved to a place of safety, before both the drilling rig and constructed drilling pad partially descended into the sinkhole.

Figure 3 The blind boring drill rig operated by Australian Shaft Drilling Pty Ltd partially sunk in the collapsed shaft

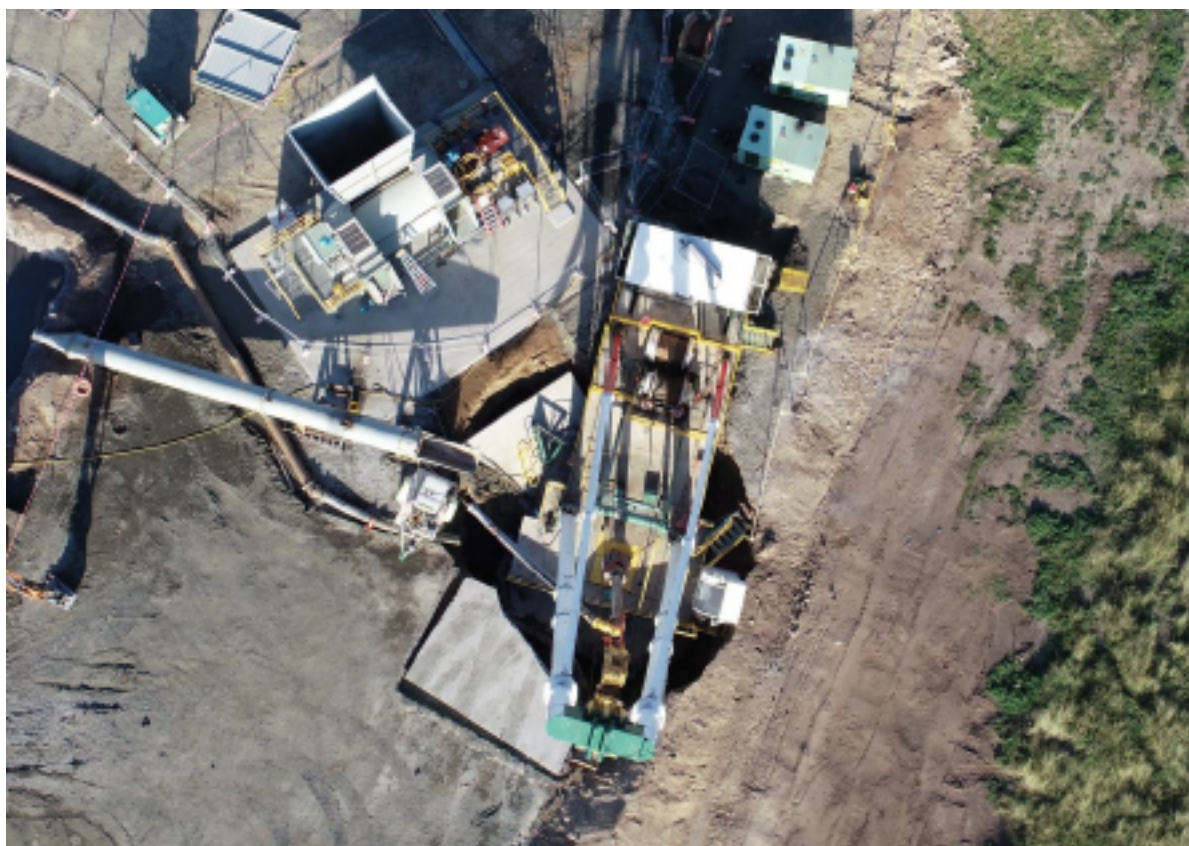
- The drillers were not injured and had removed themselves from the drilling platform before the partial collapse into the shaft collar. An aerial photo depicting the collar collapse can be seen in Figure 4.

Figure 4 An aerial view of the shaft collar collapse

At this stage of the investigation, the likely cause was considered to be the catastrophic failure of the underground bulkhead/plug seal arrangement, resulting in a rapid loss of drilling mud/confinement pressure within the shaft. This allowed the ingress of alluvial material from the upper section of the shaft surrounds into the shaft, resulting in partial collapse of the drill rig platform into the shaft collar.

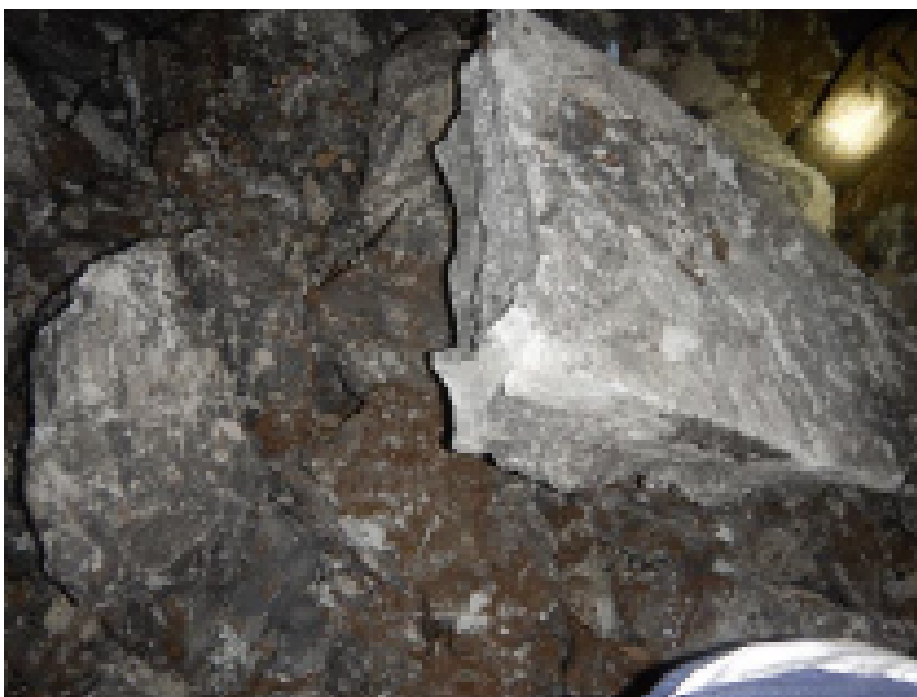
Mastermyne Pty Ltd conducted a series of tests on the placer pump and the cementitious materials used to construct the bulkheads/plug seal to determine the reasons for the structure failing to attain its design strength. These tests failed to identify any deficiency with the operation of the pump or the individual constituents of the cementitious product.

Figure 5 Failed cementitious product recovered from the failed bulkhead

- Basic cause - The basic cause of this event is the failure of the bulkhead and plug arrangement, of which its purpose is to prevent the loss of drilling fluids from the drill shaft.
- Root cause - The cementitious material used to construct the bulkhead and plug arrangement did not perform to specification. The samples recovered from underground were of varying hardness and strength. This suggests that the material pumped into the void has not cured to the required strength to form a homogenous unit and therefore failed to meet the intended purpose.

- An investigation is required to understand the circumstances/factors that led to the cementitious product not curing to the intended strength.
- The design of the bulkhead and plug is to be independently reviewed by a suitable engineer experienced in the intended application.
- Review the Wambo risk management standard to develop controls that align with requirements of Peabody risk management standards.
- Peabody will undertake a review of the WRAC template to improve the notification level function and alignment to legislative requirements including the consideration for hierarchy of controls.
- Review the compliance certification for the other seal/bulkhead installations at Wambo Mine constructed from the same materials.

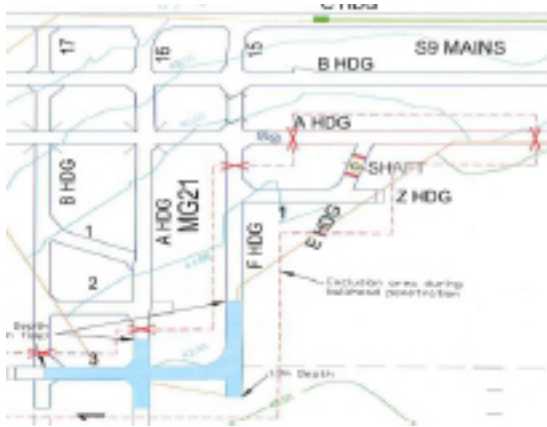
- The original strategy of drilling into virgin coal was not undertaken.
- The relocation of the shaft occurred on multiple occasions. This was a consequence of mine scheduling and financial pressures and limited locations due to underground fault systems and surface disturbance limitations.

Figure 6 A mine plan of the proposed seam intersection by the blind borehole and the inrush control zone

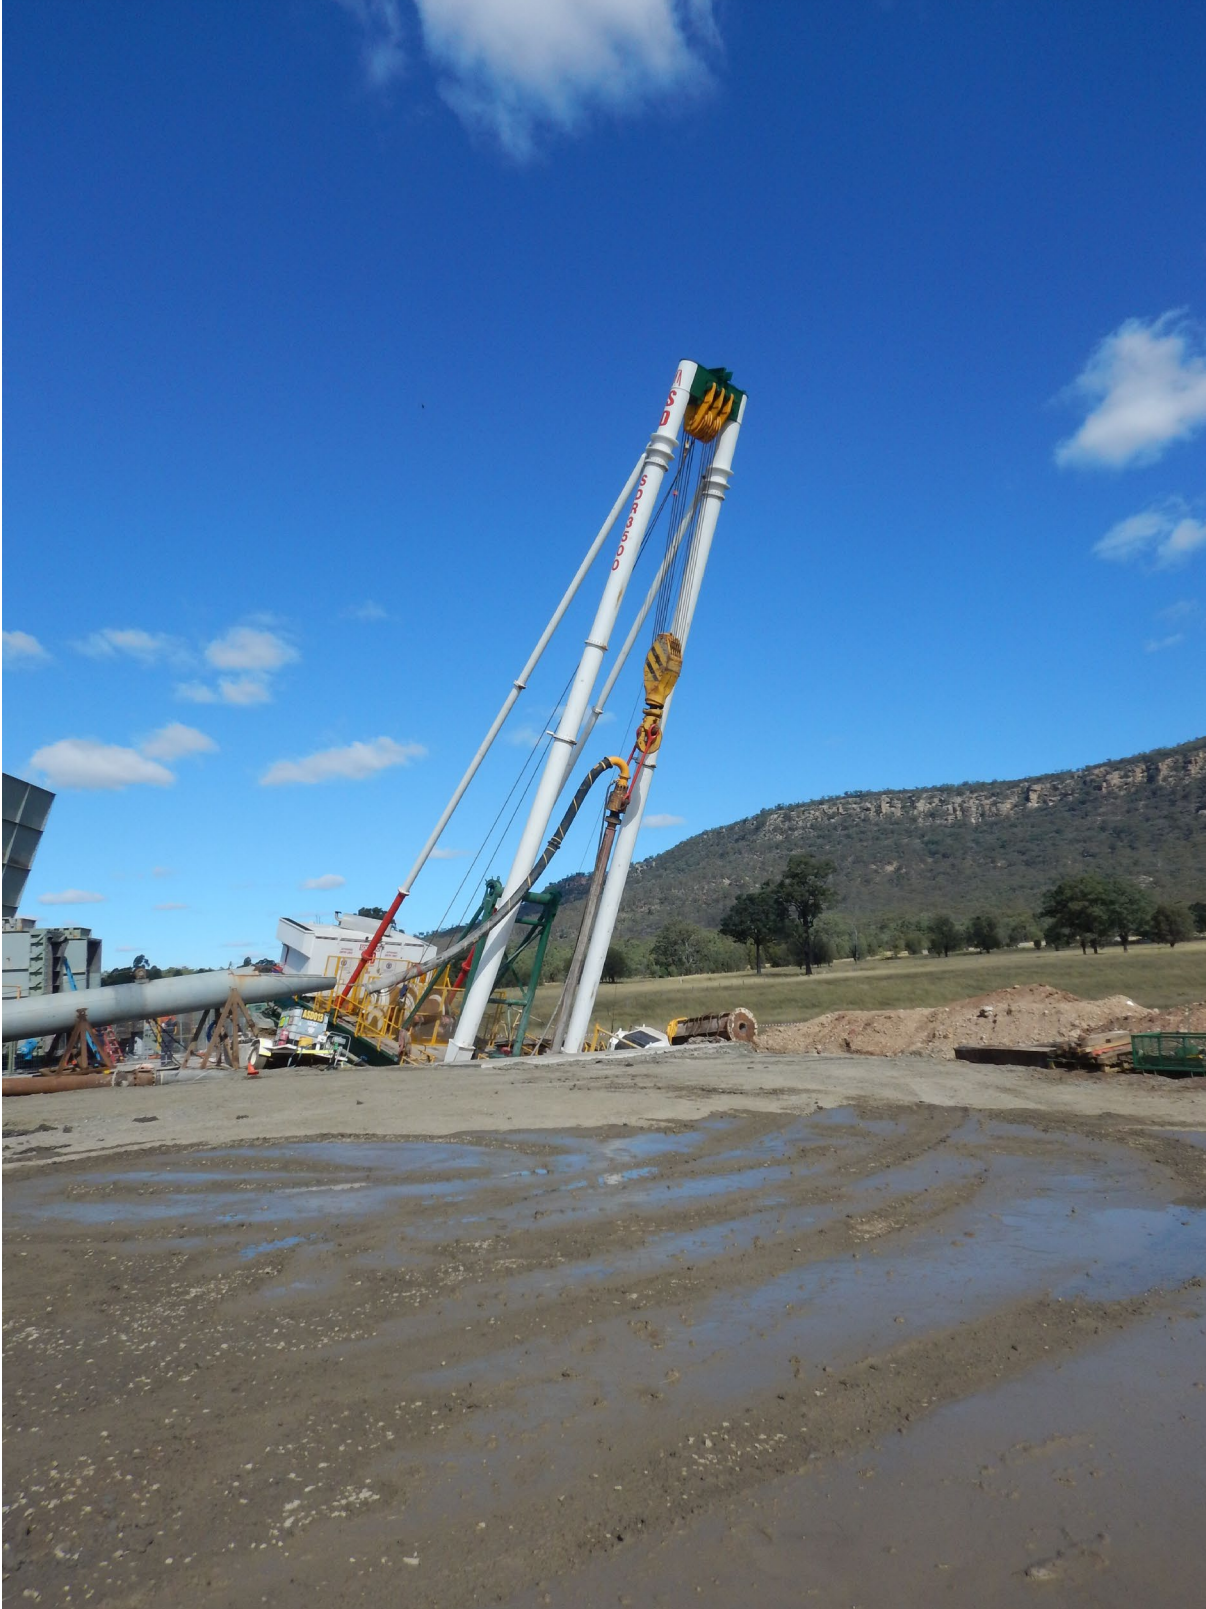
Figure 7 The incident scene
