**NSW  
Resources  
Regulator**

# **Workers trapped in shaft winder**

Causal investigation

Title: Causal investigation – Workers trapped in shaft winder

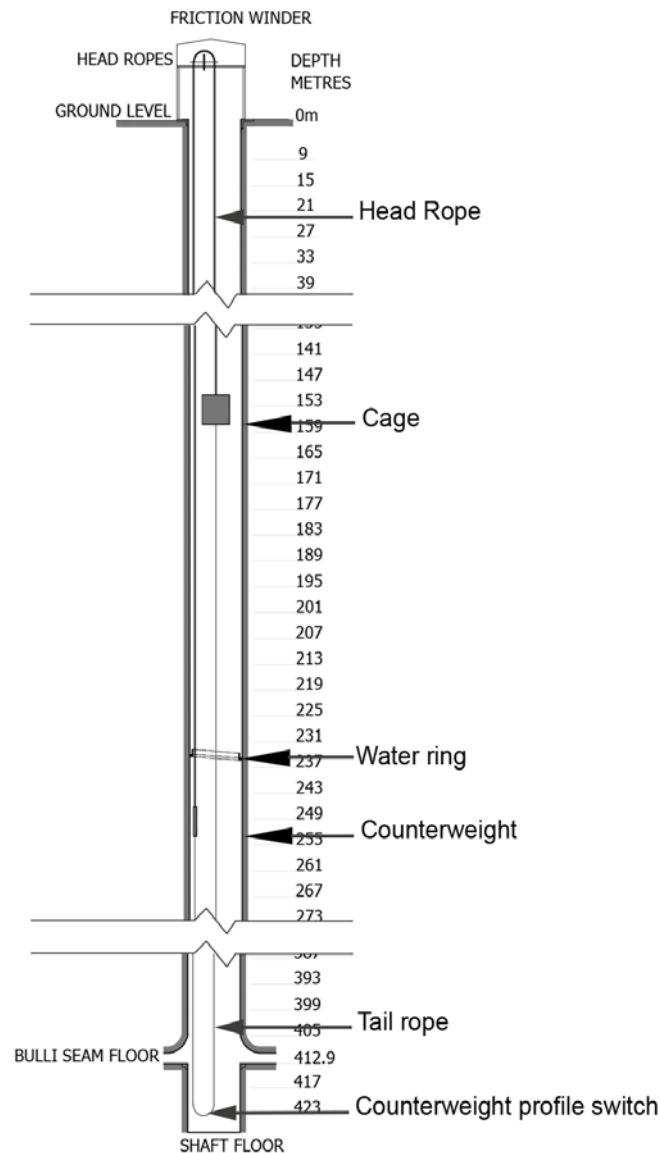
Figure 1: Annotated shaft profile drawing.

The final position of the cage conveyance was at the 162-metre mark. This is depicted in figure 1.

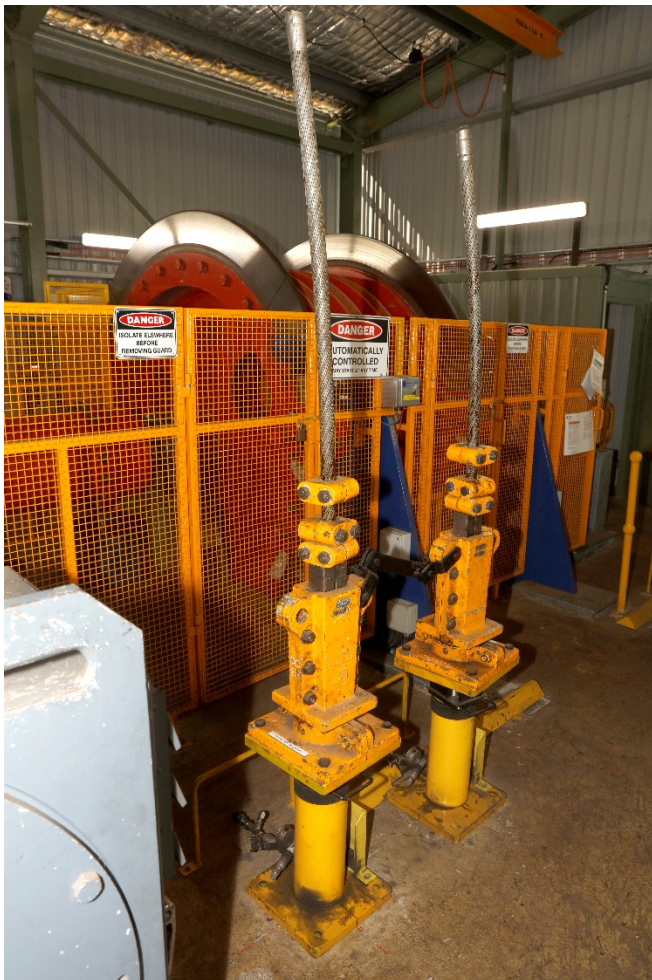
**Figure 4. Guide rope tensioning system for cage guide ropes 1 and 2.**

At the time of the incident the No. 3 shaft winding system cage and counterweight guide ropes were fixed with a static tensioning system depicted in figure 4.

Guide rope tensioning was static hydraulic instead of dynamic suspended loads (cheese weights). This unusual form of tensioning was implemented in the No. 3 shaft because of the significantly small area below the seam to install appropriate cheese weights. The static hydraulic rope tensioning system used at the mine is not preferred because it introduces failure modes such as reliance on a hydraulic system.

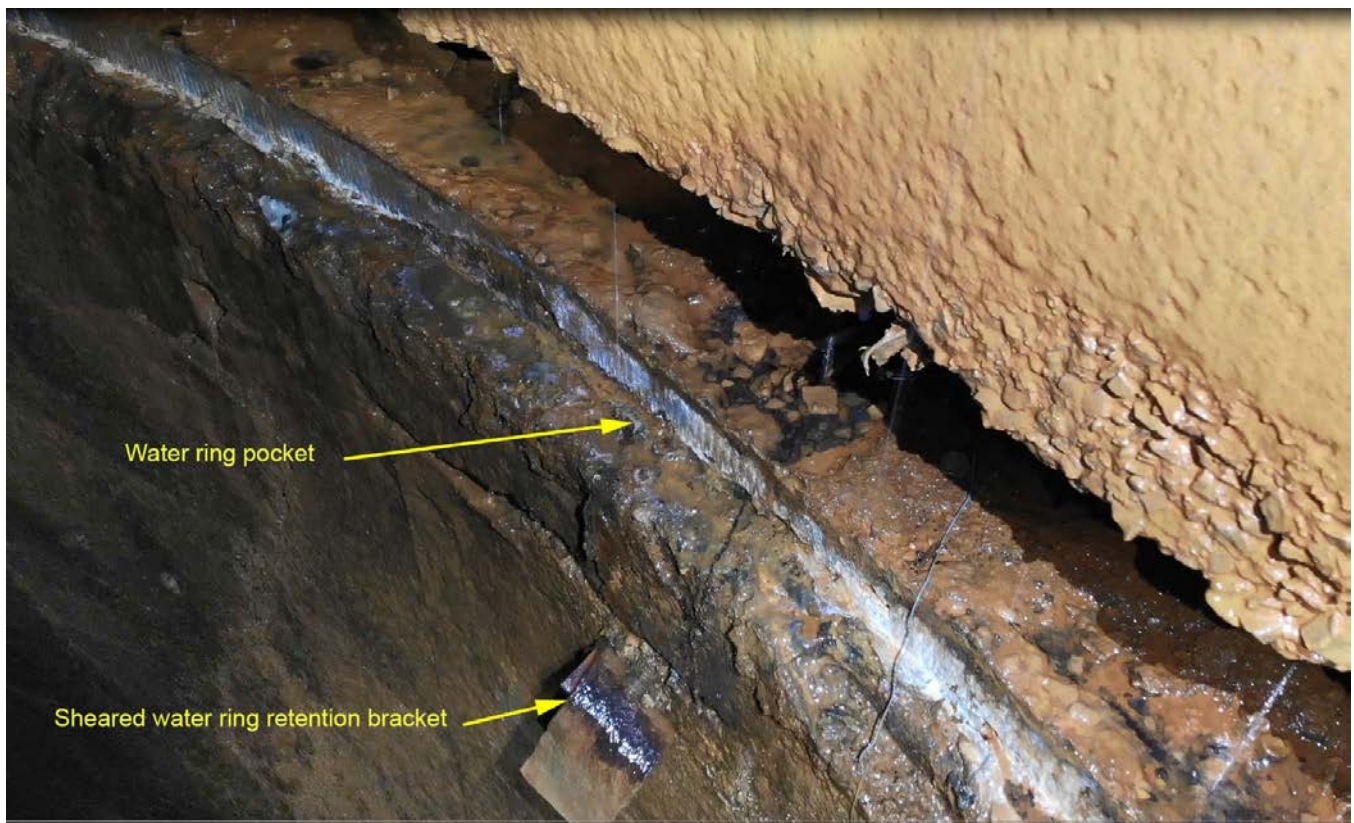
**Figure 6: Shaft water ring mounting bracket and original position.**

Post incident inspection identified an apparent collision between the counterweight and the shaft water ring, which resulted in the water ring being dislodged from its concrete pocket as visible in figure 6. The water ring, remained secured to the shaft wall at one point and collapsed around the head, guide and balance ropes pulling them out of their normal alignment. The reticulated services including air, water and drainage pipes were also pulled from the shaft wall. Figures 6 and 7 depict the damaged shaft wall and water ring in its final resting position following the incident.

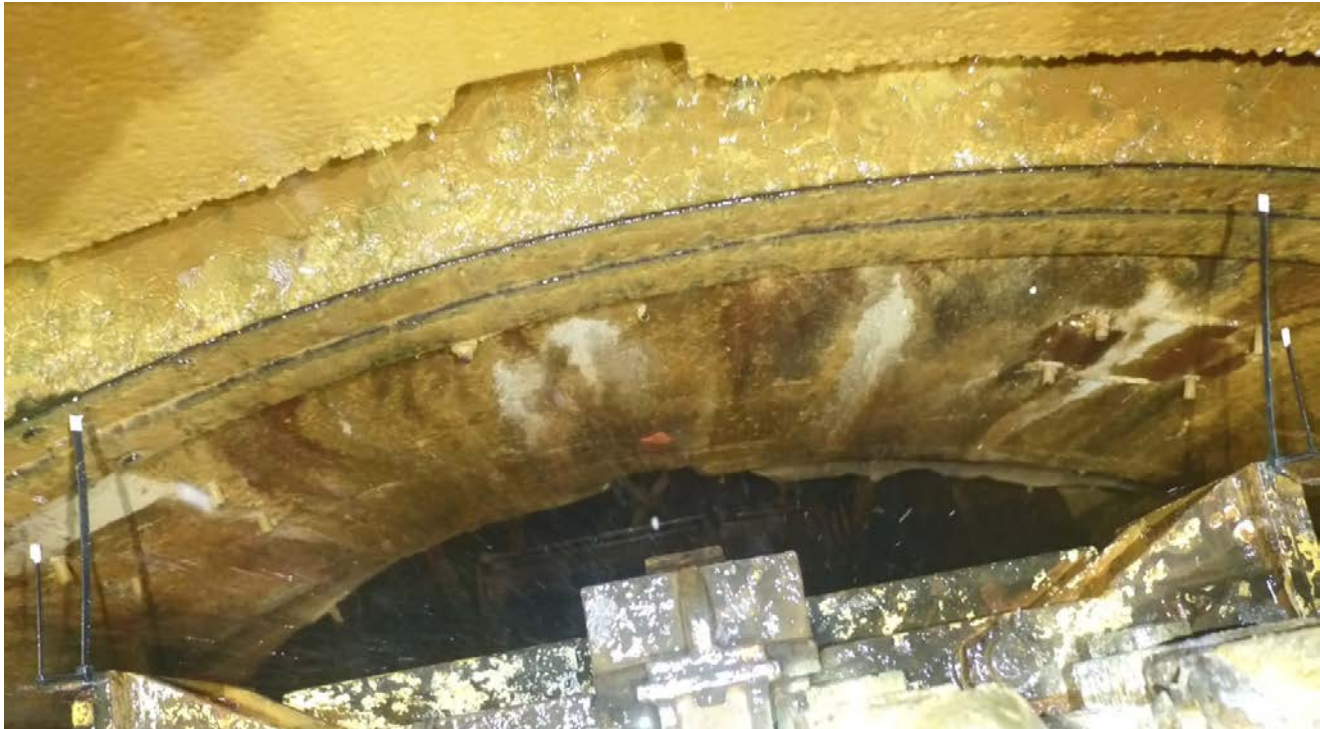
**Figure 8: Counterweight to wall clearance showing clearance at a water ring inside the No. 3 shaft.**

Once whisker tests showed acceptable clearances physical measurements between counterweight and cage were undertaken to verify clearances.

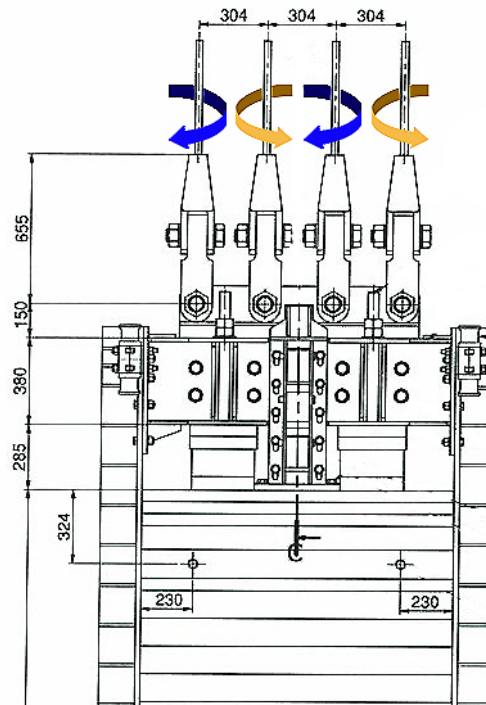
Figure 10: The Tahmoor No. 3 shaft counterweight depicting rotational torque applied to the capels from the head ropes.

Witness evidence provided by the dayshift deputy indicated that the counterweight had rotated outside of its usual axis. The most reasonable explanation for this rotation was uneven head rope tensions. The four head ropes used on the No. 3 shaft winder were 30 millimetre diameter, 1960 megapascals, galvanised 790 kilonewton ropes. Ropes 1 and 3 were right hand langs lay and ropes 2 and 4 were left hand langs lay. Langs lay ropes have a known rotational torque when a vertical load is applied. This is demonstrated in figure 10 below.

Theoretically, when all four ropes are of equal tension, the net torque on the counterweight is zero. However, each rope will have minor variances in rope rotational torque for any given load. When head rope tensions are out of balance (i.e. do not have the same load applied) a net rotational torque will be applied to the counterweight. This torque will influence the axis on which the counterweight sits and possibly rotate outside of its operating profile.

The investigation process determined that a significant cause of the incident was uneven head rope tensions, combined with drum liner wear, which allowed the counterweight to rotate outside of its normal operating profile. The rotation of the counterweight meant that it was possible for the counterweight to make contact with the number four water ring as the cage conveyance transported two workers to the surface of the mine.
