COMPLIANCE AUDIT PROGRAM

# Compliance Audit Program 2016 Report

June 2017

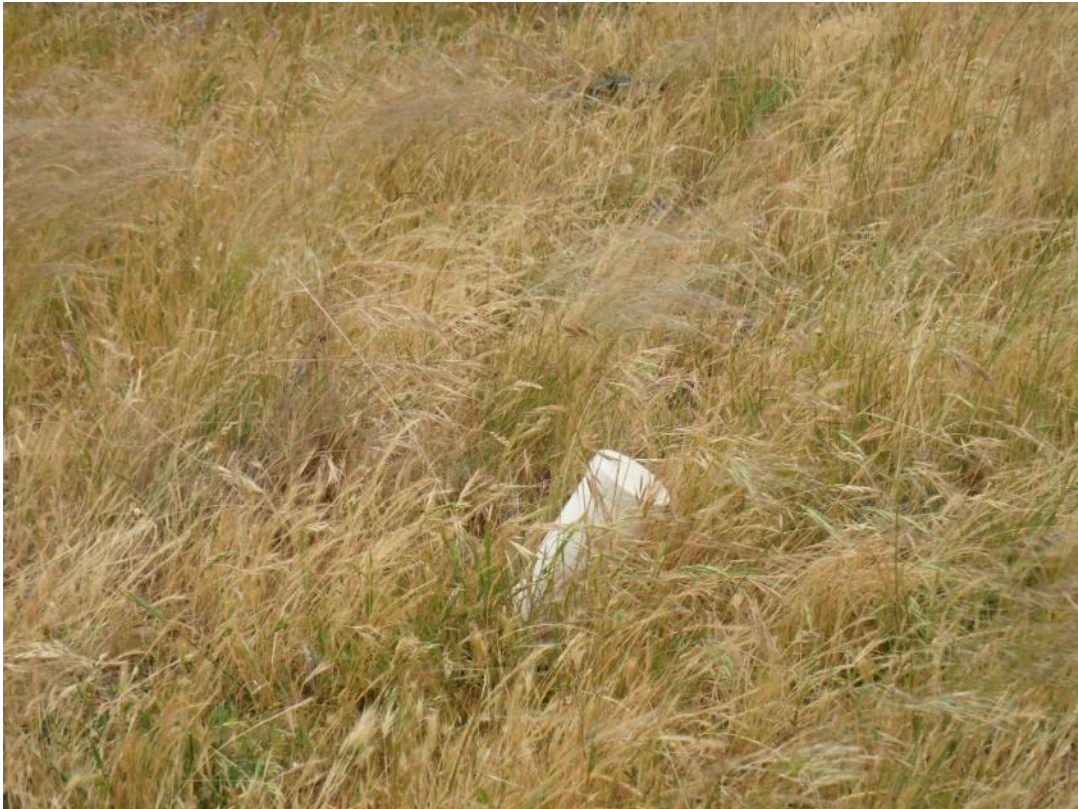
- failure to maintain adequate records of borehole sealing and/or capping
- failure to cut casing below ground level leaving uncapped casings above ground level (Photo 1)
- lack of, or inadequate, erosion and sediment controls on drill sites (Photo 2)
- poor bunding and/or poor chemical storage and handling practices (Photo 3)
- poor topsoil management practices (Photo 4)
- lack of, or poor, water management controls during drilling (Photo 5)
- failure to undertake rehabilitation in a timely manner (Photo 6).

**Photo 1 – Casing protruding from the ground on a rehabilitated borehole site**

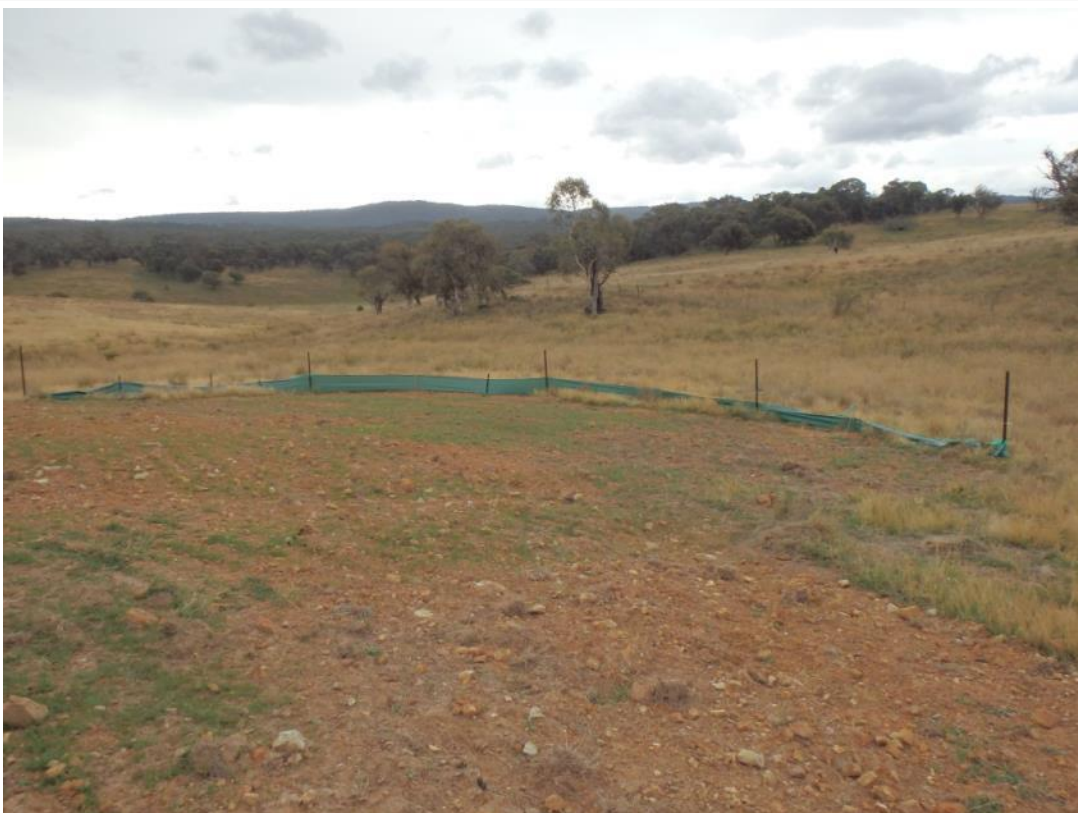
**Photo 2 – Sediment fencing in need of maintenance on a drill site**

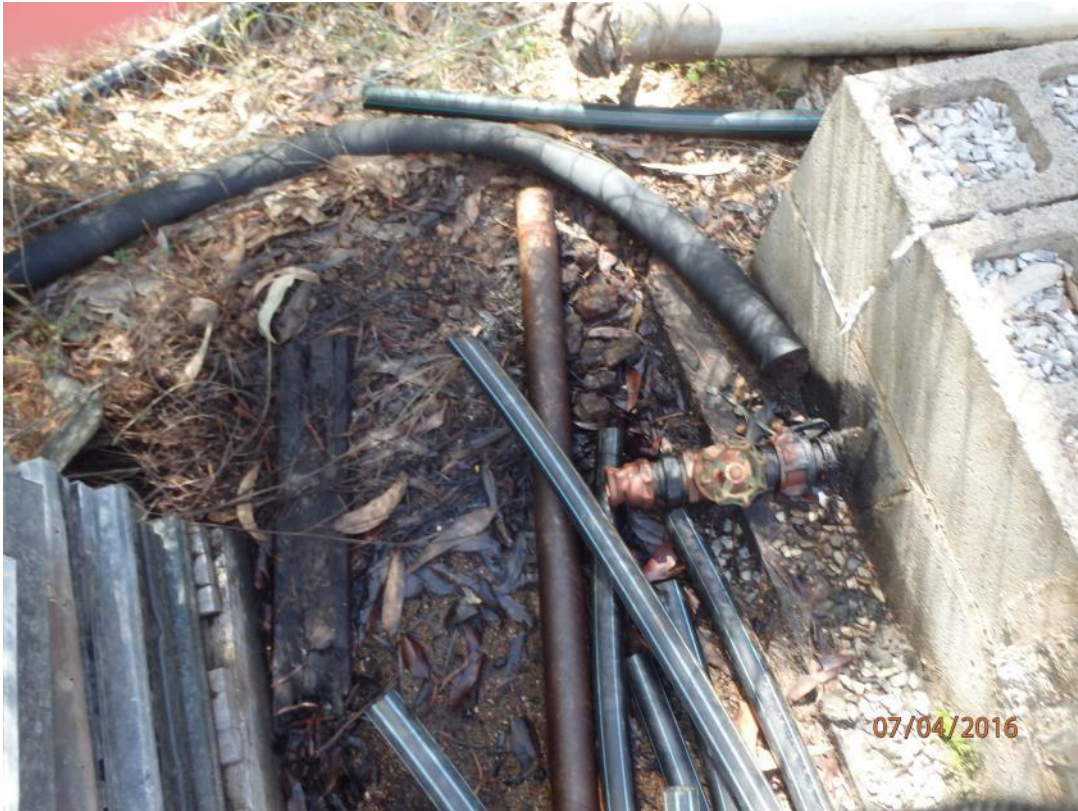
**Photo 3 – Bund drain left open discharging potentially contaminated water**

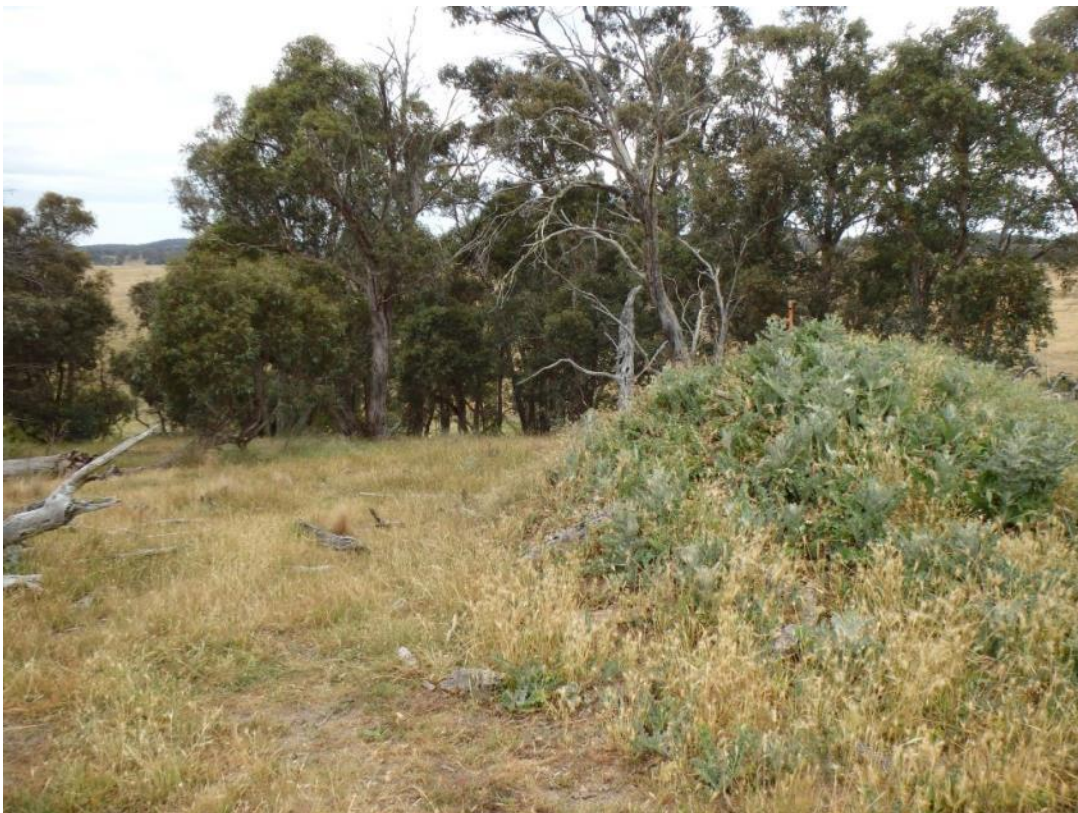
**Photo 4 – Topsoil stockpile at a drill site – note no sediment controls and weed infestation**

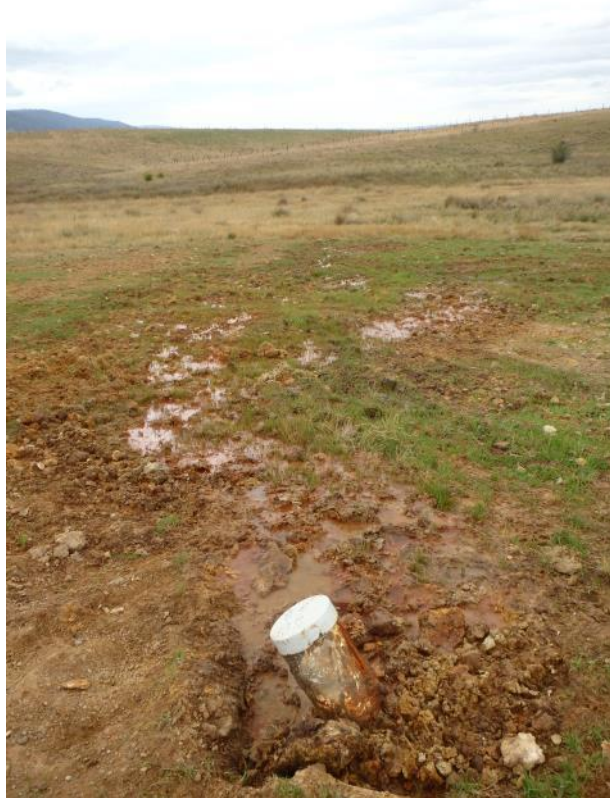
Photo 5 – Groundwater leaking from a borehole

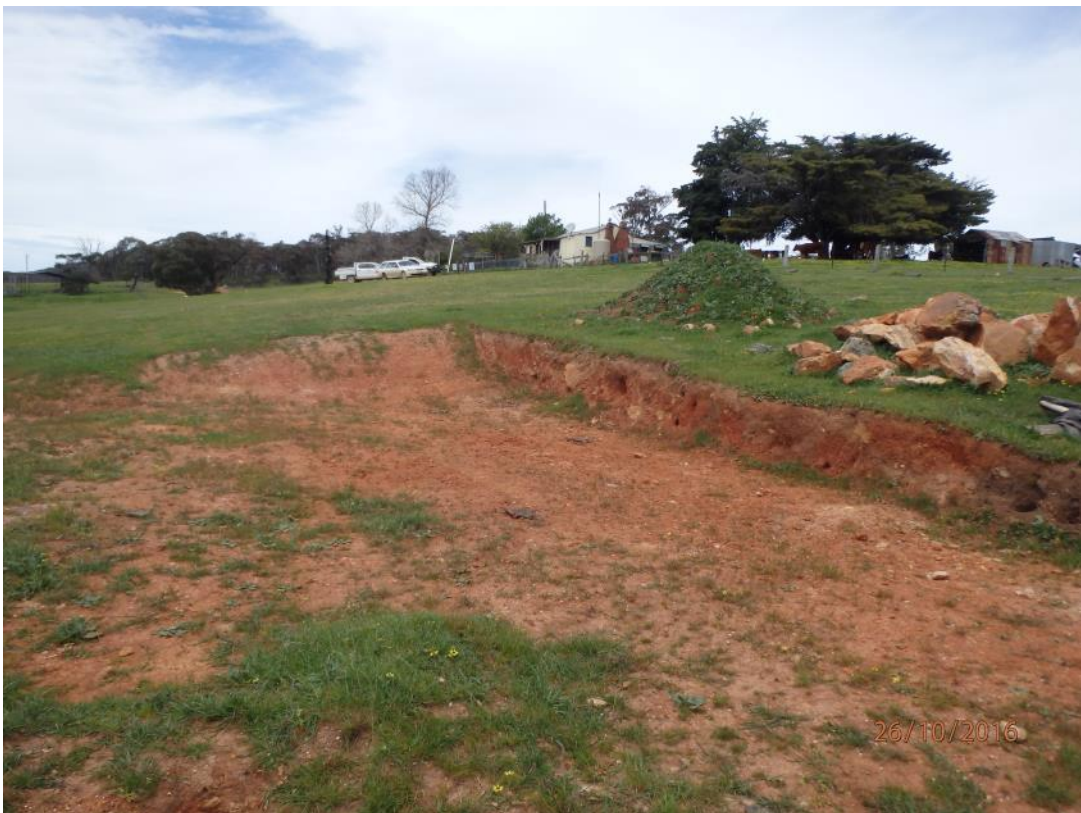
Photo 6 – Unrehabilitated drill site – drilling was completed in early 2016

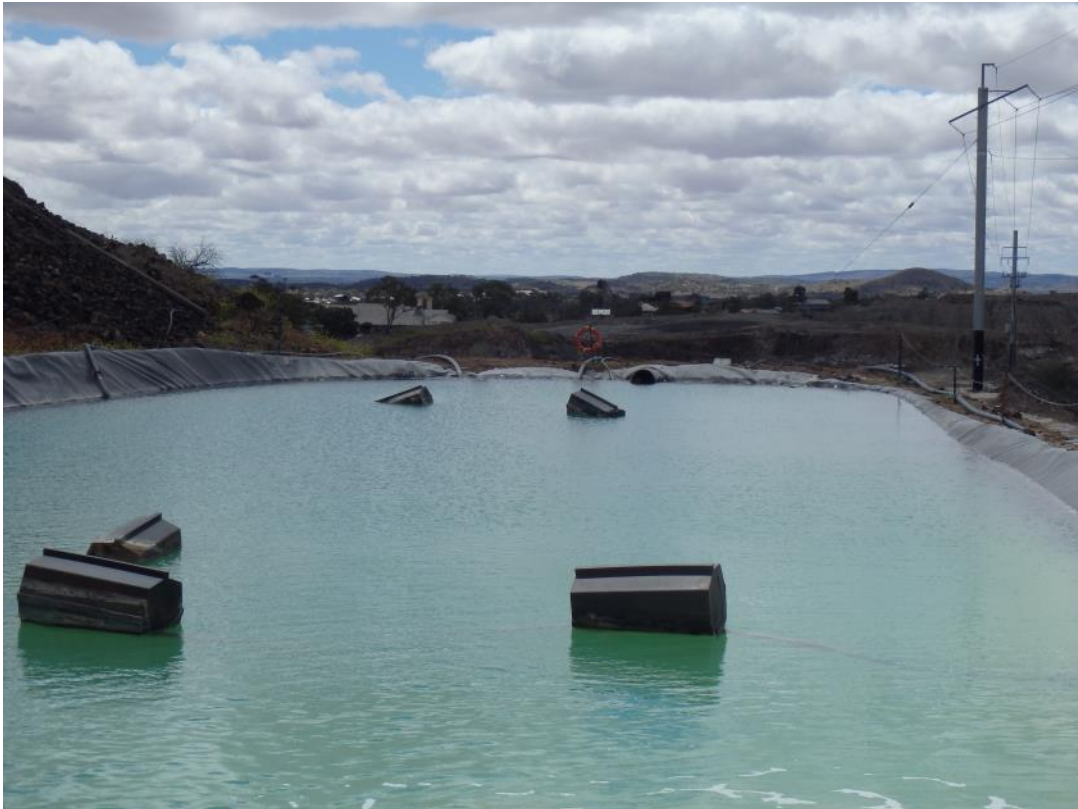
For dams other than prescribed dams, it was noted that there was generally a lack of design and construction documentation available, although most dams inspected appeared to have been constructed in a reasonable manner. However, one dam inspected during the audit program was observed to have been constructed to standards below what would normally be expected.

**Photo 7 – Inadequate dam wall construction with no operational freeboard and a noticeable low point in the dam wall**

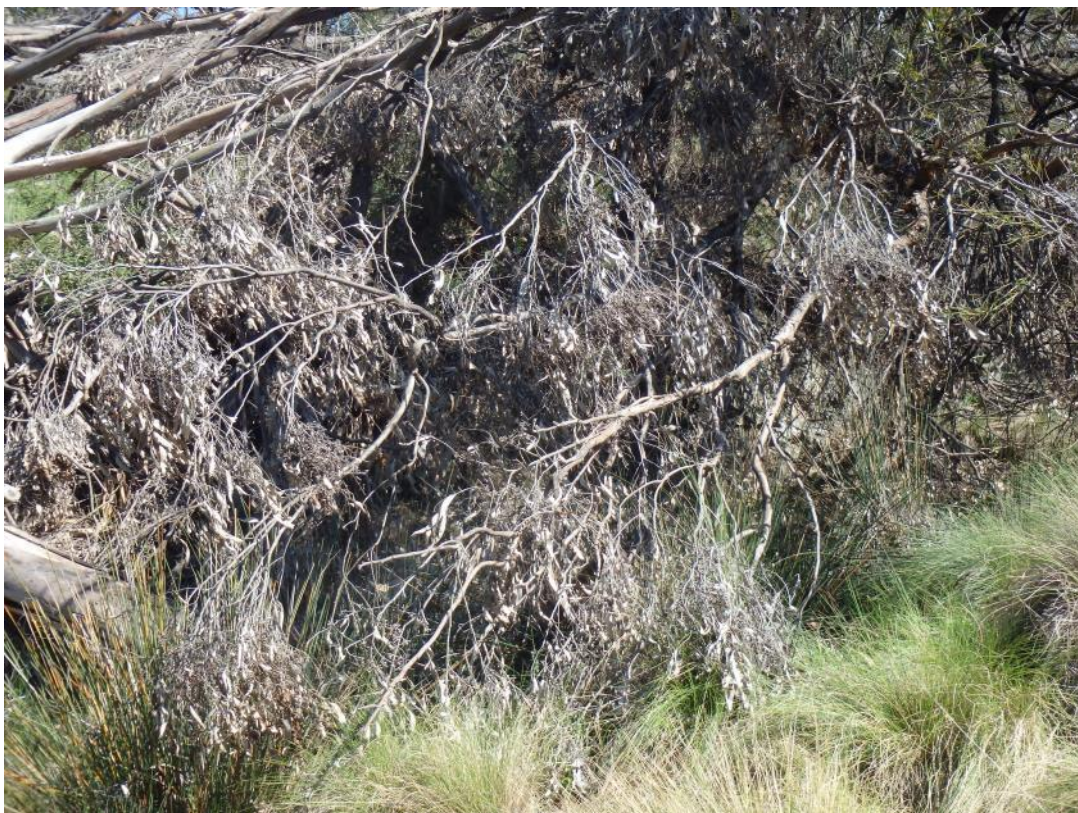
For example at one site, it was noted during the audit site inspection that a large tree had fallen across the spillway of one dam, effectively blocking the spillway (Photo 2). However, a review of the inspection checklists for the week prior to the audit showed that this had not been picked up during the routine inspection process; hence no action had been taken to remove the tree. It was noted that each of the checklists reviewed had the 'Spillway obstructions' box ticked as 'okay' with no actions required. At another site, a movement survey monument on one dam was observed to have been damaged, while a water level gauge board in another dam had fallen over such that it would not be able to be used for water level gauging (Photo 3). Neither of these issues appeared to have been identified in the routine inspections, and consequently no corrective actions had been initiated.

**Photo 8 – Fallen tree blocking the grassed spillway on a sediment dam**

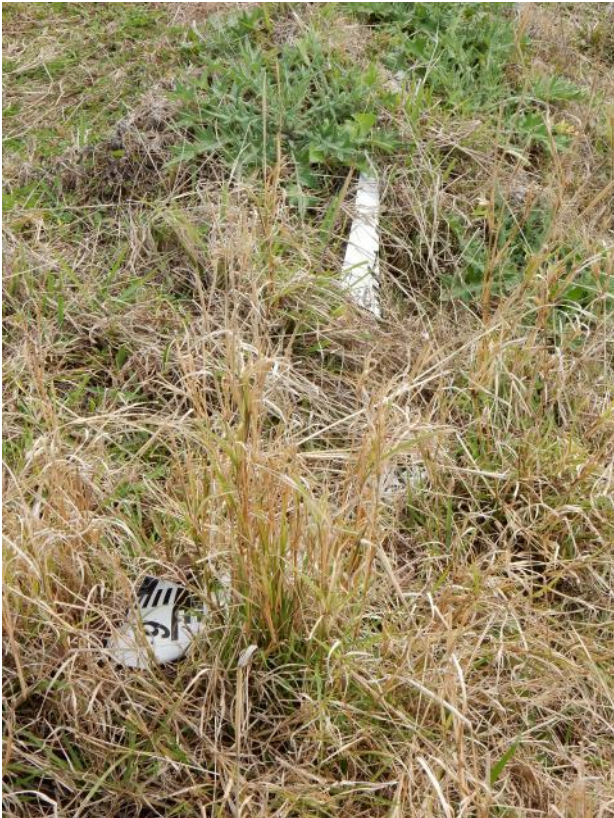
The inspection and maintenance of monitoring equipment was also identified as an issue. At several sites, the auditors observed damaged gauge marker boards and survey prisms, and at one site a monitoring probe was observed lying in the grass adjacent to a seepage monitoring well. For the monitoring programs to be effective in identifying potential issues with the dam structures, it is important that any monitoring equipment installed is regularly inspected and maintained.

Photo 9 – Damaged gauge marker board on a major water storage at one site

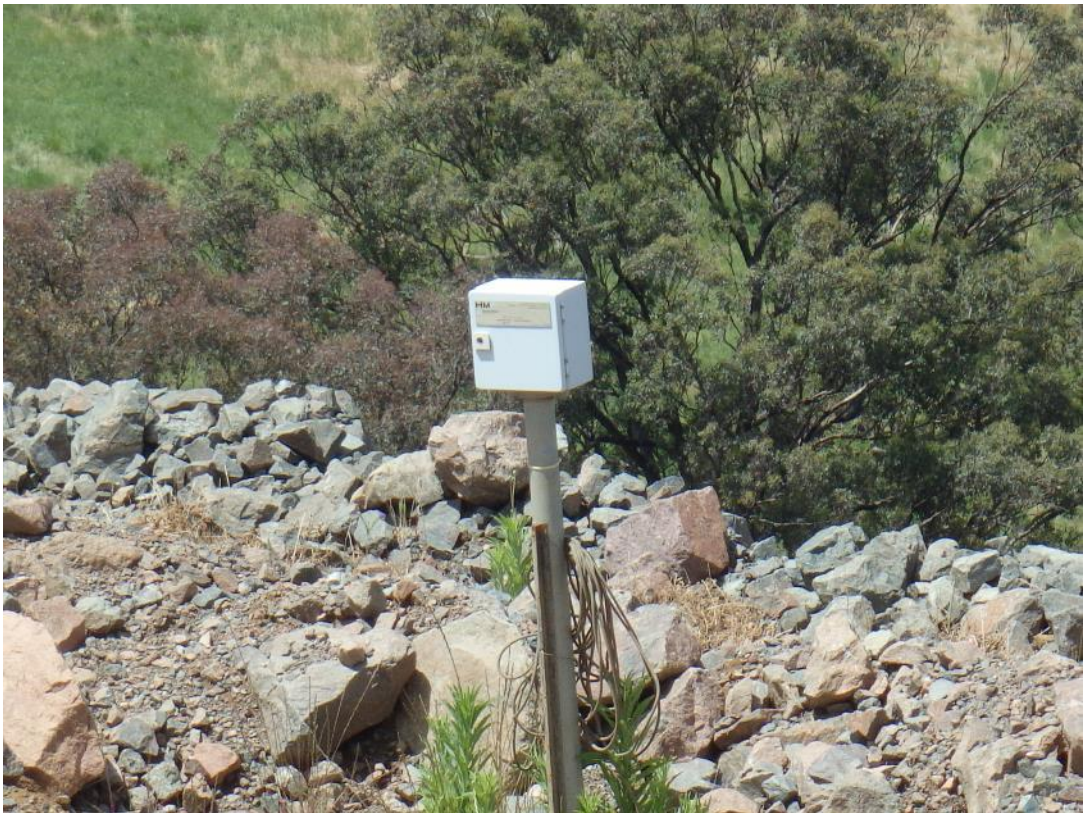
Photo 10 – Example of automatic monitoring piezometer installed on a dam wall

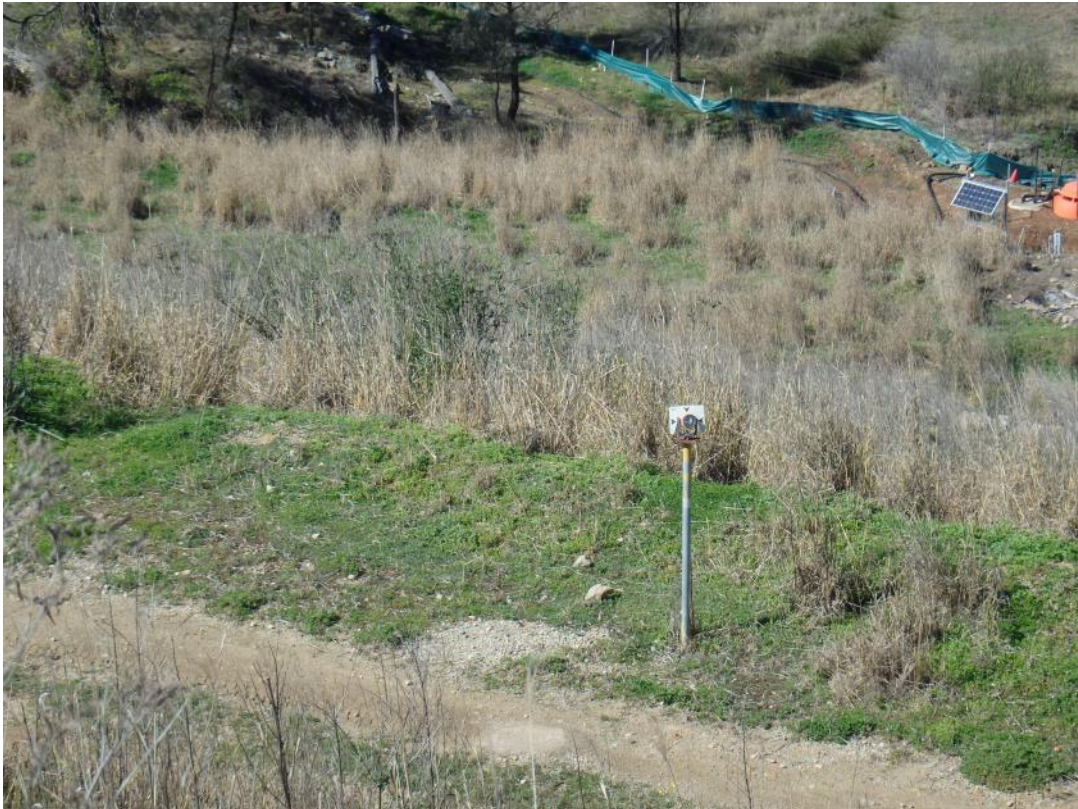
Photo 11 – Example of movement survey prism on a dam embankment

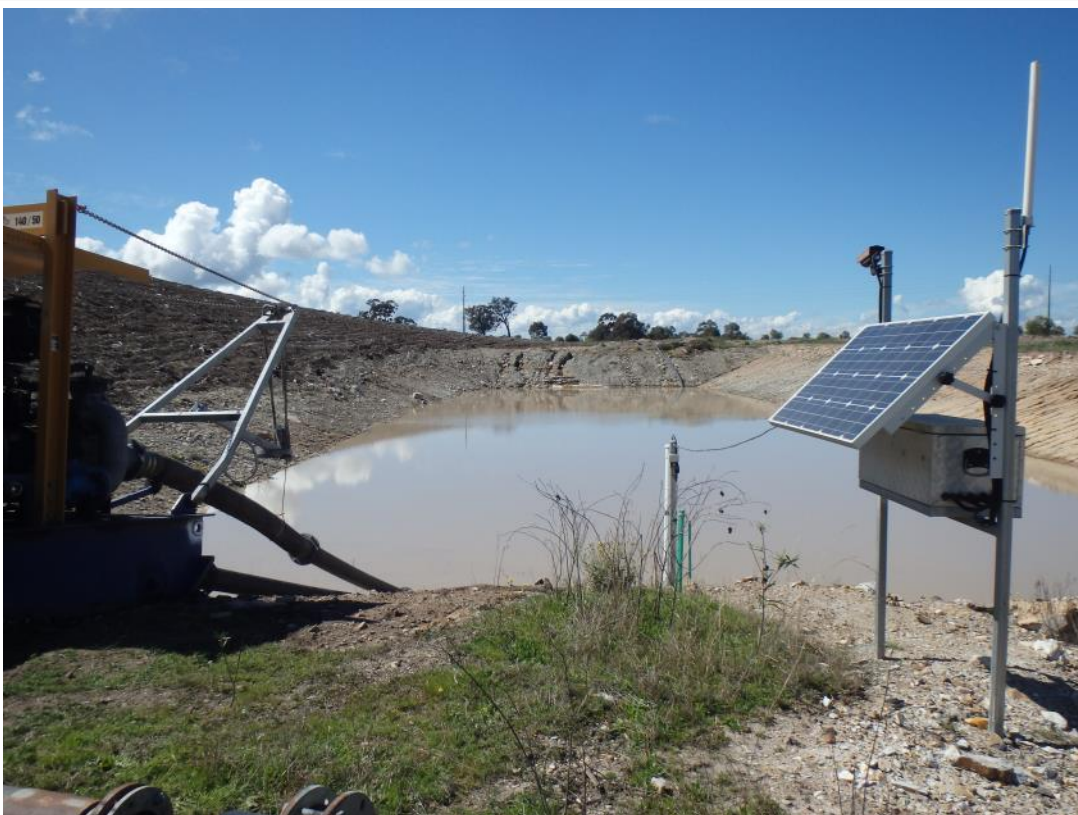
It was noted that one mine site had adopted the innovative practice of installing solar powered automatic water level sensors and webcams on its sediment dams as a means of being able to easily ascertain the status of any sediment dam at any time, without the need for operators to be out manually reading water level gauges in severe weather. The webcams also provided the facility to be able to confirm any alerts issued by the water level sensors. The webcams automatically captured a still photograph every 30 minutes which was stored as a record of dam water levels along with information from the water level sensors.

Photo 12 – Example of solar powered automatic water level sensor and webcam installed on a sediment dam

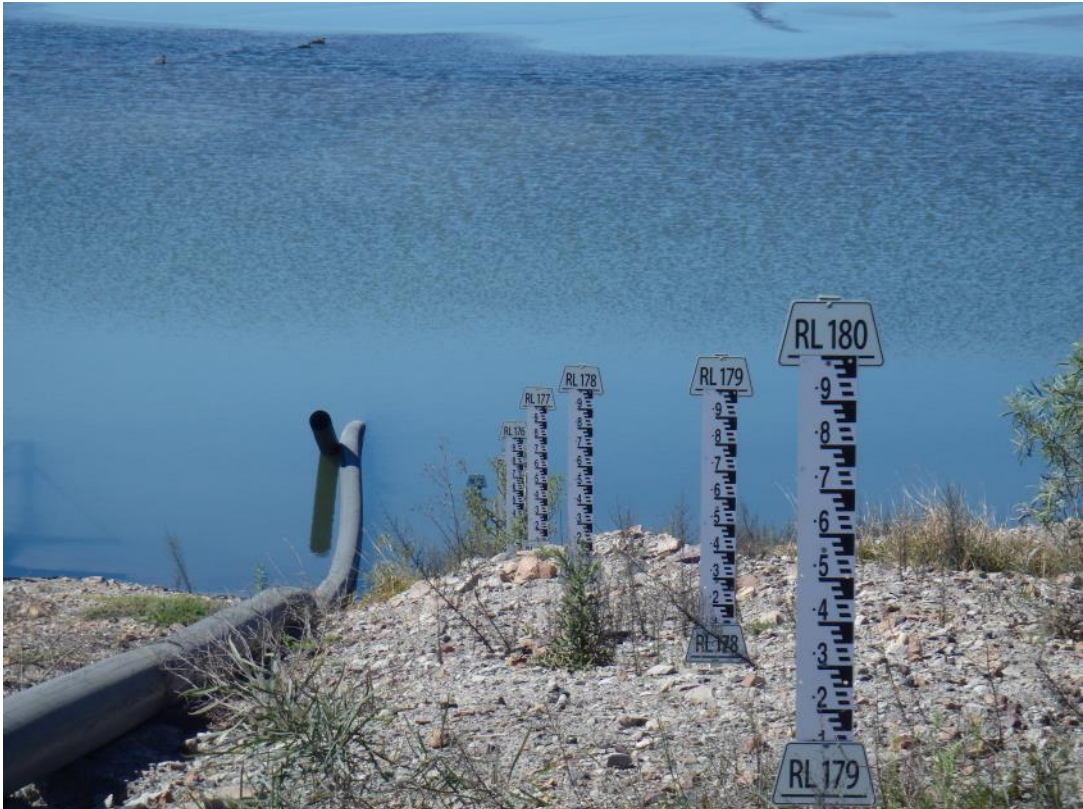
Photo 13 – Example of manually read gauge marker boards in a tailings dam
