Investigation Report

Incident resulting in fatal injuries to a
subcontractor on Eastern Star Gas
Petroleum Assessment Lease 2 on
1 August 2009

Report prepared for the Director-General of the
Department of Industry and Investment by the
Investigation Unit, Thornton

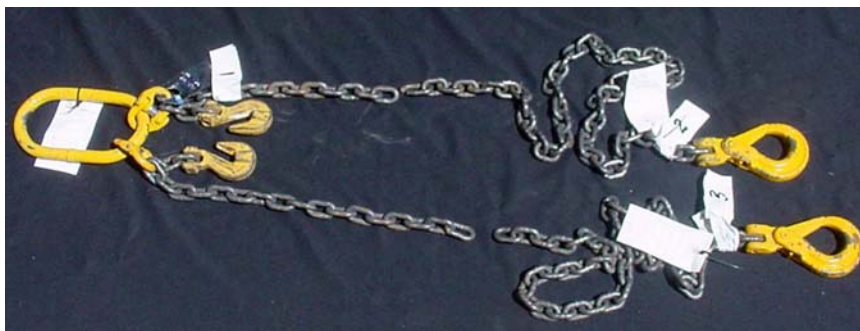
The 10mm chain set used had two legs, each leg was broken. The chain set had a nominal 5.5 tonne Working Load Limit (WLL) based on using the two chains at a 60 degree separation. Each leg of the 10mm diameter high tensile chain used in the incident had a nominal WLL of 3.2 tonnes and a minimum tensile failure load of 12.8 tonnes when used as lifting chain.

The chain set was used to pull the pipe with one leg tied in a clove hitch knot around the pipe and the other leg connected around a bucket tooth.

As the chains were used in a knot and pulled over hard surfaces, an unquantified de-rating of the chain capacity is applicable. The chains would then be expected to fail below the rated failure strength of 12.8 tonnes.

General view of the two leg chain set. Both chain legs were broken.

It was evident that the two chain legs had failed. The report identified stretching (overload), of the chains as well as scuffing and marks on the chain, consistent with the chains being used while touching other metal objects, such as the chain or a hook.

The report found in summary that “.. *both legs had suffered tensile overload fracture failure. ...Surface damage, suggestive of metal to metal contact was present on the chain links, possibly indicating that the pinlok latch hook had been choke hitched at the fracture location.*”

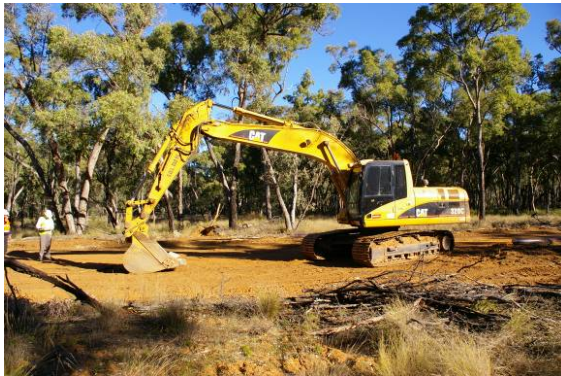
It appears the excavator had sufficient capacity, under normal operating conditions, to create enough pull force to rupture the chains.

The Cat 320C excavator at the incident scene.

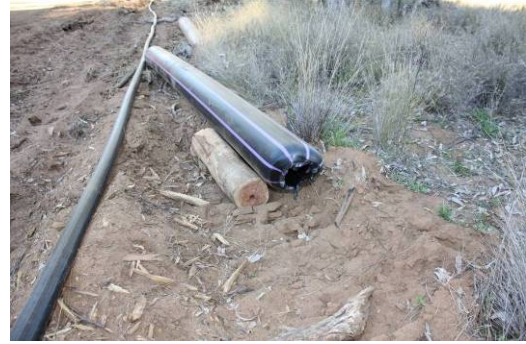
Then a piece of wood was cut and placed inside the pipeline, a better grip with the chain connection was achieved and the pipeline began to move when towed by the excavator.

The piece of wood that was placed in the pipe was found at the scene next to a sheared piece of the pipeline.

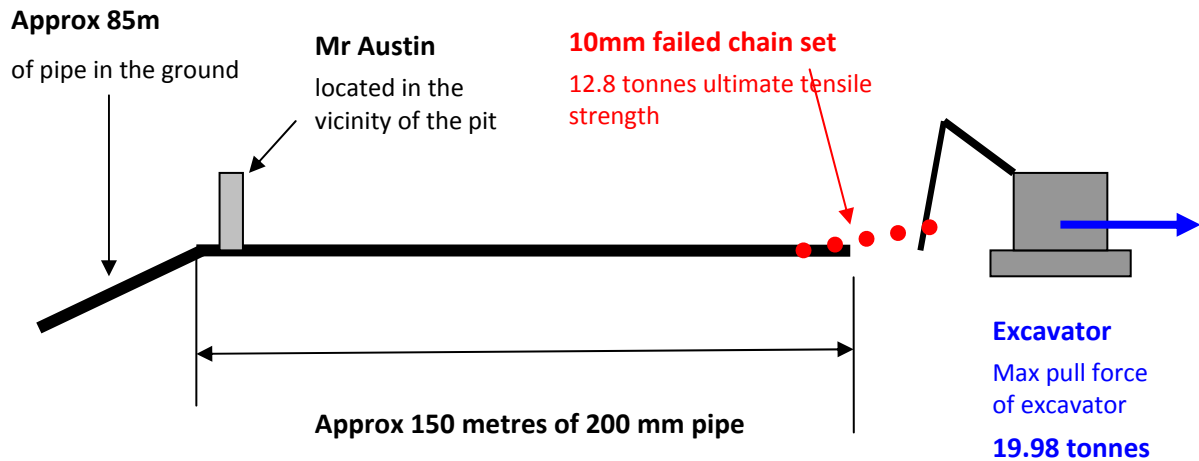
Diagrammatic representation of the incident – not to scale

The ADDS supervisor resumed pulling of the pipeline, with directions being supplied by the ADDS crew member. The operation progressed with the pipeline reported to be moving freely. When approximately 150 metres of pipe was outside of the borehole, the chain failed and released the stored energy in the pipeline.

When the pipeline recoiled, it appears it reared up at the pit end and struck Mr Austin who was standing nearby.
