FIRES ON MOBILE PLANT

April – June 2020

Title: Fires on mobile plant, April to June 2020

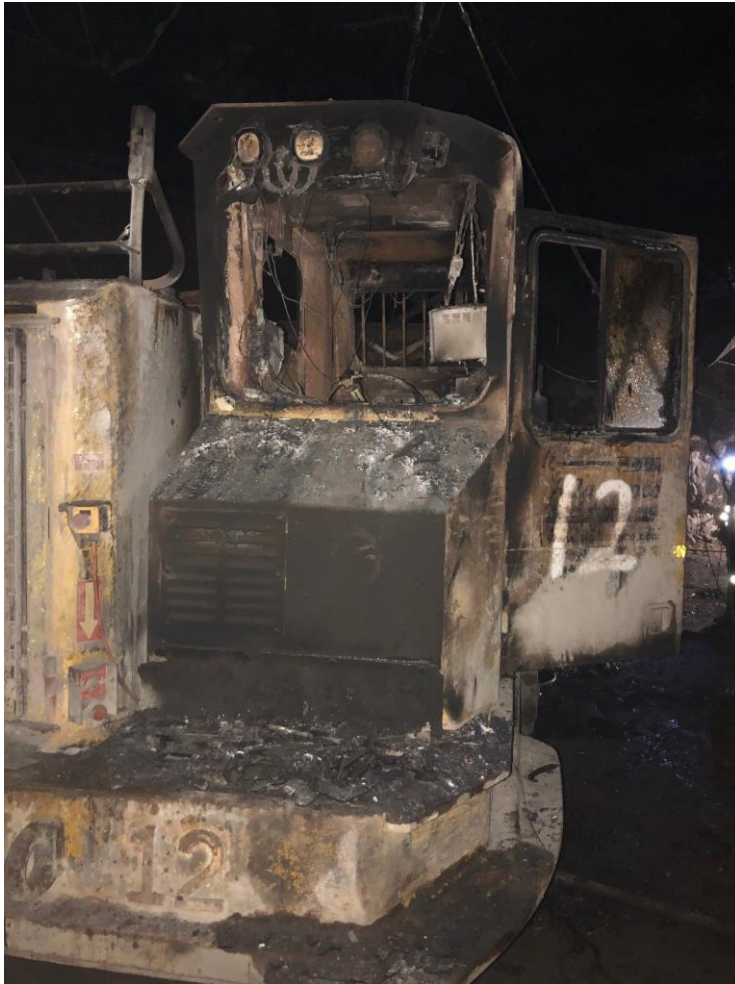
Figure 1. Short to earth in power supply to starter motor causes fire on haul truck

An operator was driving a haul truck in an underground metalliferous mine. The operator saw flames coming from the front of the machine. While the operator was attempting to activate the fire suppression system a fireball erupted from the engine bay. The operator immediately left the cab and went to a nearby crib cuddy to raise the alarm.

The investigation identified the cause as a short to earth in the power supply to the truck's starter motor. The short resulted in

the cable sheathing overheating and igniting. This fire then damaged the adjacent fuel return line which created a larger fuel source.

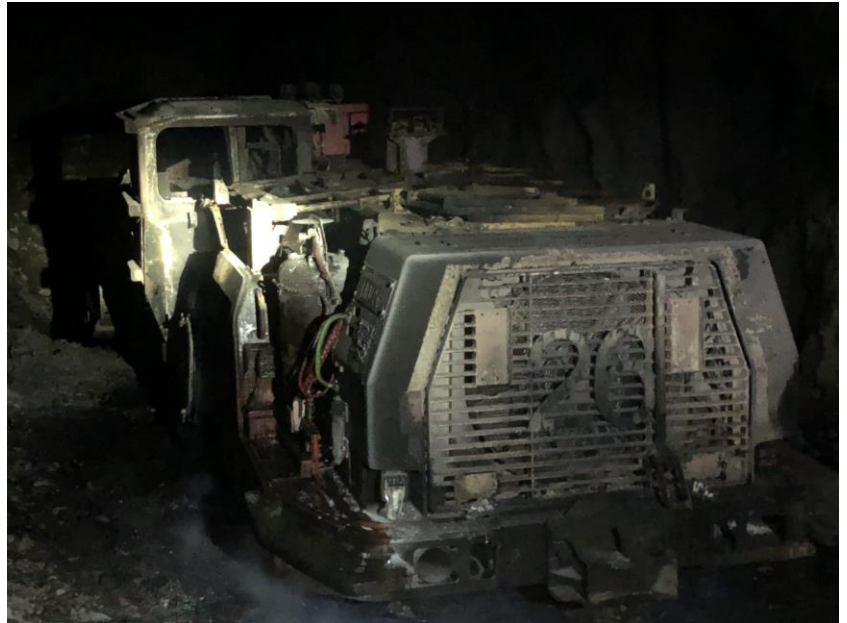
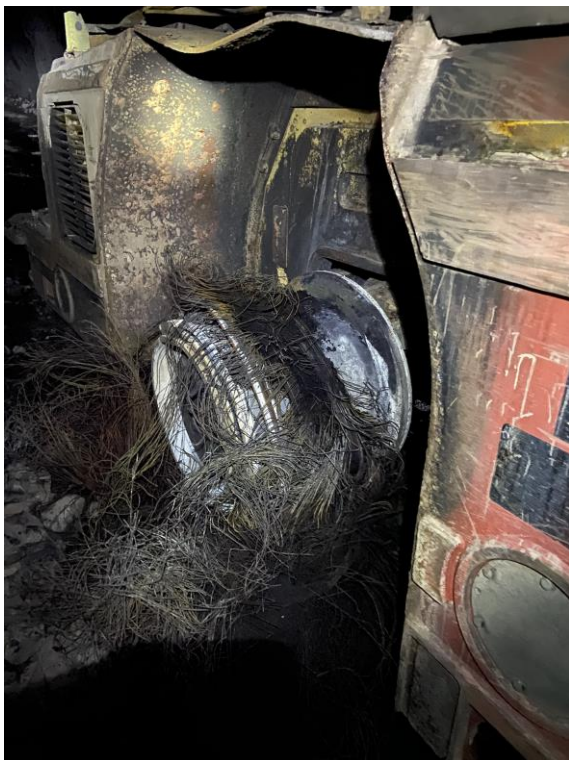
Figure 2a and 2b. Broken wire to brake solenoid causes fire to loader being operated under tele-remote conditions

A loader was being used to muck out under a shaft during construction and was being operated under tele-remote conditions from a nearby control hut. A fault occurred on the brake pack, which resulted in the brakes applying. As the loader was operated, the dragging brake generated sufficient heat to cause an ignition.

Another worker arrived at the hut and could smell burning rubber and informed the loader operator. The loader was shut down and the workers proceeded to the loader and saw a fire on the right rear tyre.

They returned to the hut, activated the fire suppression system and advised control of the emergency. The fire suppression was ineffective as the system does not cover the wheel areas of the machine. The workers returned to the loader and saw a small fire on the tyre. They used three extinguishers which knocked down the flames but the flames would then flare back up. The workers then proceeded to refuge chambers. The loader suffered extensive damage.

The cause of the fire was identified as a broken wire to the brake solenoid. The tele-remote system identified the fault, however, this fault was not immediately clear to the operator. The supplier of the system was engaged, and changes were made to how faults are communicated to the operator. Alarms are now audible and include a pop up style warning.

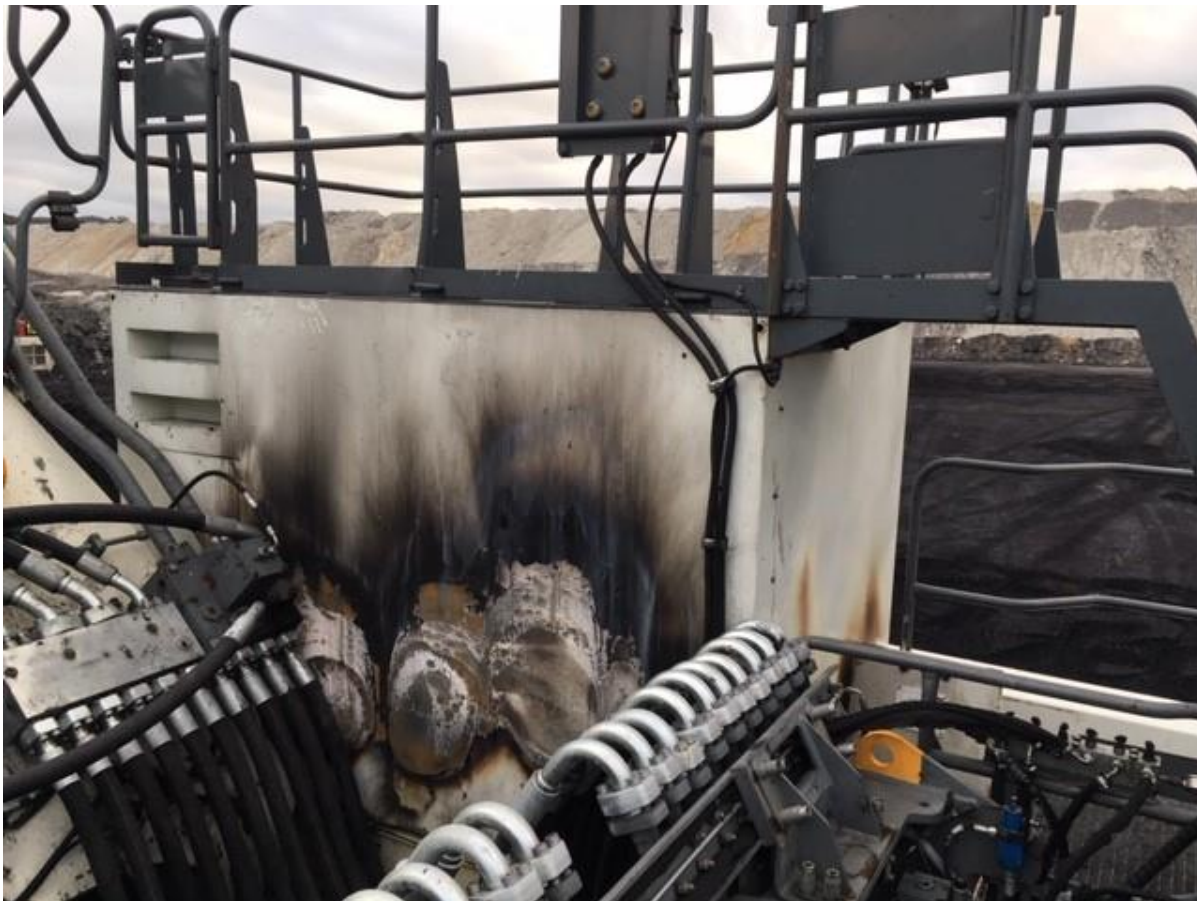
Figure 18. Mangoola coal mine

A worker saw smoke coming from a sound suppression box on top of a hydraulic cooler room on an excavator. The worker manually activated the fire suppression system and a water cart was also used to extinguish the fire. The excavator had undergone maintenance earlier in the day, and fish plates had been welded onto the bottom of the sound suppression box. The excavator had been idle for about an hour before starting up.

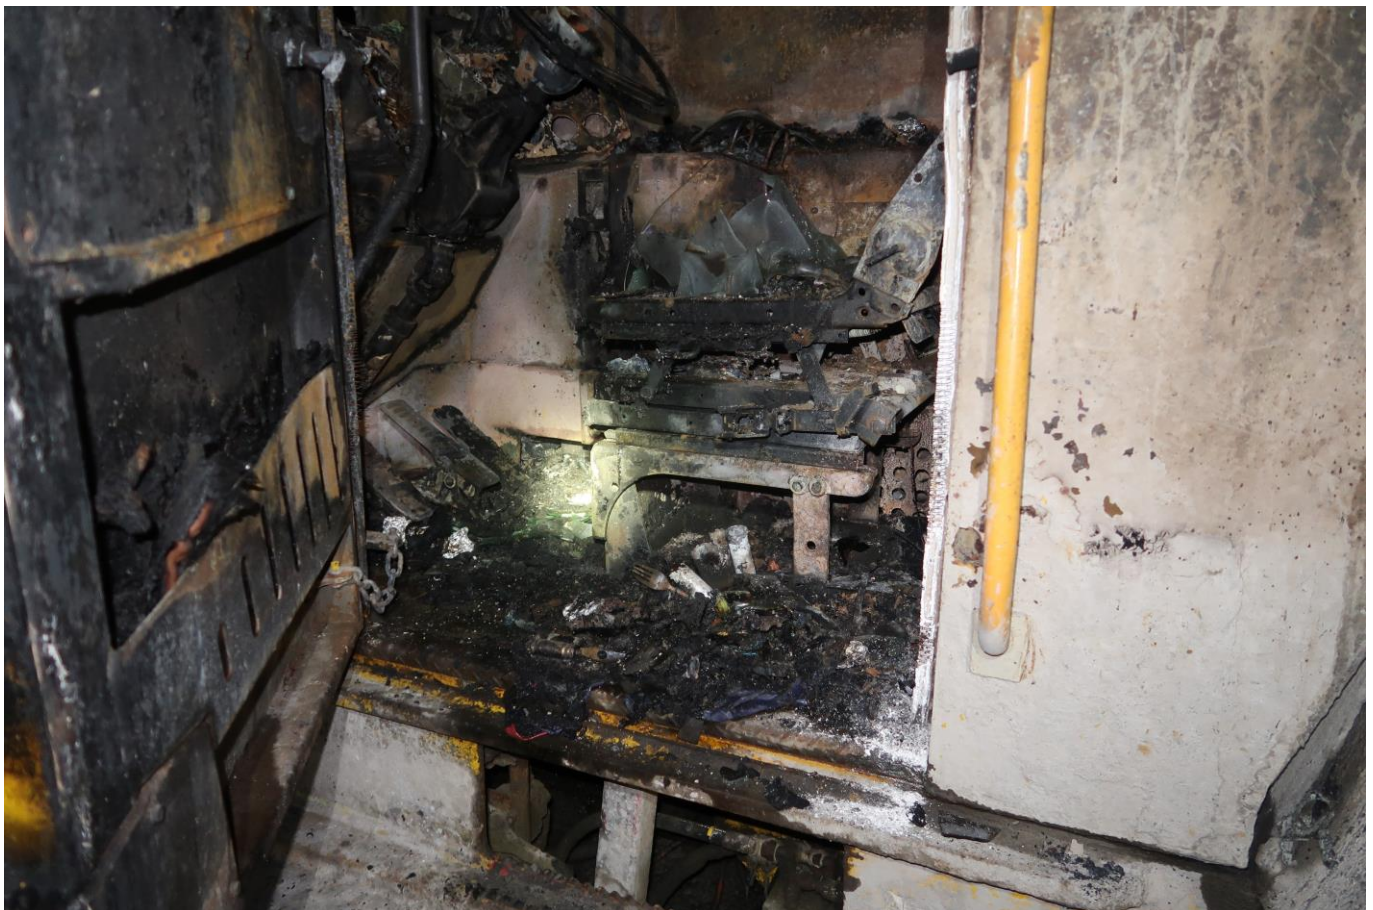
Figure 19. Southern Operations

The operator of an underground dump truck saw flames coming from an engine bay. The operator tried to activate the fire suppression system but was unsuccessful. They immediately exited the cabin and retreated to the crib to report the incident.

Two other workers in the area tried to extinguish the fire with hand-held fire extinguishers but were unsuccessful.

The mine initiated its emergency response procedures and all workers retreated to fresh air bases. All workers were subsequently withdrawn to the surface. The mine's fire and rescue team members re-entered the mine and successfully extinguished the fire.

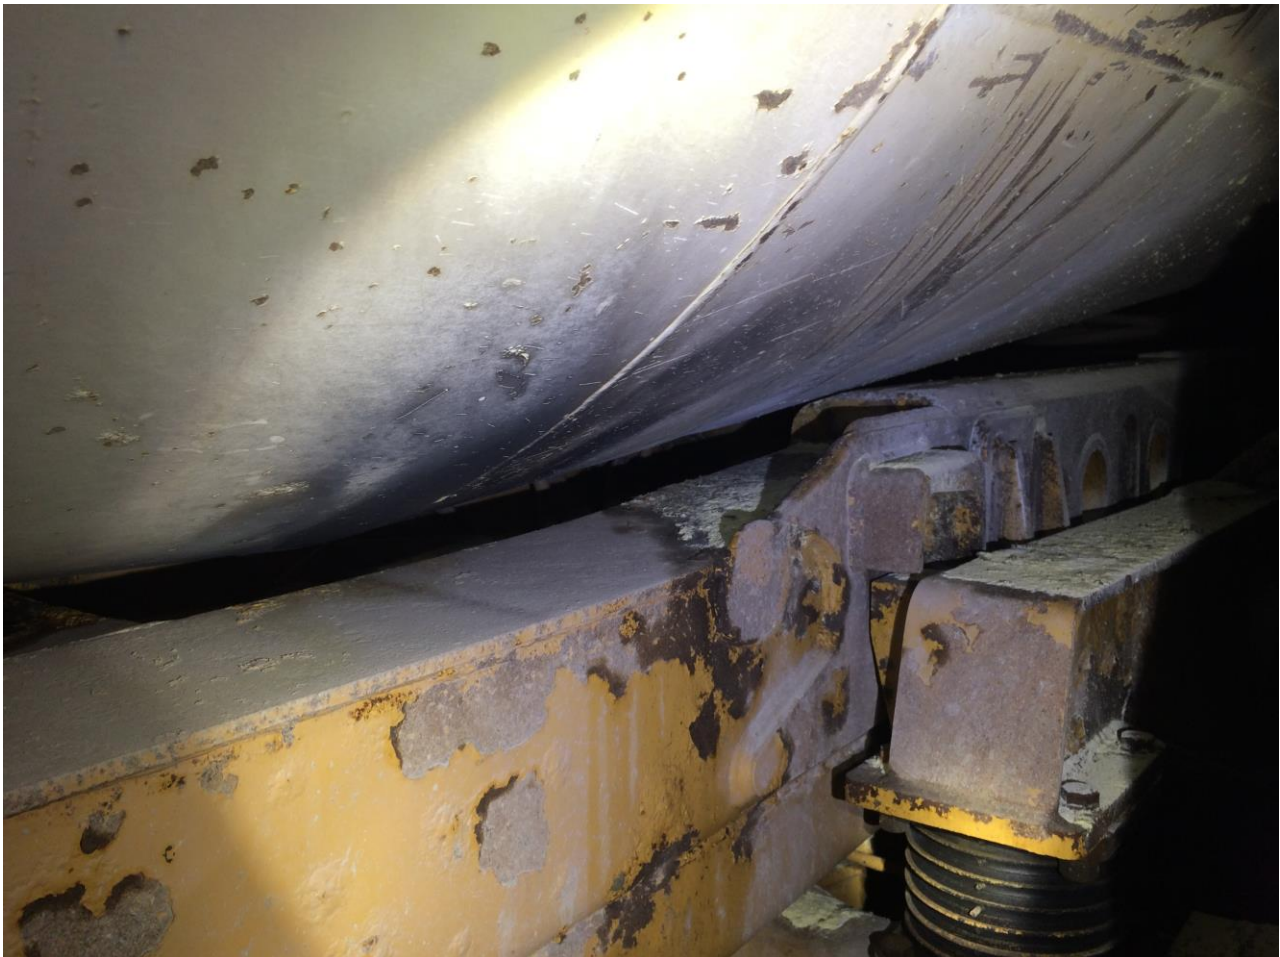
Figure 20. Cadia East underground

An agitator was driving down the decline when the truck began to labour and a warning buzzer sounded. The operator noticed a glow on the decline wall and immediately stopped the agitator. The operator yelled to other workers nearby who assisted in extinguishing the fire.

The investigation identified a wire to a brake solenoid was rubbing on a hydraulic fitting causing the brakes to apply and drag. The heat generated from the dragging brake initiated the fire.

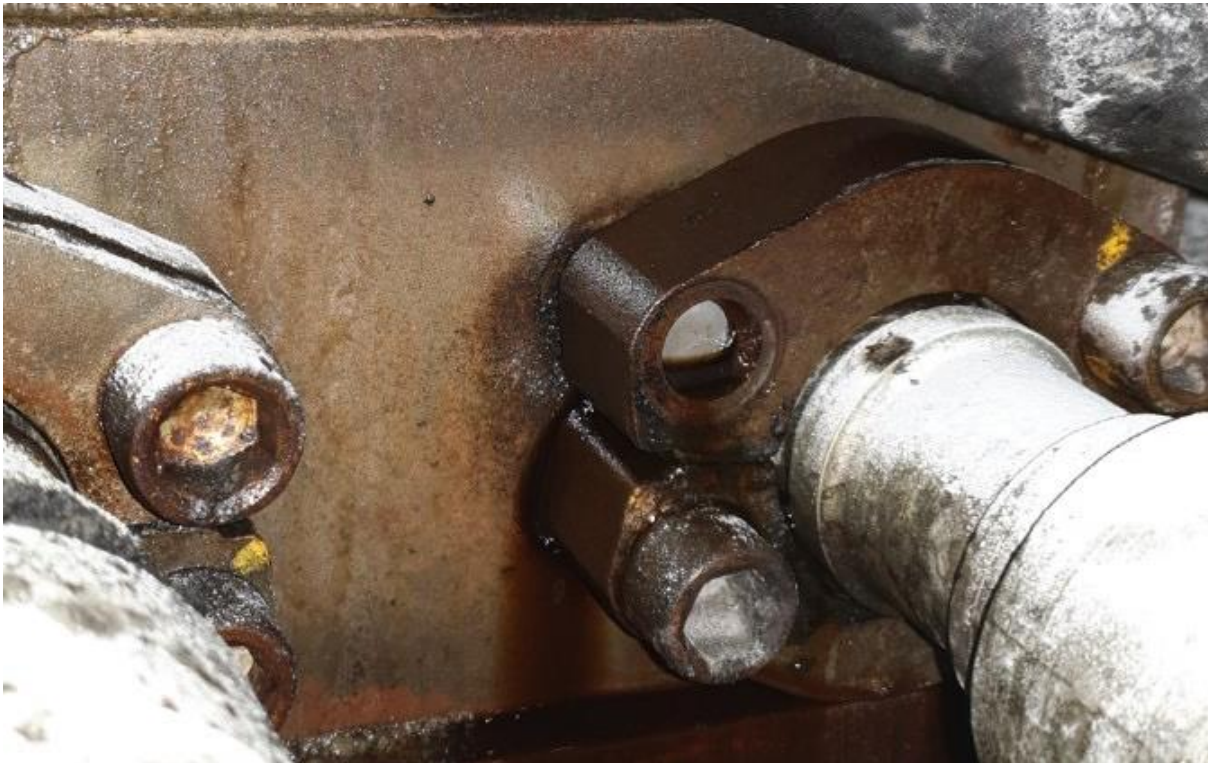
Figure 21. Mount Pleasant Operations

A major hydraulic oil leak occurred on an excavator, resulting in hydraulic oil spraying onto the turbo and catching fire. The apparent cause of the leak was from a broken flange bolt. The automatic fire suppression system activated and the excavator operator used a fire extinguisher to extinguish the remaining flames.
