FIRES ON MOBILE PLANT

January – March 2020

Title: Fires on mobile plant, January to March 2020

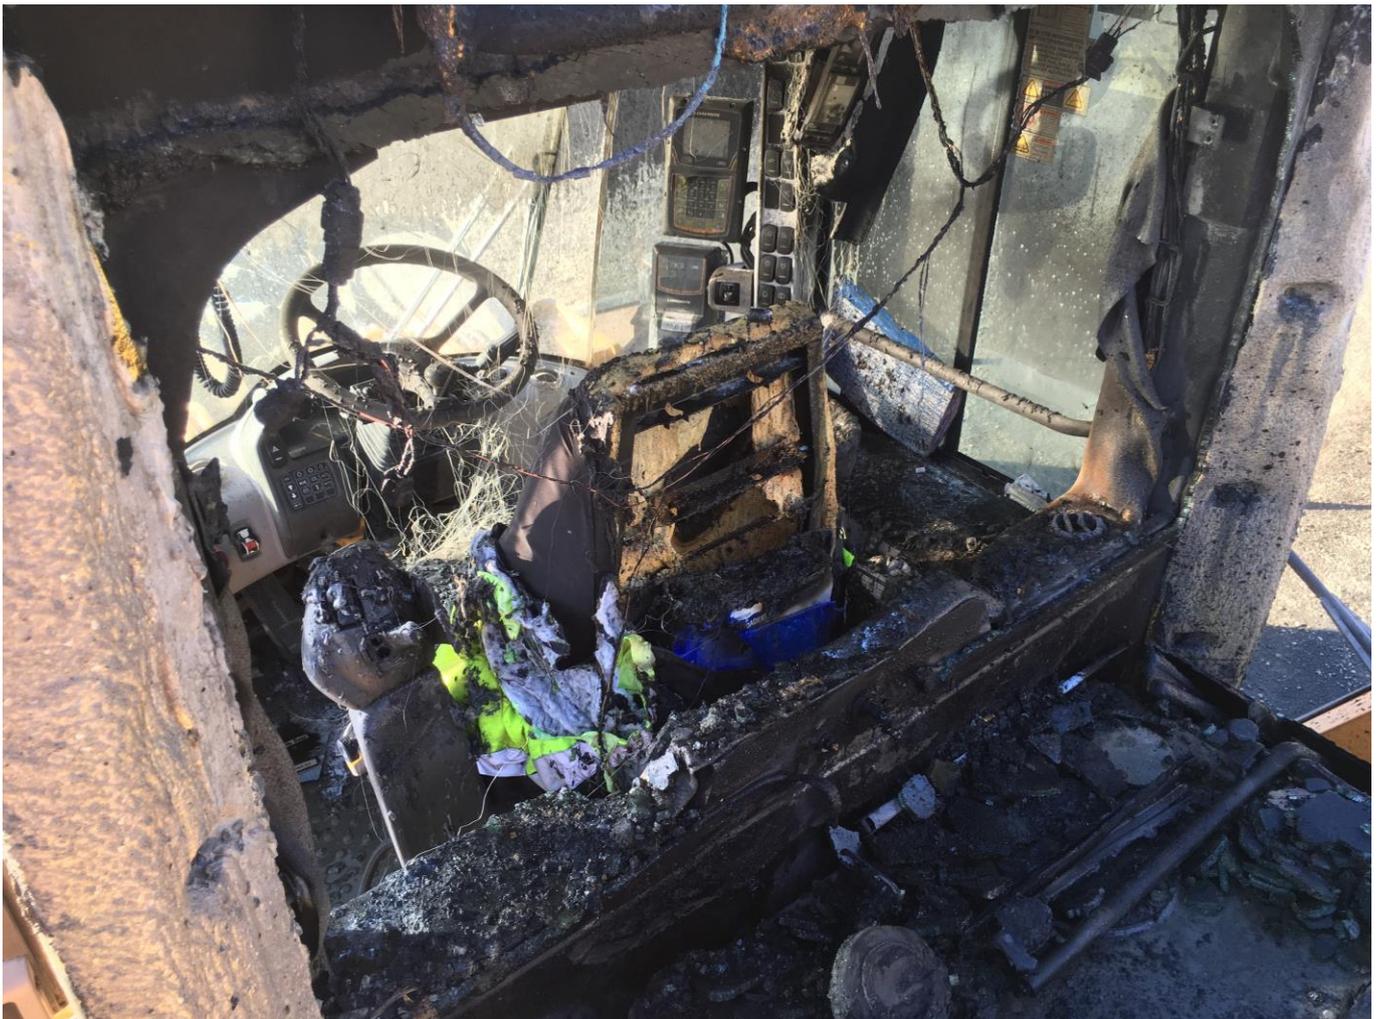
FIGURE 1. HOSE FAILURE DESTROYS CAB

At a quarry, a dump truck operator observed oil on the ground under a Volvo L250G front-end loader and advised the operator. Approximately 30 seconds later, the excavator operator, who was loading the dump truck, saw flames on the loader and instructed the operator to get out of the loader. The fire suppression system was activated, and a water cart was used to extinguish the flames. The loader was extensively damaged.

A non-genuine engine oil hose was poorly installed in the engine bay and had rubbed through. When the hose failed, it sprayed engine oil through the engine bay which ignited. Due to the extent of the damage, the loader had to be craned onto a truck to remove it from site for major repairs.

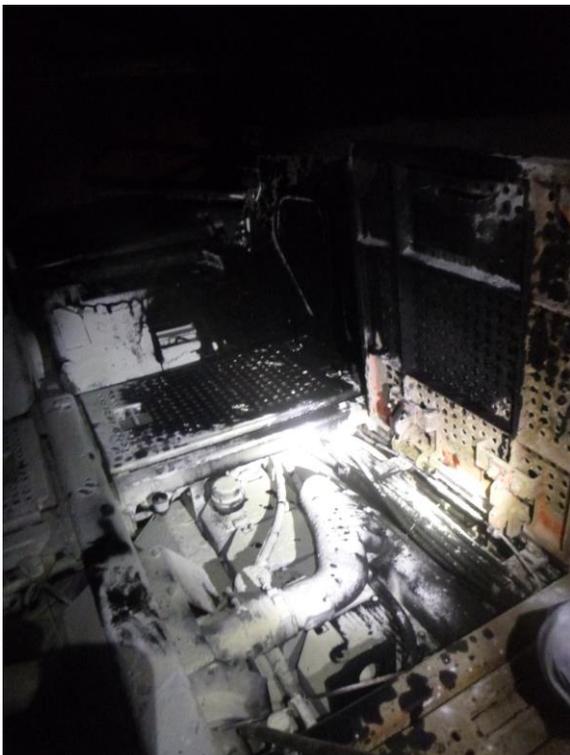
FIGURE 20. TRITTON COPPER MINE

At a metalliferous mine, a Sandvik haul truck caught fire while travelling up a decline. The cause of the fire was an internal failure in a recently rebuilt engine. A mine investigation identified the tappet cover breather caps were modified from a metal cap that was held in place with a circlip, to a plastic cap held with silastic. A component failure has allowed coolant into the sump. The over-pressured engine oil escaped from the breather and contacted the hot engine. The original equipment manufacturer (OEM) is investigating the engine failure.

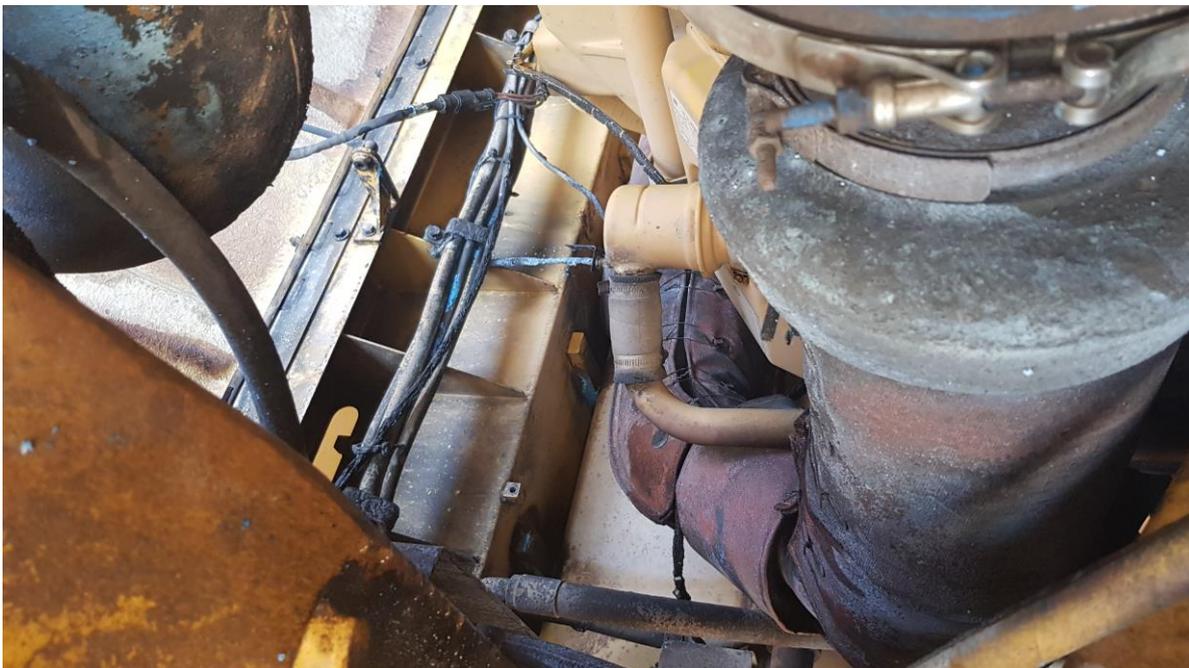
FIGURE 21. ALBION PARK QUARRY

A dump truck operator smelled fuel during mining operations. The operator drove the Caterpillar 775E dump truck to where a maintenance fitter was located, before parking the machine. The fitter saw smoke and attempted to put the fire out with an extinguisher. A water cart attended and extinguished the fire. A mine investigation identified there was a fuel line damaged near the turbo. It was also identified that there was no fire suppression system fitted to the truck.

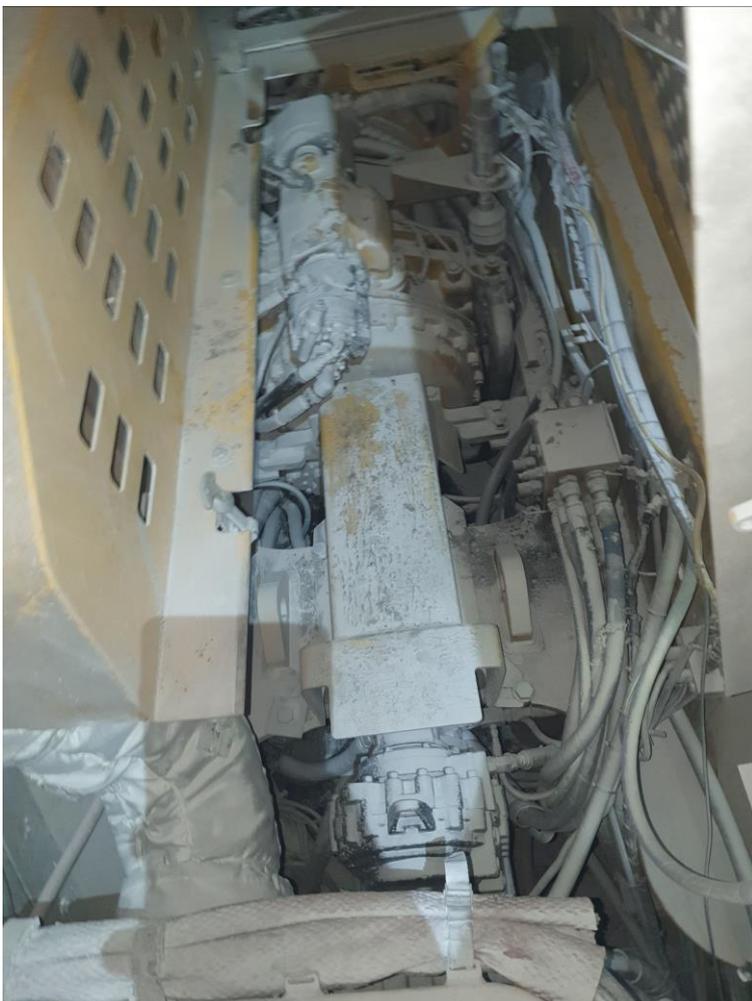
FIGURE 22. NORTHPARKES MINES

During mining operations at an underground metalliferous mine, a haul truck operator saw smoke, and then flames. He parked the Atlas Copco MT6020 haul truck and activated the fire suppression system. With the help of another two workers, they extinguished the fire with hand-held extinguishers. The fire was in the engine bay and articulation point of the truck. The mine investigation identified the cause of the fire as a failure of a driveline bearing. The truck had recently returned from a transmission rebuild.

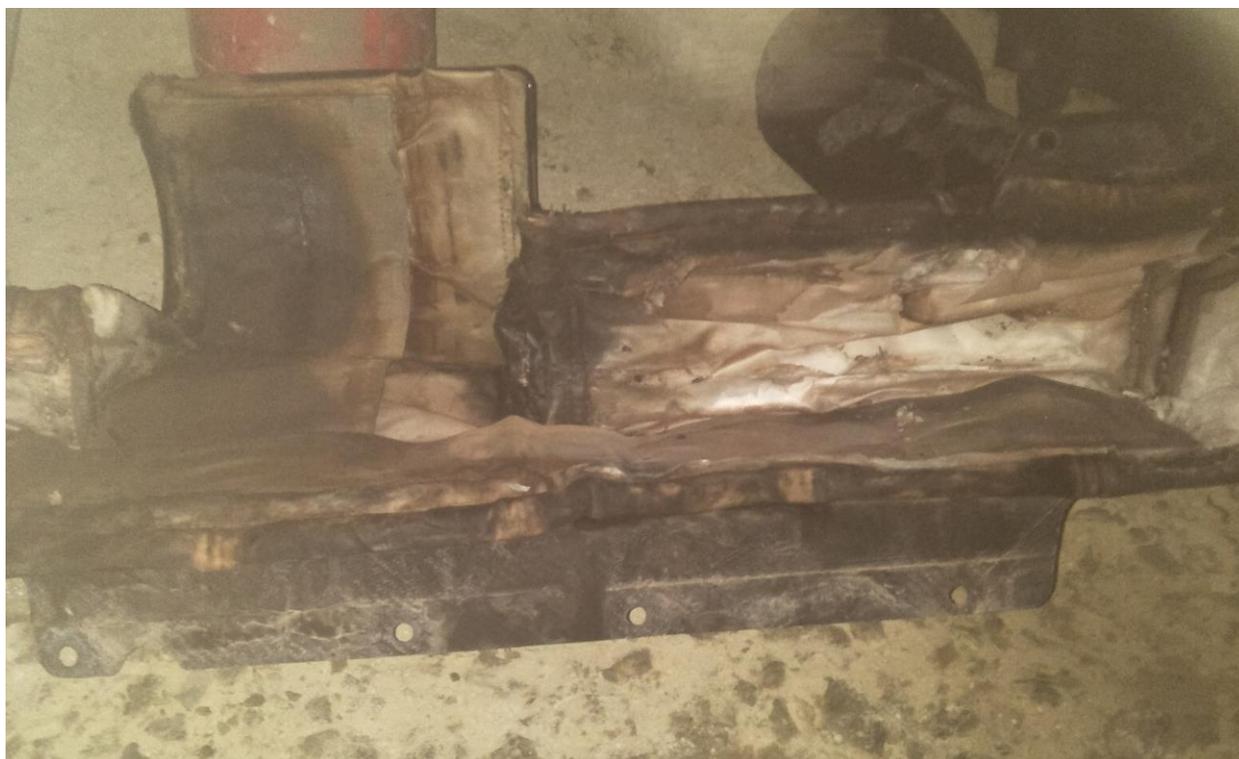
FIGURE 23. NEW COBAR & CHESNEY

At an underground metalliferous mine, a Volvo L120 integrated tool carrier (IT) was being used by a charge-up crew when they noticed a flame on the right-hand side of the engine. The onboard fire suppression system was activated manually, which extinguished the fire. The IT was hosed down to extinguish smoldering cladding that was surrounding the exhaust system.

The mine's initial investigation identified an overflow or leak in the coolant system that doused the exhaust lagging with coolant. The coolant containing glycol, or similar chemical, can be flammable when dried.

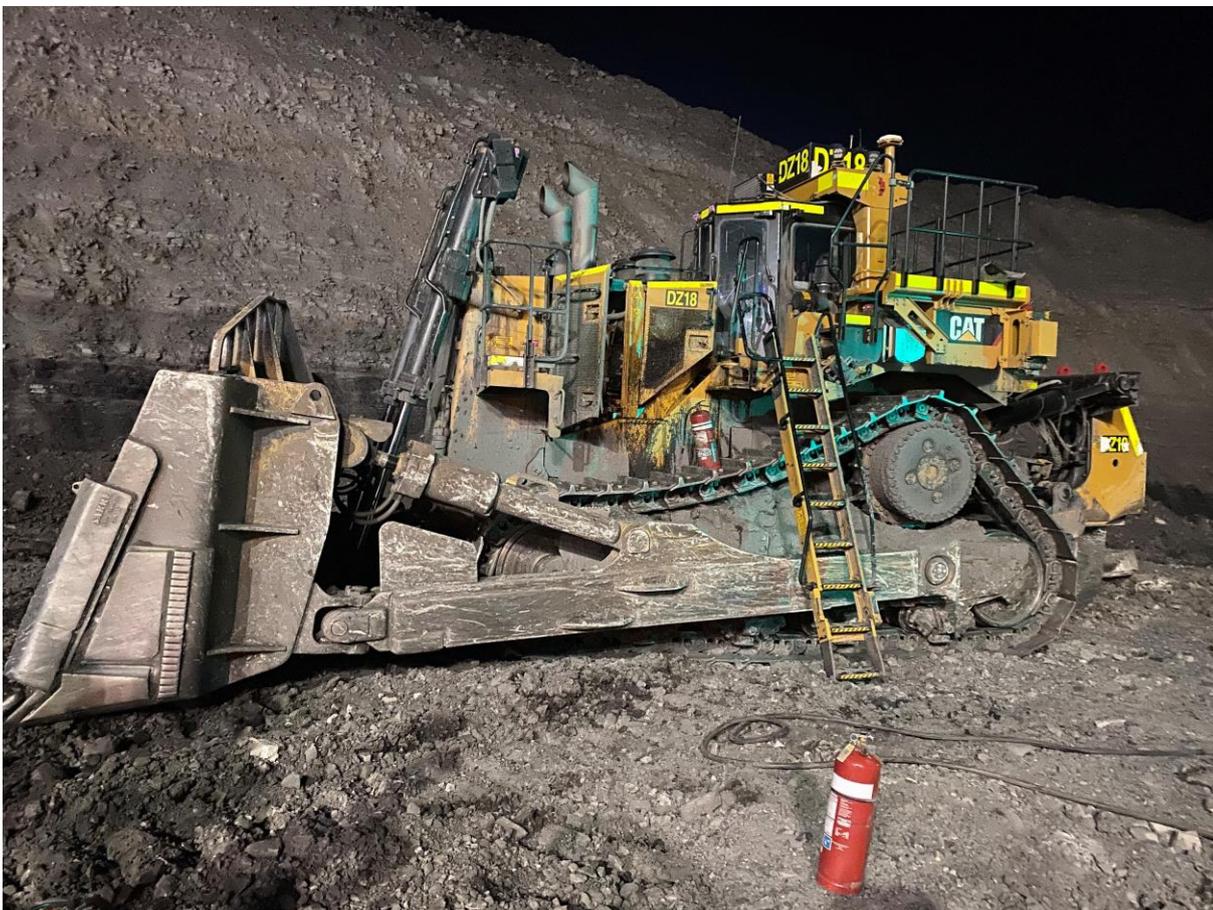
FIGURE 24. BENGALLA MINE

A Caterpillar D11T dozer at a surface (open cut) coal mine was working next to the dragline when the driver smelled fumes. The operator pulled the dozer back and saw smoke coming from the engine compartment. The fire was extinguished using a hand-held fire extinguisher. The mine's initial observation identified that the hydraulic pilot filter came loose, which allowed oil mist to be drawn into the engine compartment and make contact with hot surfaces.

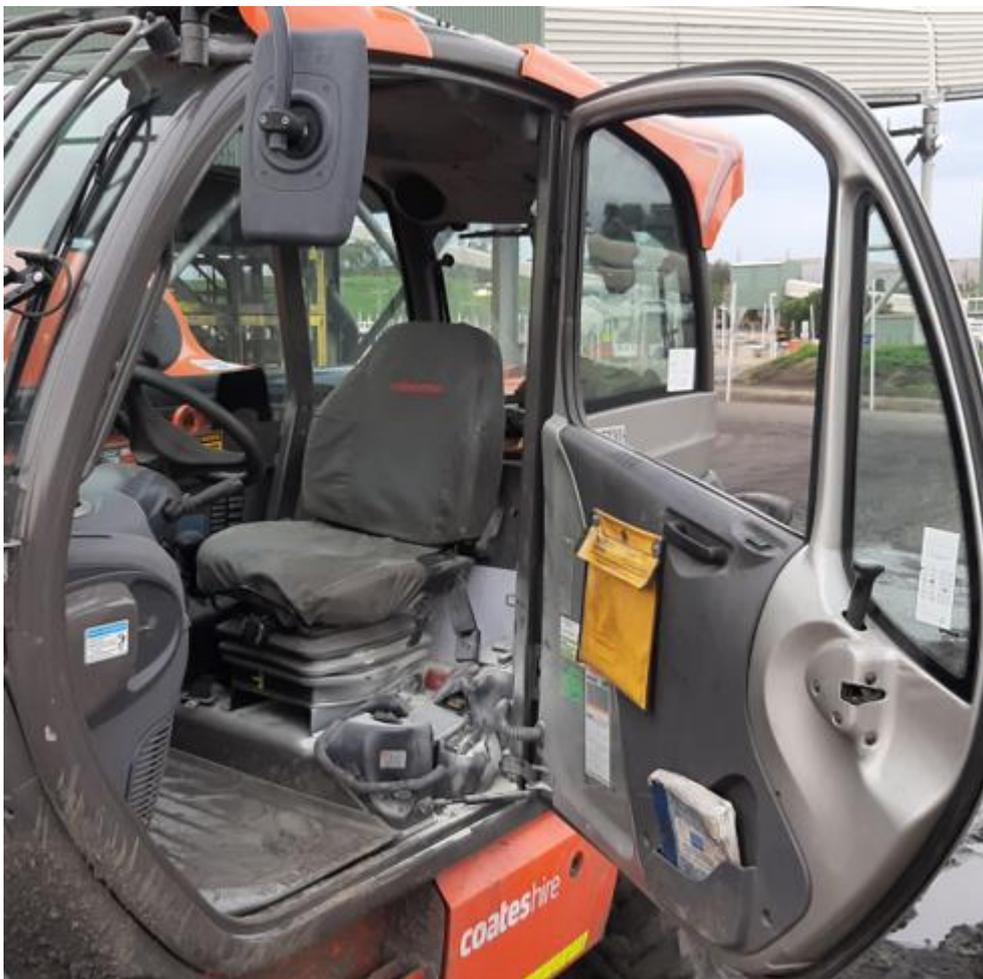
FIGURE 25. BENGALLA MINE

At a surface (open cut) coal mine a technician operating a Manitou MT1040 telehandler in the CHPP area saw smoke in the cab. The technician looked down to the left-hand side and witnessed flames in the cab near the two-way radio. He parked the machinery, lowered the implements and turned the machine off. The technician put the flames out with the fire extinguisher and turned the battery isolator off.

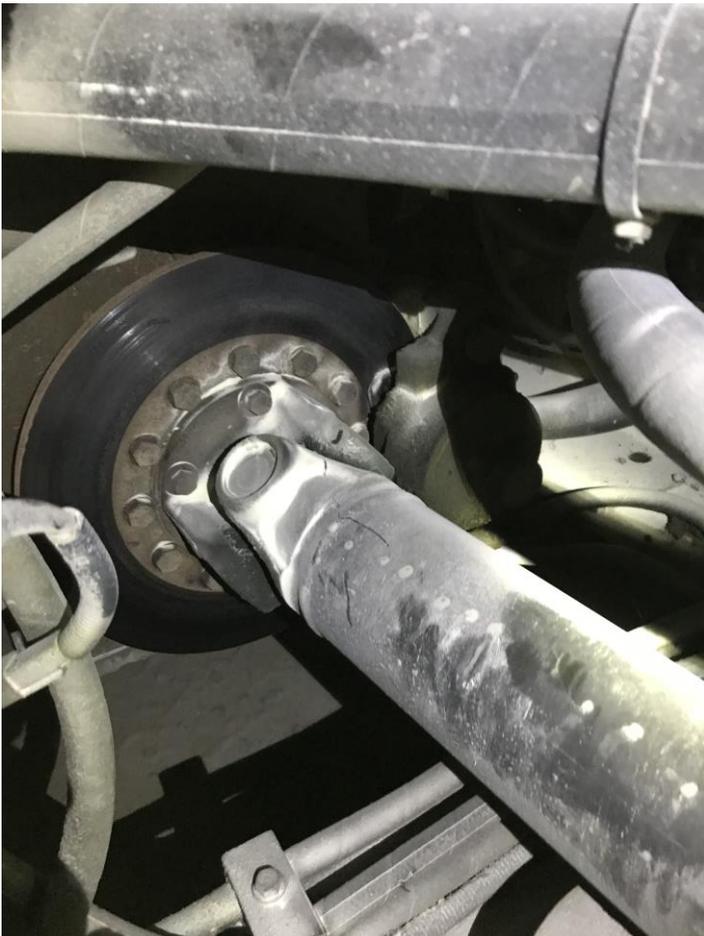
FIGURE 26. PEAK GOLD MINE

At an underground metalliferous mine, a small fire occurred on the park brake of a Volvo L70F Integrated Tool Carrier underground. The fire was immediately extinguished by the operator. The investigation identified the oil supply to the brake calliper was leaking. The leak was dripping onto the calliper. The leak resulted in a decay of oil pressure which caused the brakes to drag, generating heat.

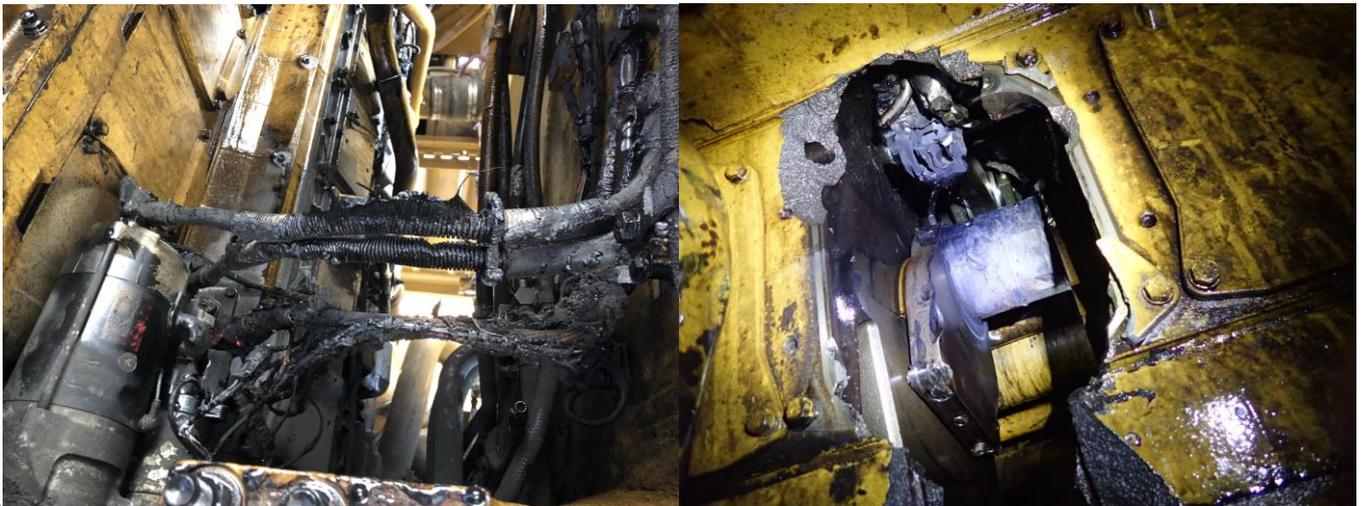
FIGURE 27 & 28. WAMBO OPEN CUT COAL MINE

At an open coal mine, a Caterpillar 793 haul truck suffered a catastrophic engine failure whilst travelling on the main haul road on the way back to the workshop. The operator brought the truck to a stop and activated the fire suppression system. This extinguished the fire in the engine bay area, and the operator was able to safely exit the vehicle. A water cart extinguished a residual oil fire in the Pos 4 tyre area.

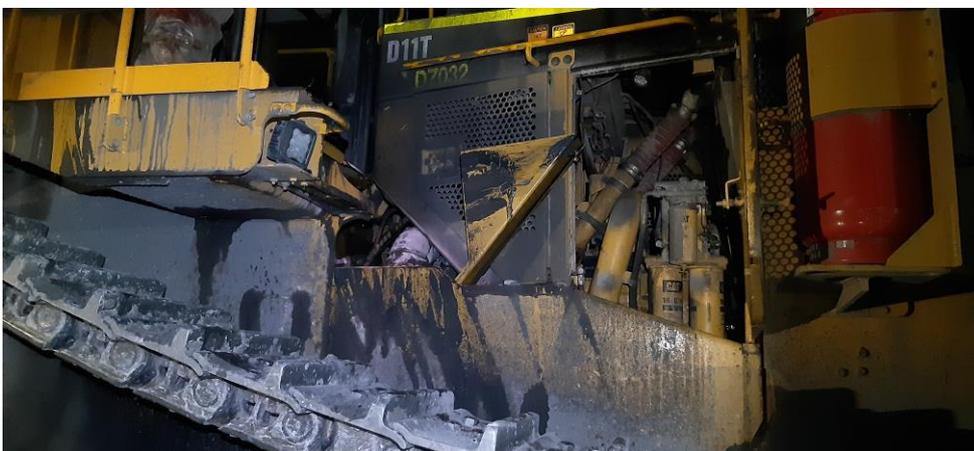
FIGURE 29. BENGALLA MINE

An operator of a Caterpillar D11T noticed an oil leak and smoke coming from the front of the machine. Flames were then observed coming from the engine bay. The fire suppression system was manually activated. This did not fully extinguish the fire so the operator used a handheld fire extinguisher to fully extinguish the fire. The investigation found that the fan pump signal hose has failed which allowed pressurised oil to spray into the engine bay.

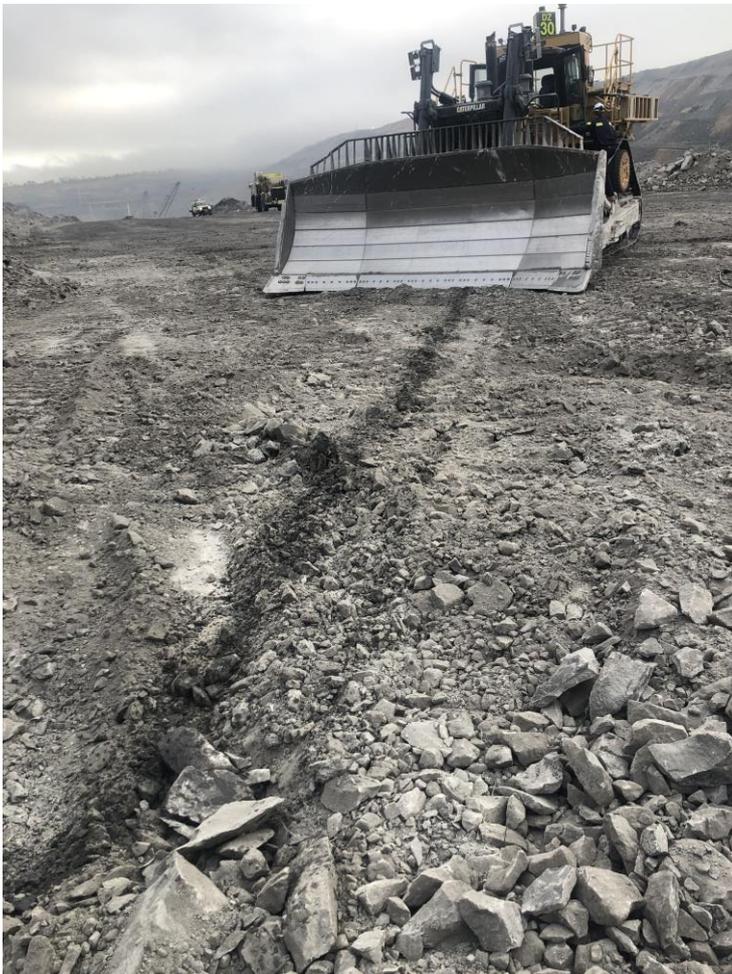
FIGURE 30. BENGALLA MINE

An operator of a Caterpillar D11T was pushing material when a glow was noticed at the front of the machine. At the same time, a truck called emergency. The operator immediately reversed from the wall and saw flames.

The operator manually activated the fire suppression system. The operator inspected the engine bay and there was no evidence of fire, however he used an extinguisher as a precaution. A water cart was sent to the scene and was used to cool the area. A blade hose tilt failed, which sprayed hydraulic oil over the machine and into the engine bay.

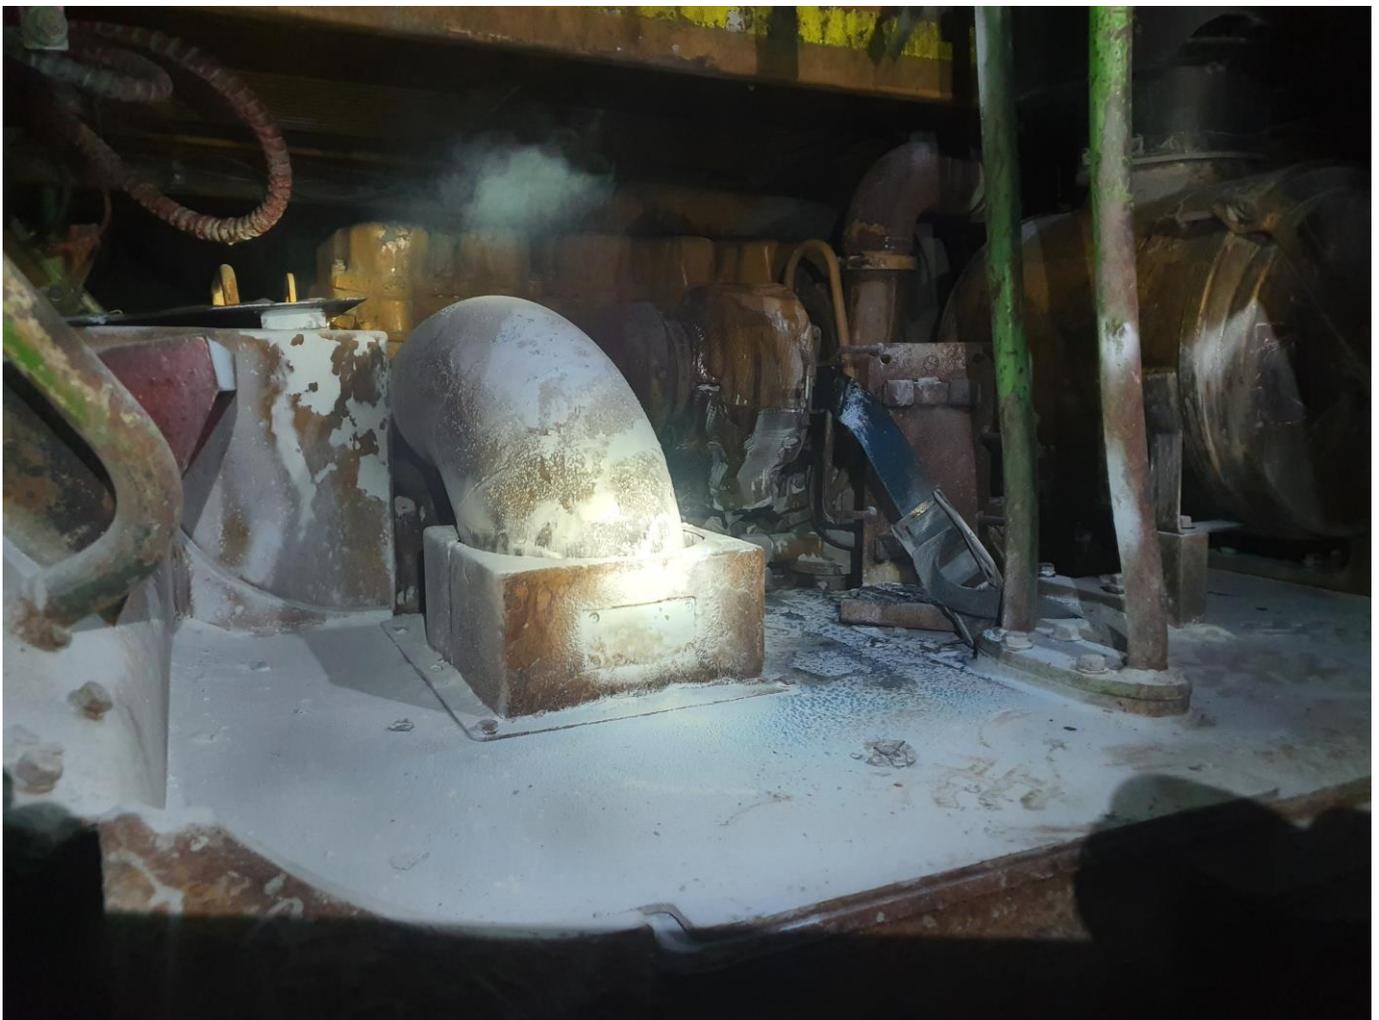
FIGURE 31. CSA MINE

A Caterpillar R2900G underground loader was idling when the operator saw smoke and flames at the back of the machine. The operator activated the fire suppression system and extinguished the fire. The investigation identified a failure of the fuel tank. It was leaking diesel onto hot components which caused the fire. The stress induced into the loader frame during recovery of the loader when stuck in stopes was identified as a contributing factor.
