MINE SAFETY INVESTIGATION UNIT

INFORMATION RELEASE

Fatality

Incident date	21 May 2014
Event	Worker crushed while using mobile elevated work platform
Location	Boggabri Coal Mine, Boggabri NSW

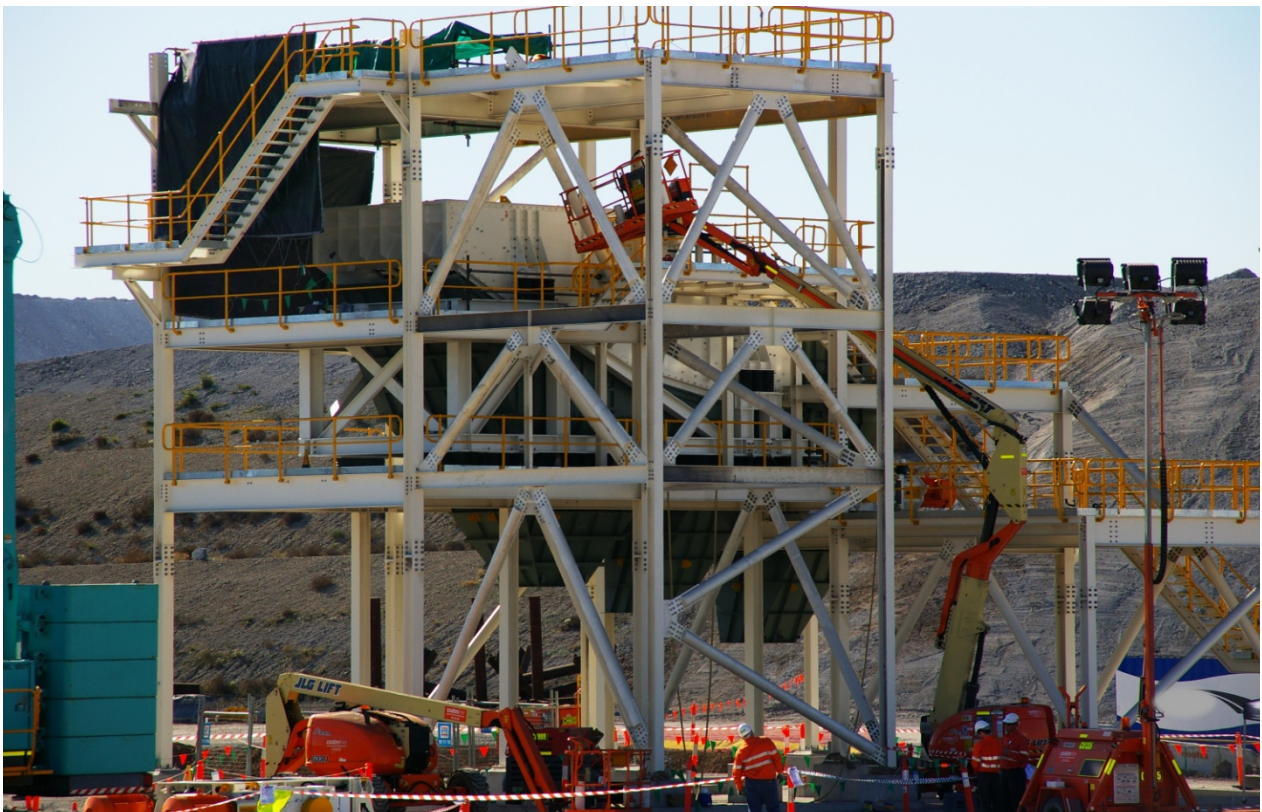
A construction worker was using a mobile elevated work platform (MEWP) within a steel structure when his head was crushed between the protective rail of the MEWP work basket and an overhead steel beam about 14 metres above ground level. Investigations into the incident are continuing.

Steel structure with MEWP in approximate position (after recovery of worker) - *Photograph by Investigation Unit*

In response to this incident, Mine Safety inspectors issued the mine operator with a notice requiring a full risk assessment to be undertaken in relation to all MEWPs at the site. The notice also requires the mine operator to consider the use of engineering controls that provide overhead protection for operators working in MEWP baskets.

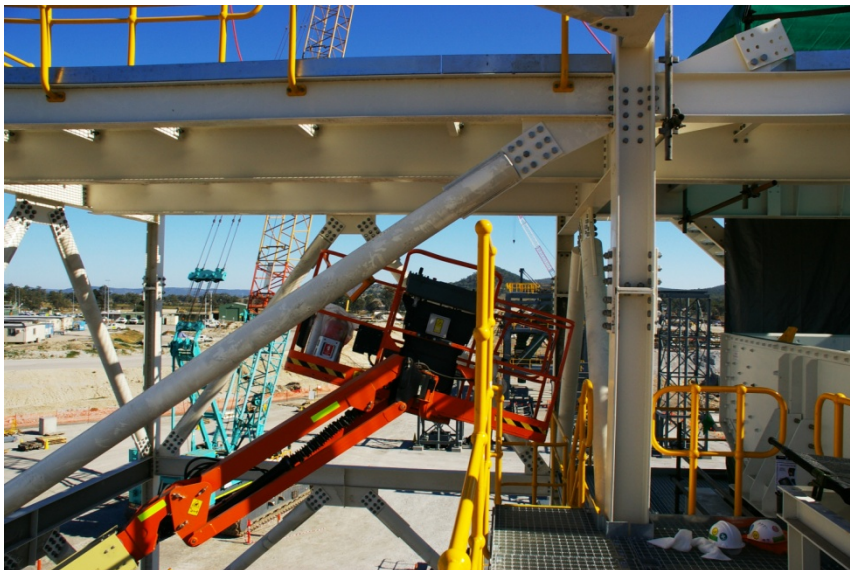
Position of MEWP basket (after recovery of worker) - *Photograph by Investigation Unit*

The base of the mobile MEWP was on a concrete pad at the base of the building. The basket had been positioned centrally within the building, and underneath the upper floor level. The articulated boom had been manoeuvred to reach in between the structural elements of the building.
