MINE SAFETY INVESTIGATION UNIT

INFORMATION RELEASE

High potential incident

Incident date	12 March 2016
Event	Collision between front-end loader and light vehicle
Location	Whitehaven Coal Handling Preparation Plant, Gunnedah NSW

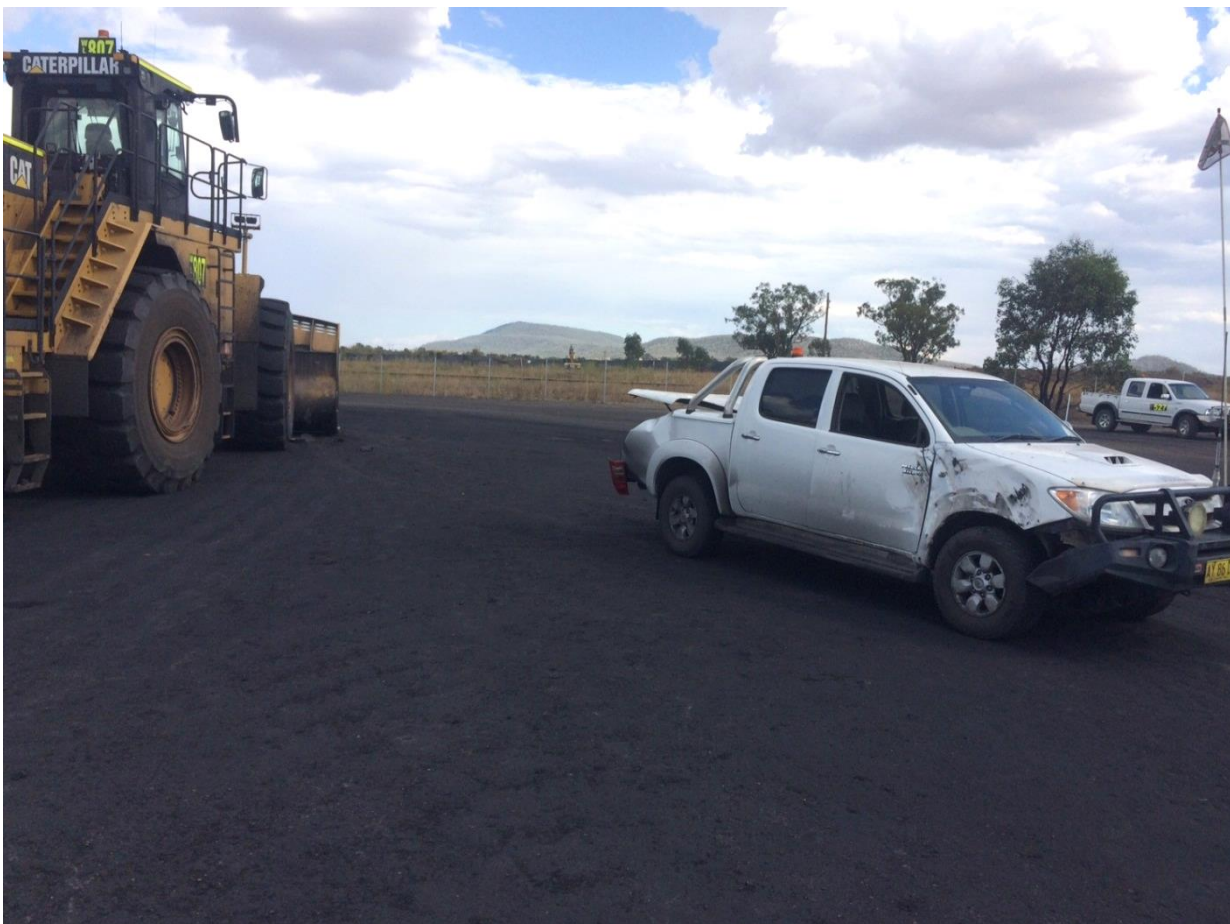
A Caterpillar 992 front end loader reversed into a light vehicle that entered a coal stockpile work area. The dual cab Toyota Hilux was damaged but the light vehicle operator was not injured.

Photograph taken by the mine of the damaged light vehicle and the loader involved in the incident.

The loader's right front wheel skimmed the light vehicle near the driver's door and the loader bucket impacted the rear of the light vehicle before it stopped. The light vehicle operator then drove the damaged vehicle away from the loader.

Mine operators should consider:

- opportunities to eliminate light and heavy vehicle interactions
- the adequacy and robustness of their surface transport management plans and communication systems and protocols on site
- use of the available technology to control vehicle and mobile plant interactions such as proximity detection, collision avoidance and proximity lockout systems
- human factors such as environmental, organisational and job factors with the goal of managing human reliability and failure.
