INVESTIGATION INFORMATION RELEASE

Causal investigation - partial collapse of a ventilation shaft

Incident date: 3 May 2020

Location: North Wambo Coal Mine, NSW

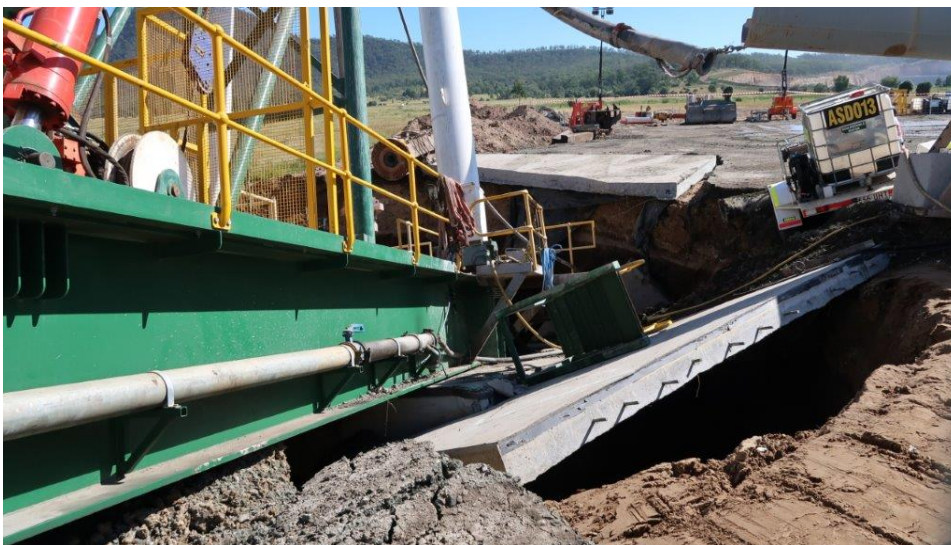
Figure 1: Fan shaft collar collapse

At around 8:15am, at a drilling depth of 59.3 metres, a three metre diameter bore shaft was being drilled toward an existing development roadway underground. The drillers on the surface reported a loss of drilling mud from within the shaft. At this point, the bulkhead seal had catastrophically failed, causing the drilling mud to enter into the underground workings. Drilling operations were approximately 500 millimetres above the underground roadway. Within minutes, the alluvial materials close to the surface began to collapse into the shaft void, due to the rapid loss of confinement pressure.

A sinkhole rapidly developed and the drill rig personnel moved to a place of safety, prior to both the drilling rig and pad partially descending into the sinkhole.

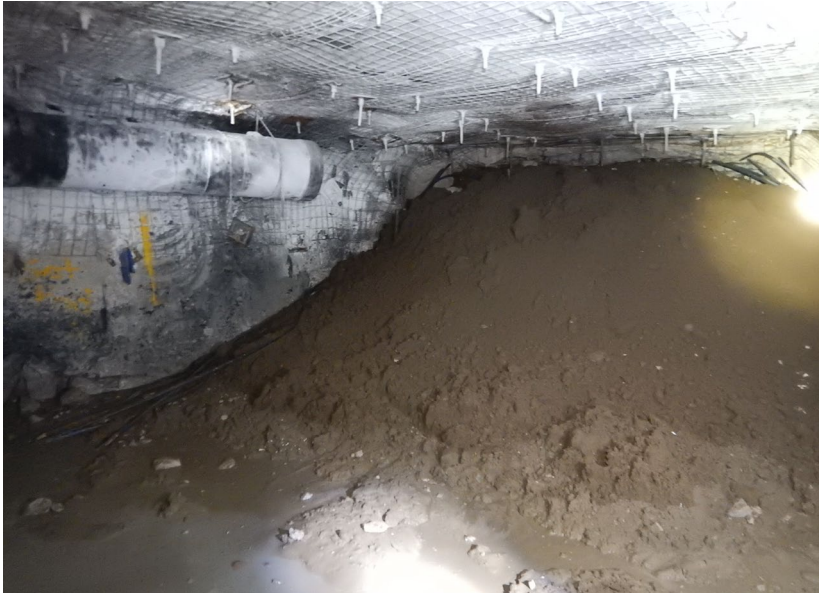
On 3 May 2020 at approximately 8:15am, there was a rapid loss of drilling mud from a blind bore drilling shaft, caused by a catastrophic failure of an underground bulkhead seal.

An engineering designed underground bulkhead seal was installed directly beneath the blind bore drilling project, where the shaft was to intersect the roadway underground. The purpose of this bulkhead seal was to confine the drilling mud to within the shaft column for the duration of the drilling project, and to prevent interaction with the underground workings. The design strength of the bulkhead seal was intended to reach 7.6 megapascal (mPa), however after three weeks of curing time, the average strength of the bulkhead seal was determined, through sample core testing to be approximately 2.5mPa.

The mine contacted the design engineer to seek his opinion on how the lower strength material would perform compared to the original design. A revised factor of safety was introduced to the seal, along with the understanding that the seal may show signs of cracking and/or leaking, however would not catastrophically fail.

Subsequently, an underground inspection was undertaken by mining supervisors, who confirmed that there was clear evidence that the bulkhead had catastrophically failed, and that no further source of ground instability was identified.

Figure 2: Bulkhead seal failure

- The loss of confinement pressure in the shaft due to the catastrophic failure of the bulkhead had not been considered in respect to the impact on the integrity of the unlined shaft, and consequently no controls were identified. The assumption maintained throughout the risk assessment process was that the drilling mud would remain insitu until the drilling had been completed.

- Design risk assessments should be carried out prior to the commencement of construction activities.
- Operational risk assessments should consider the findings from within the specified design risk assessment and implement appropriate risk controls to effectively reduce the risk, to as low as reasonably practicable.

- Critical controls identified in both design and operational risk assessments should be accompanied with a system of work to verify the effectiveness of the critical controls, along with prescribed actions to be completed if deficiencies are identified.
