INVESTIGATION INFORMATION RELEASE

Worker's arm injured in belt press filter

Incident date: 17 May 2020.

Location: Moolarben Coal Operations – Coal Handling and Processing Plant ('the CHPP')

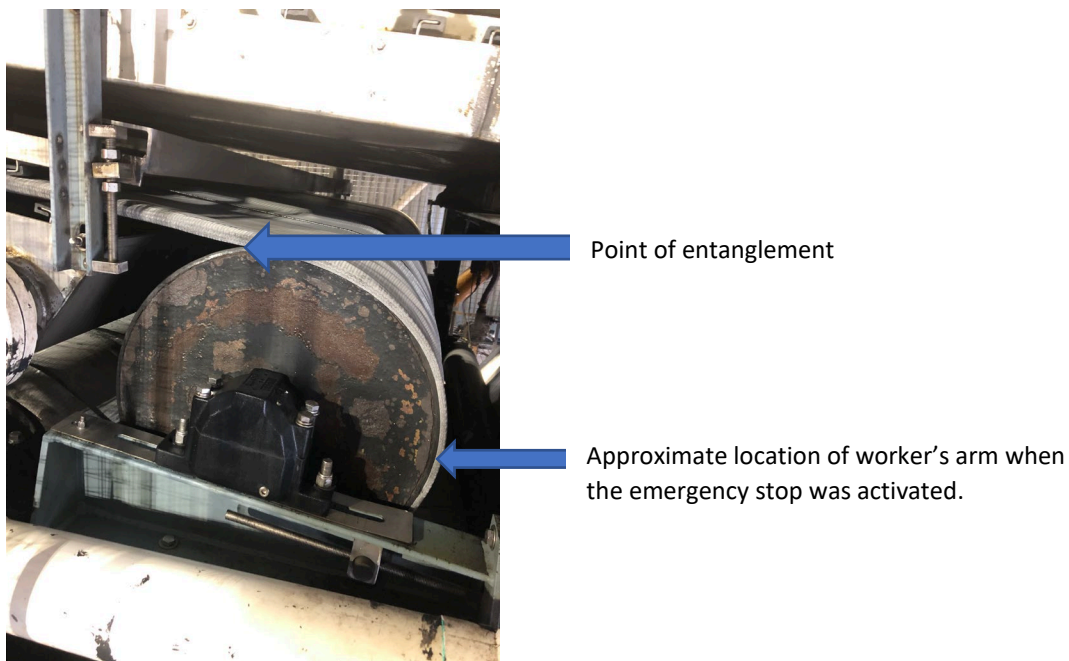
A worker opened guarding around an operating belt press filter in order to correct a misaligned belt. He lost his balance while moving towards the filter, causing his arm to become caught between the belt and a moving drum. He sustained serious arm injuries which required surgery.

Figure 1 – Location of belt press filter where the worker's arm became caught

The worker was moving towards a rotating drum located in an area where the guarding had been opened. He stated that he lost balance and reached out to what he thought was part of a fixed structure adjacent to the drum. His left forearm was caught between the belt and the rotating drum. The drum had rotated approximately 135 degrees, when the supervisor arrived in response to the worker's earlier radio message. The supervisor and another staff member activated the filter's emergency stop and reversed the drum to release the worker's arm.

Mine operators and workers must ensure that when guarding around plant is removed for maintenance or cleaning purposes, all energy sources are isolated. Consideration must be given to installing interlock

devices that prevent unguarded plant from operating when risks are present. Guarding must be restored to its secured position before the plant resumes operation.

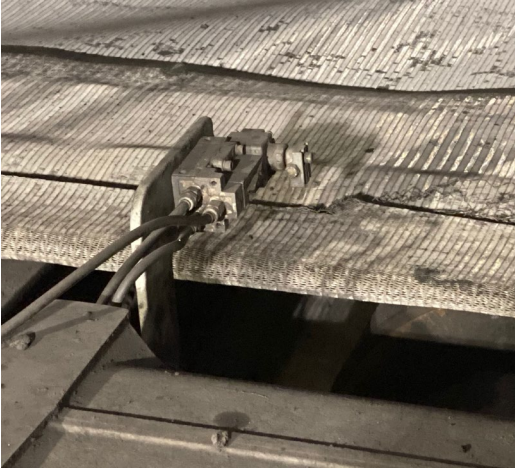
The worker restored air pressure to the above components. He believed that the tracking drum would straighten the misaligned belt as it rotated. However, the tracking limit switch on the filter was designed to stop the plant from operating when a metal prong referred to as a 'cats' whisker' contacted a misaligned belt. In order to override this function and allow the tracking drum to continue to turn and align the belt, the worker removed the 'cat's whisker' by disconnecting it from the limit switch.

Figure 2 – Filter 3 with cat's whisker removed

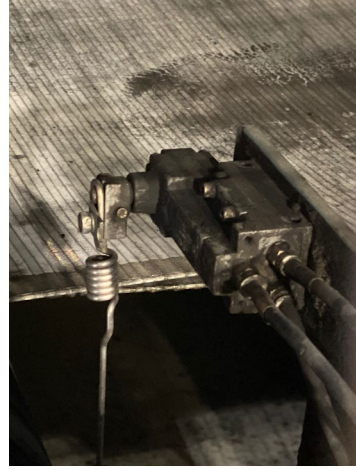
Figure 3 – Adjacent filter with cat's whisker fitted

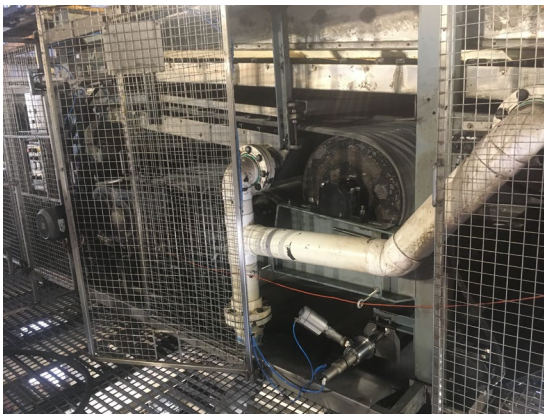
Figure 4 – Proximity of filter to the open guard door

Where it is identified that guards must be removed to complete a particular task while the plant is in operation (i.e. when replacing belts on filters), a risk assessment must be undertaken and additional controls implemented to ensure that risks are reduced as low as reasonably practicable.
