# INVESTIGATION INFORMATION RELEASE

## Worker suffers serious injuries when pinned by boom of a continuous miner

**Incident date:** 5 February 2021

**Location:** Myuna Colliery, Lake Macquarie NSW

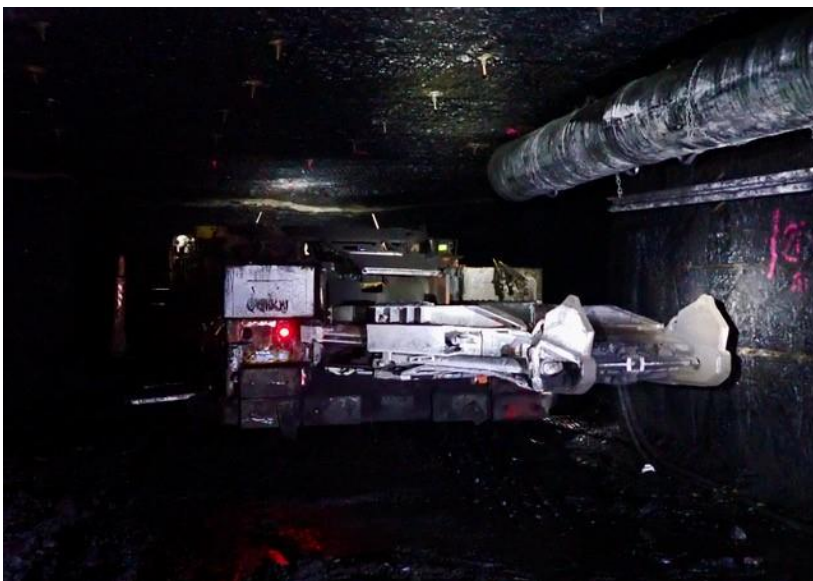
A mine worker was in the process of picking up a feeder cable behind a moving Joy 12CM wide head continuous miner (**the miner**) when his upper body became pinned between the boom of the miner and the rib. The worker sustained serious internal injuries, arm and rib fractures.

*Figure 1 Position of continuous miner after worker was released*

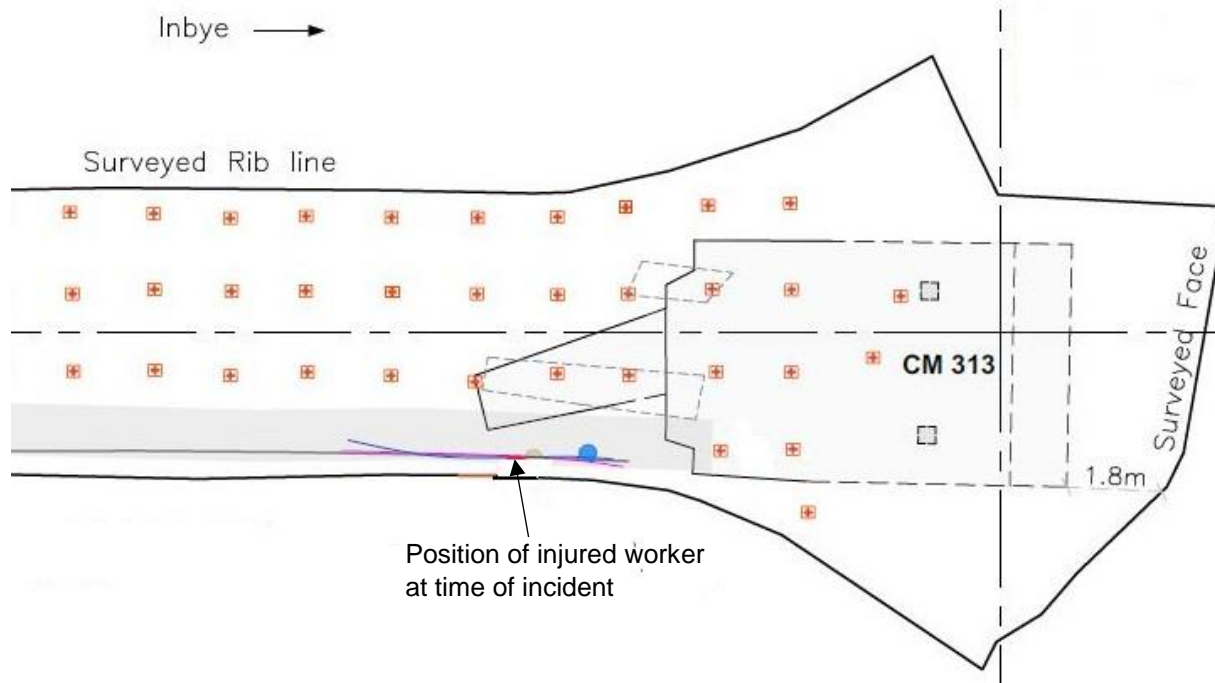
At some point the injured worker left the platform of the miner. It had been identified that the left-side bolt storage cassette on the miner was empty and needed replacing. The miner concluded its bolting cycle and prepared to tram outbye. Its boom was angled toward the right rib at an angle of 21 degrees (relative to the continuous miner body) and remained in this position throughout the incident.

The miner slewed to the left which caused the boom of the miner to move in a sideways direction towards the injured worker who was standing next to the right rib.

The injured worker became pinned between the right-side of the boom and the rib. The miner operator heard the injured worker's screams and slewed the miner away from the rib thereby releasing the worker.

Figure 2 Incident area showing position of miner after the injured worker was released

- The miner involved in the incident was not fitted with a proximity detection system.
- The mine operator was unaware of the location of the injured worker immediately prior to the incident.
- The injured worker was unaware that he was in close proximity to the boom of the miner immediately prior to the incident.

- Review their safety management systems to ensure they adequately identify and control the risks associated with interactions between continuous miners and workers.

- Assess the practicability of installing proximity detection systems on continuous miners. Proximity detection systems significantly reduce the risk of death or serious injury caused by workers being pinned or crushed around continuous miners.

- When operating a miner, keep other workers out of no-go zones and in safe locations when moving machines.
- Ensure that positive communication is maintained between miner operator and other workers during tramming operations.
- Always maintain situational awareness when working near moving mining equipment.
