**NSW
Resources
Regulator**

Investigation report

The death of Mark Siegel at mineral claim 44507 near
Lightning Ridge on 4 November 2016

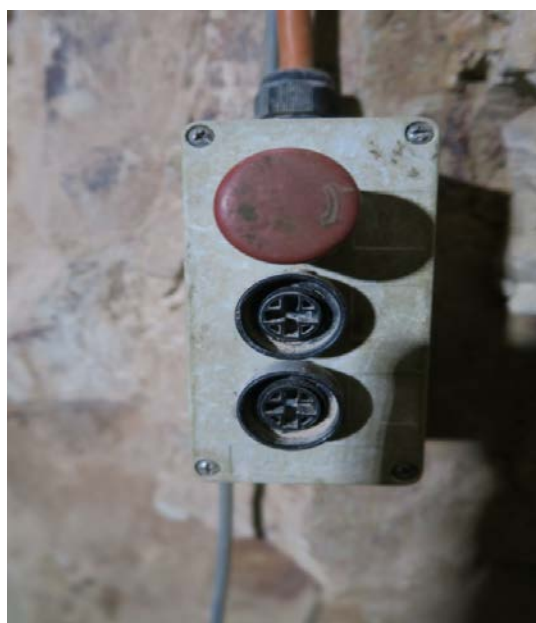
Figure 6: Hoist control unit (underground).

Note: the control panel underground was not labelled to indicate the operations of the buttons

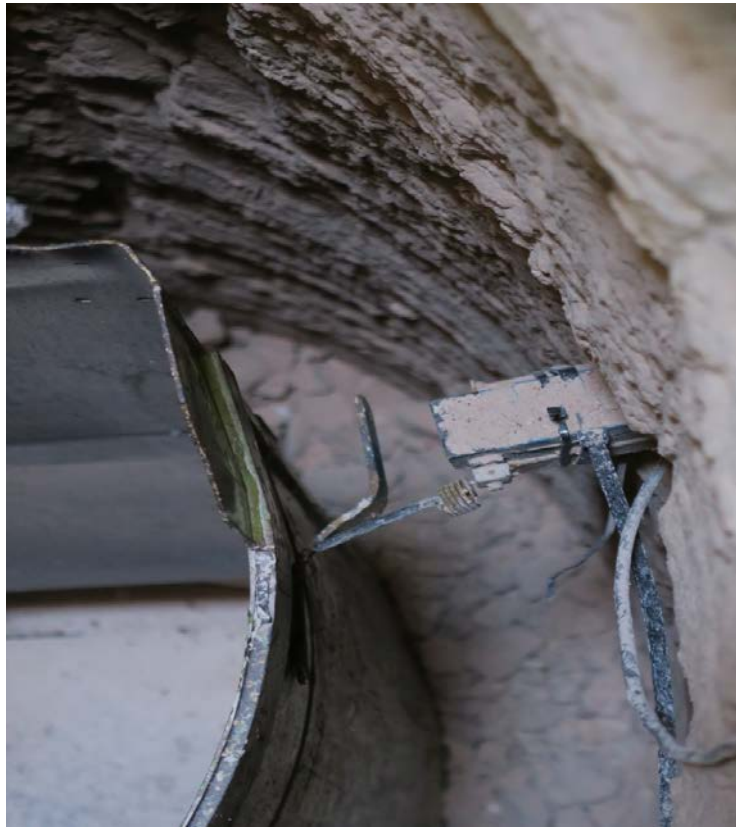
Figure 11: The bucket in the sump (bracket and limit switch).

The lower limit switch was not activated when the bucket entered the sump. This could have been as a result of the bucket's bracket missing the lower limit switch due to its position (upon inspection of the lower limit switch it was found to have been loose and not secure, however, it cannot be determined if this was as a result of the incident or if it was poorly installed, or mullock in the bottom of the sump preventing the bucket lowering sufficiently for the bracket to activate the limit switch.

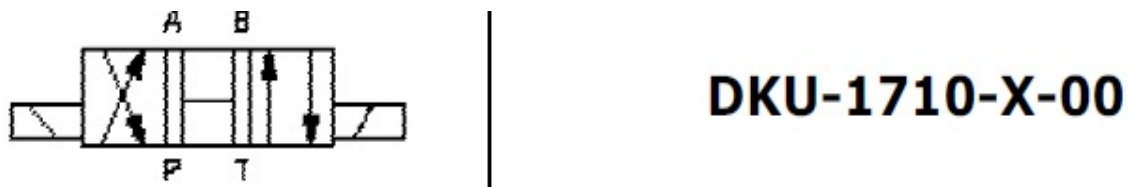
Figure 16: Converted solenoid valve configuration in the system at the time of the incident.

Inquiries made with Southcott Pty Ltd identified Southcott used to be authorised to convert valves, however Atos removed conversion approvals by all distributors worldwide about 10 years ago.

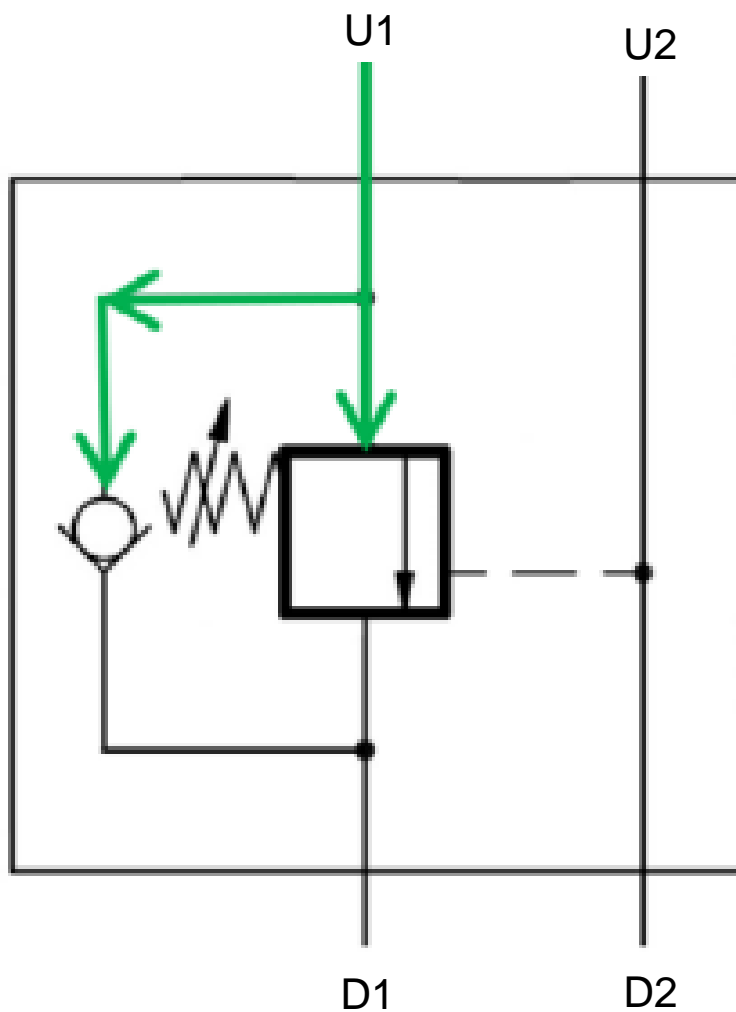
Figure 22: Flow of oil prevented due to the ball valve.

‘Freewheeling of the hydraulic motors is prevented in only one direction, the reverse direction, this type of counter balance is called a single acting counter balance valve.’

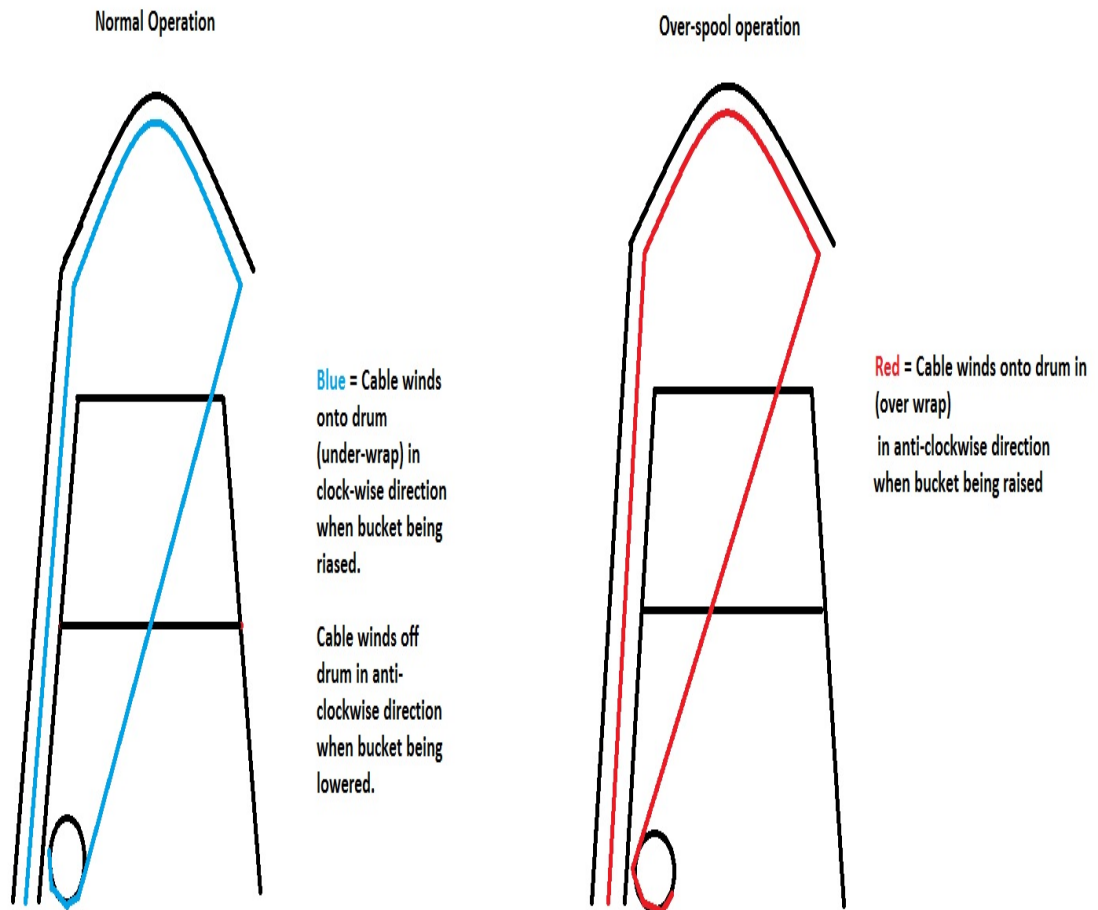
Figure 24: Normal and over-spool operation of the hoist's drum and cable.

The hoist bucket is raised and lowered by the hydraulic system turning the drum, which houses the steel cable. The steel cable is attached to the drum via a U-clamp at one end and attached to the bucket at the opposite end. In the event that the limit switch inside the underground sump is not activated, the cable continues to unwind. When fully unspooled, the drum continues to turn causing the cable to wind onto the drum in the wrong direction (figure 24). This causes the bucket to unintentionally rise back to the surface.

Due to the limit switch not being activated, the hoist's drum continued to turn, unspooling the cable. This caused the cable to wind onto the drum in the wrong direction and lifted the bucket unintentionally back to the surface.

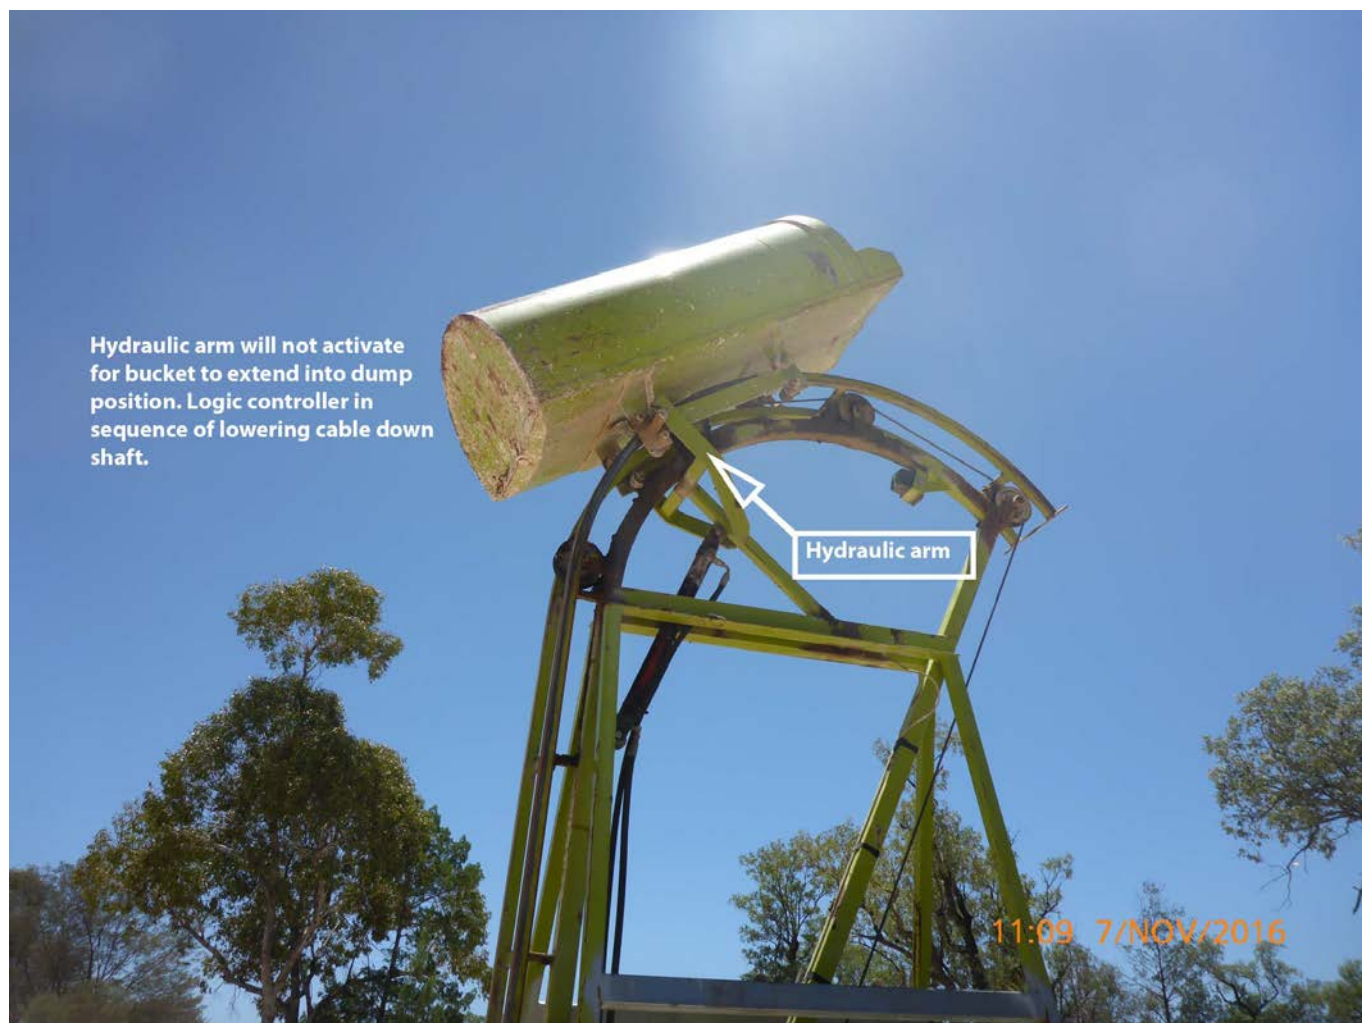
Figure 25: The bucket unable to fully engage into the tip position.

As the bucket reaches the arc of the hoist, it hits the hydraulic arm brackets. However, as the hoist's electrical system has not detected the lower limit switch being activated, it will not allow the bucket to engage with the hydraulic arm (figure 25). The bucket remains in this position with the hoist's motor still running.

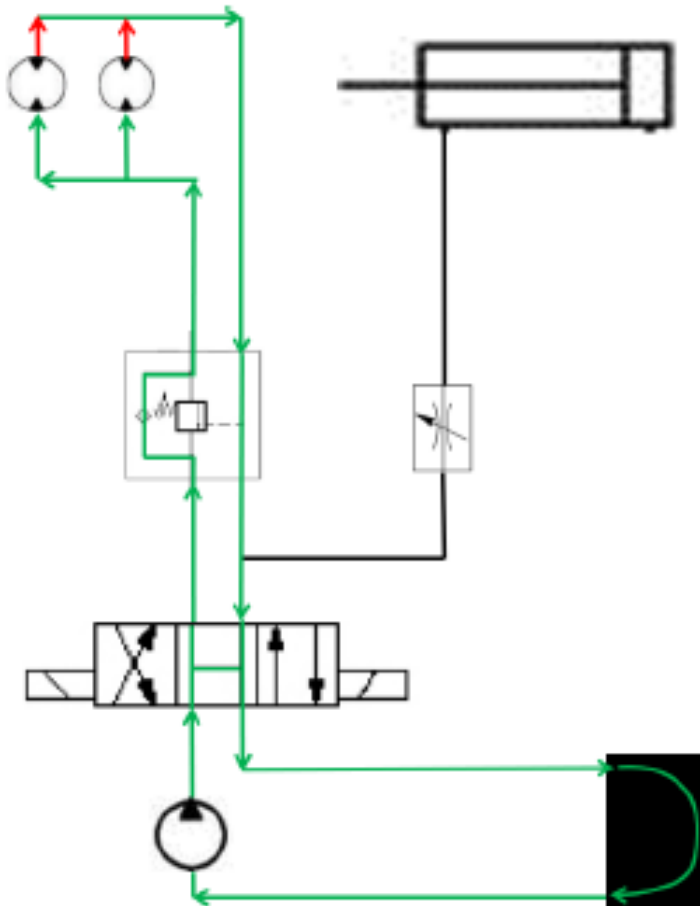
Figure 26: The over-spool hydraulic scenario with motors rotating pumping oil forward.

The weight of the bucket then turns the motors (freewheeling) and because of the counter balance valve being single-acting (figure 18 and 22) there is no resistance to the motors pumping oil forward (figure 26) resulting in the motors turning and the bucket free-falling down the shaft.

The counter balance valve was (only) single acting, there would have been no material resistance to the hydraulic motors pumping fluid 'forwards', and the bucket would not have been braked.
