MINE SAFETY INVESTIGATION UNIT

INFORMATION RELEASE

Double fatality

Incident date	15 April 2014
Event	Major rib burst in an underground coal mine
Location	Austar Coal Mine, Hunter Valley NSW

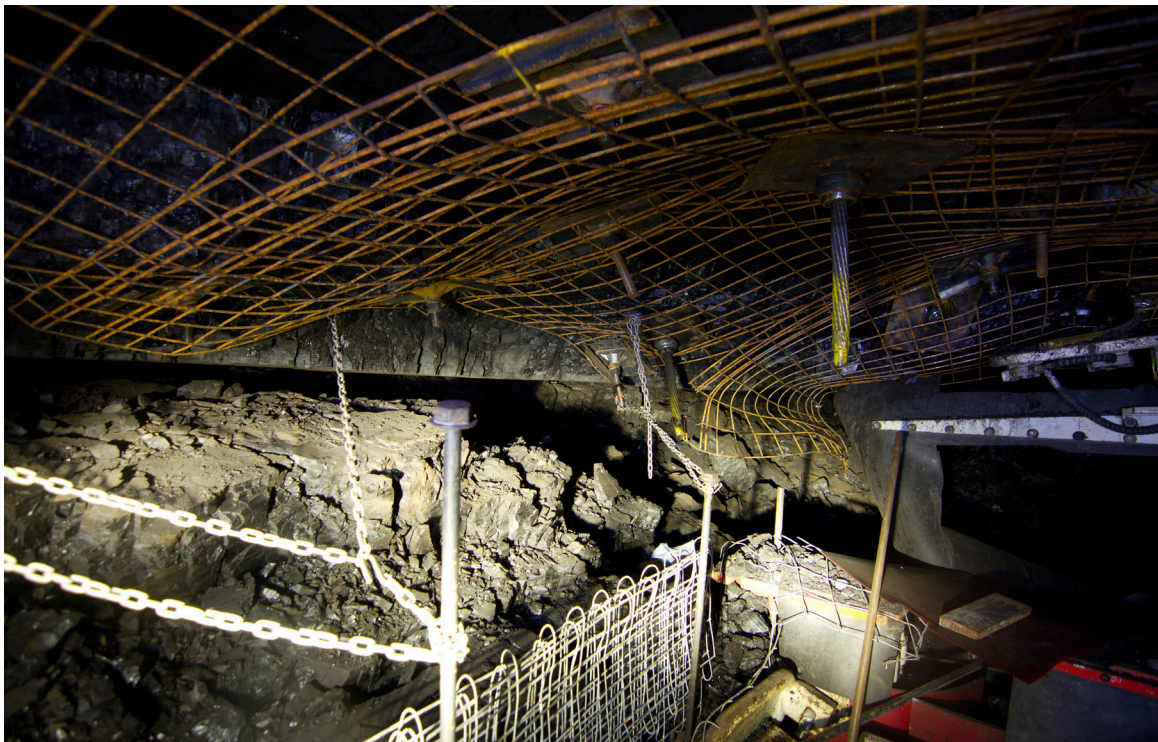
Rib on the left of the bolter miner after the workers were recovered. - Photograph by Investigation Unit

Two of the workers were on the left hand side of the bolter miner when a major burst of coal from the rib occurred. During this event a large section of the left rib that was supported with various lengths of bolts and mesh lost confinement and moved sideways into the roadway where the two men were working. Rib material engulfed both men who died at the scene.

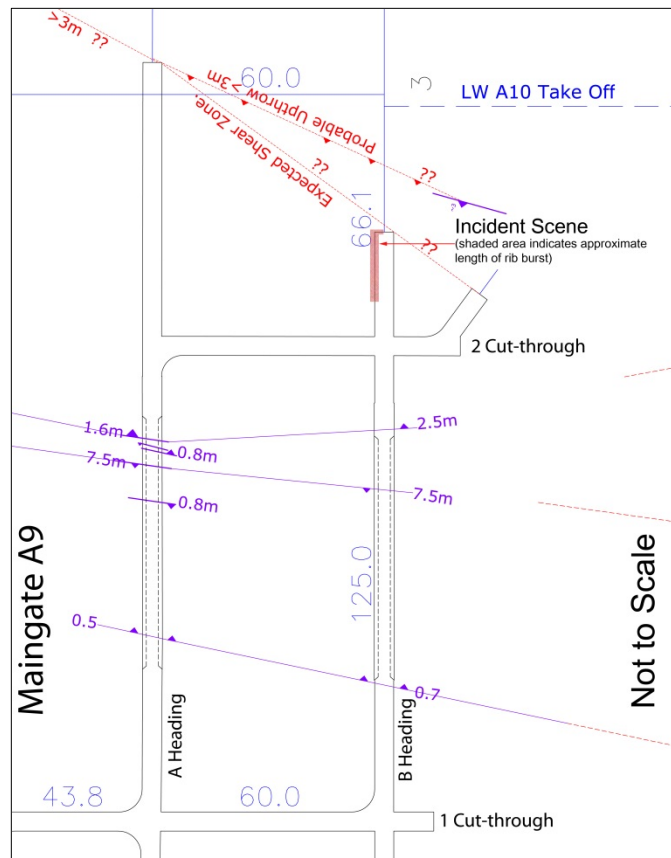
The incident occurred at 9.05 pm on 15 April 2014. The incident site was in maingate A9, B heading about 25 metres inbye from the second cut-through. It was about 10 kilometres from the mine entrance and 555 metres below the surface. At this depth the rib and roof strata of the coal seam is subject to significant stress.

This particular heading is in a geologically disturbed zone near an upthrow fault and shear zone. The workers were mining toward the upthrow fault when the incident happened.

Steel mesh and bolts supported the roof and ribs at the incident site. A combination of steel mesh and chemically anchored roof bolts and cable bolts supported the roof. A combination of steel mesh, chemically and mechanically anchored bolting systems supported the rib. The extent and nature of the bolting is yet to be confirmed.

Plan of the incident site supplied by the mine.
