Investigation report

Report into the death of Stephen Norman
at the Rix's Creek Coal Mine, Singleton, NSW,
on 13 December 2016

First published: November 2018

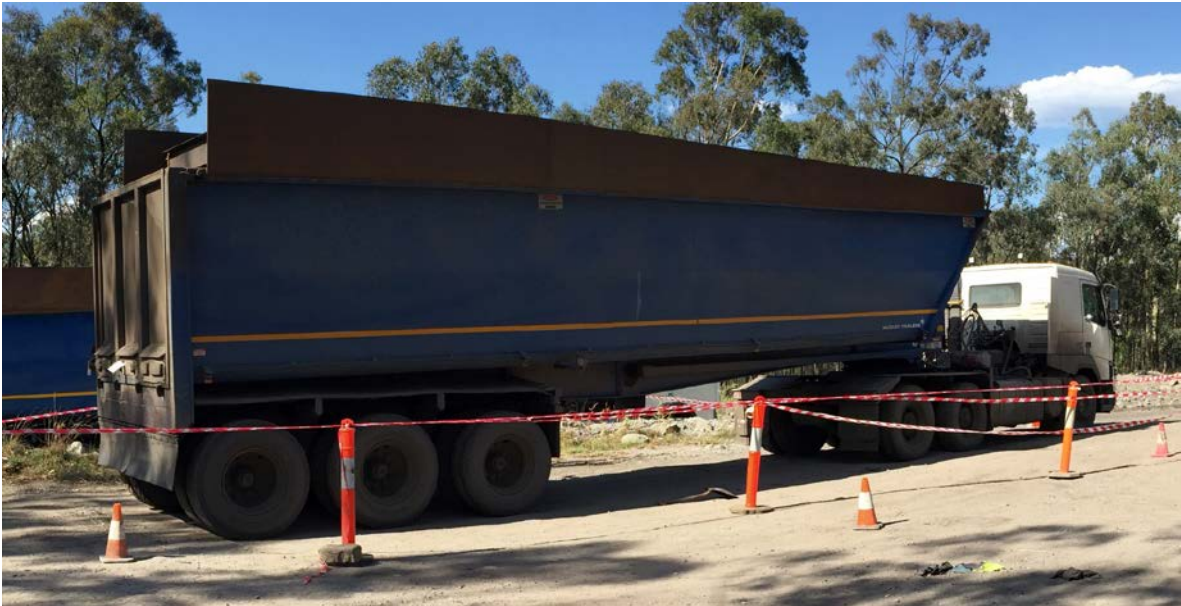
Figure 4: Truck and Muscat trailer involved in the incident.

The coal haulage truck was a Volvo prime mover (registration CG 50 MV) with a Muscat MT2103 tipping trailer (registration W68252) as shown in figure 4.

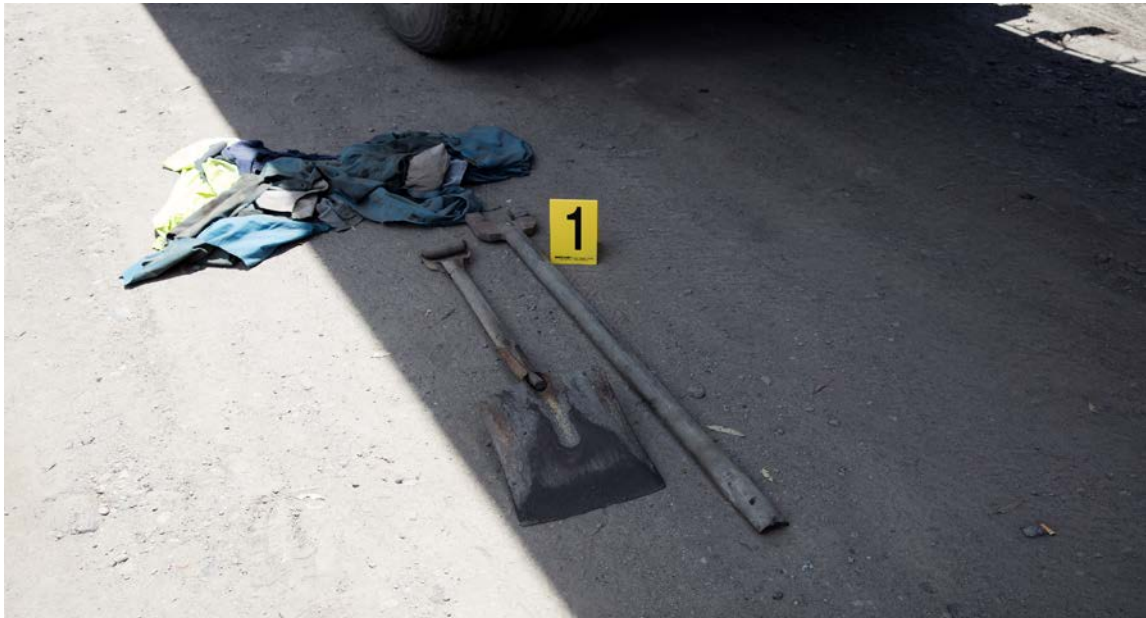
Figure 5: Handmade tool and shovel.

Mr Norman used a shovel to pry open the tailgate and propped it open with a handmade tool (pipe wrench) as shown in figure 5.

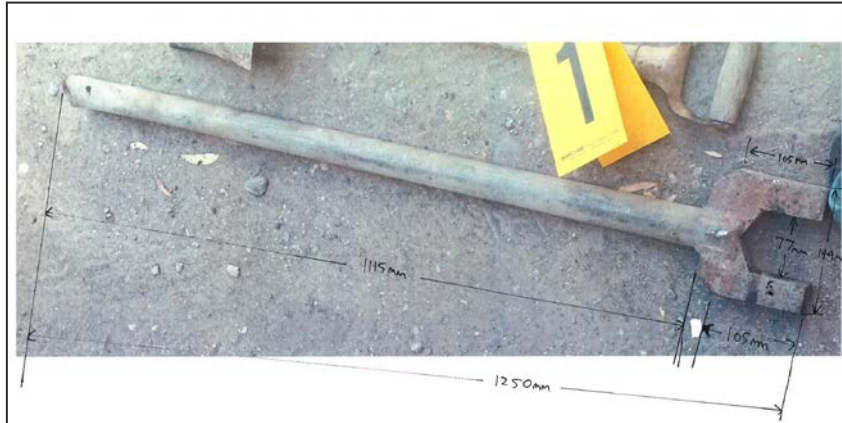
Figure 6: Handmade tool used to prop open the tailgate of the Muscat trailers.

The tool used as a prop during the incident was a handmade tool described as a pipe wrench or breaker bar. It was 1250 mm in length as shown in figure 6. This tool had been on the site for many years and was used by Mr Norman for several different functions that he carried out at the mine site.

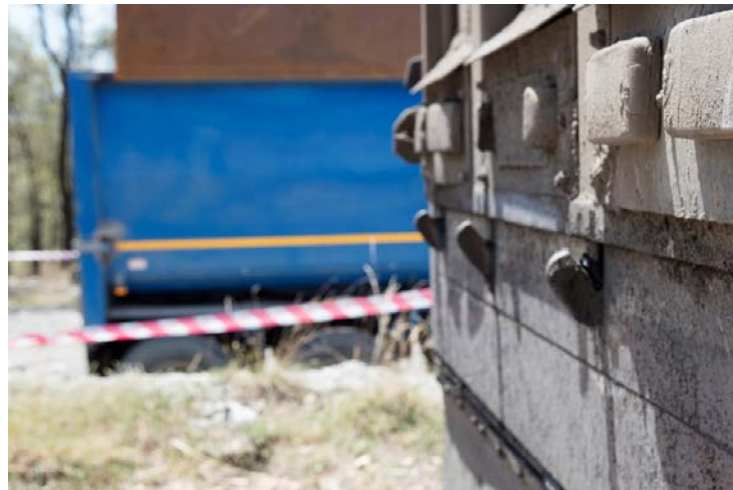
Figure 7: Trailer locking devices.

The Muscat trailers have mechanical locking devices on the rear known as fingers, which are used to keep the tailgate closed.

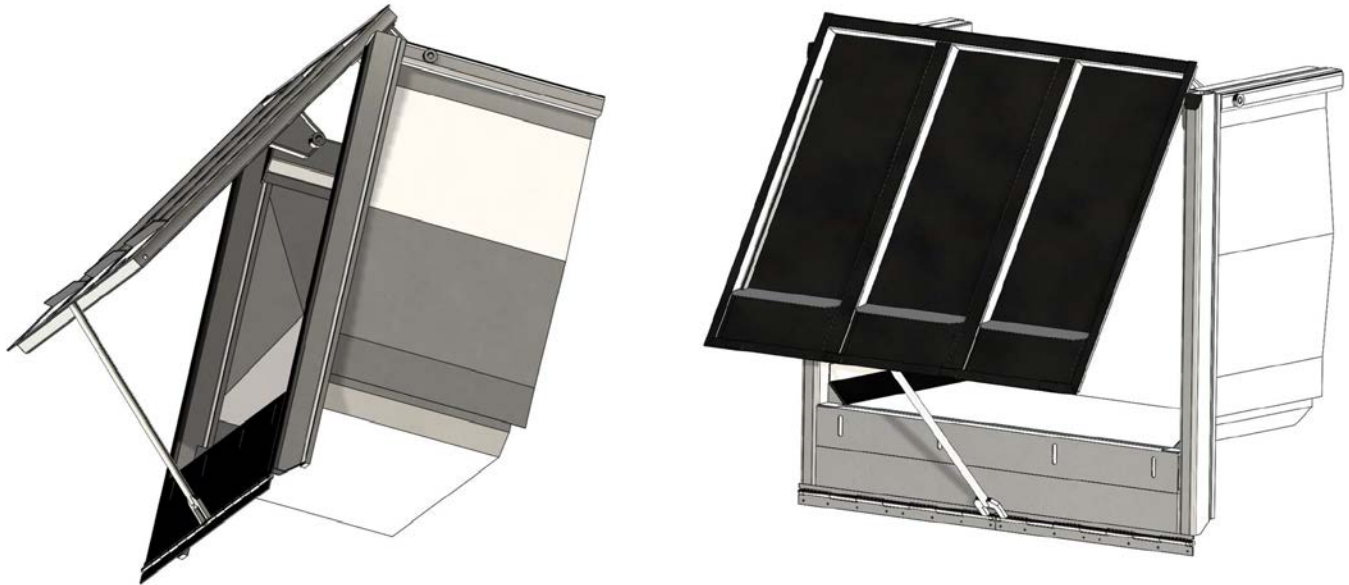
Figure 8: Position of the prop to open the tailgate.

The exact location where Mr Norman attempted to prop the tailgate cannot be definitively established.

A witness stated that Mr Norman placed the prop with the pipe end under the lip of the tailgate and the forked end with the forks in a horizontal position against the hinges at the rear of the trailer, as shown in figure 8.

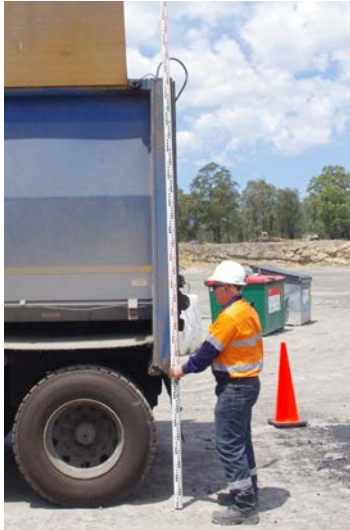
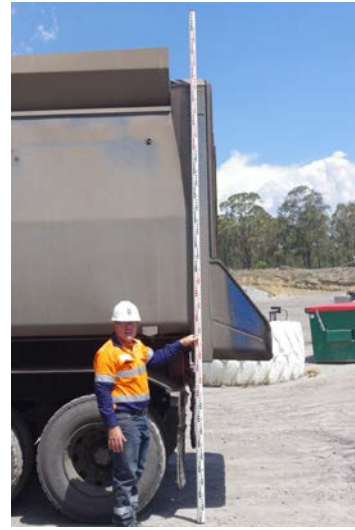
Figure 9: Differences between the Marlin and Muscat trailers.

<p>The Muscat trailers were 2130 mm longer than the Marlin trailers.</p>

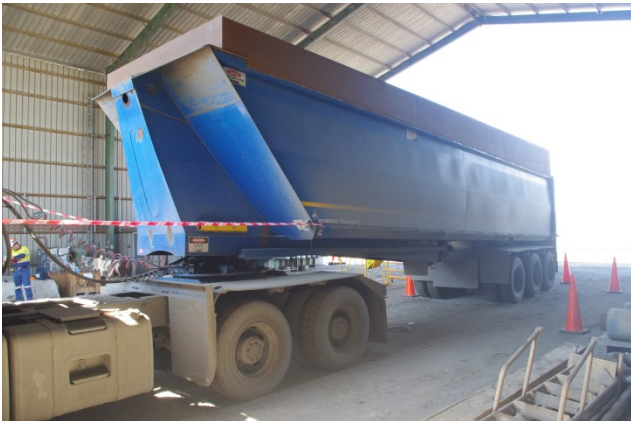
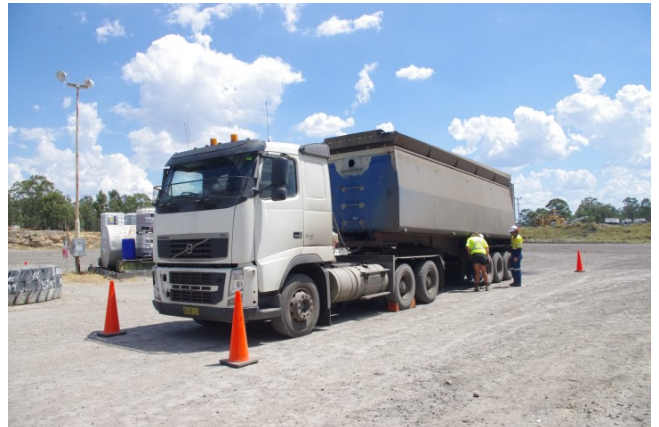
The floor of the Muscat trailer was 150 mm lower to the ground than the Marlin trailer, which made it easier to attempt the manual lift.

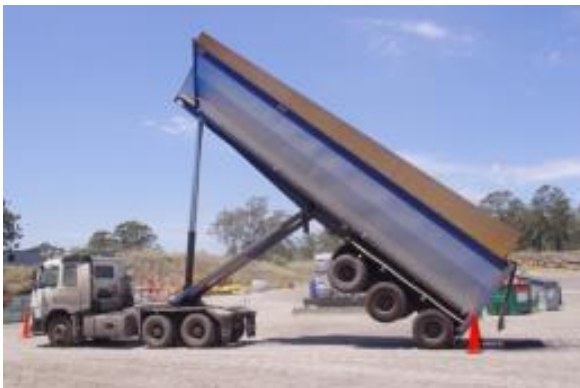
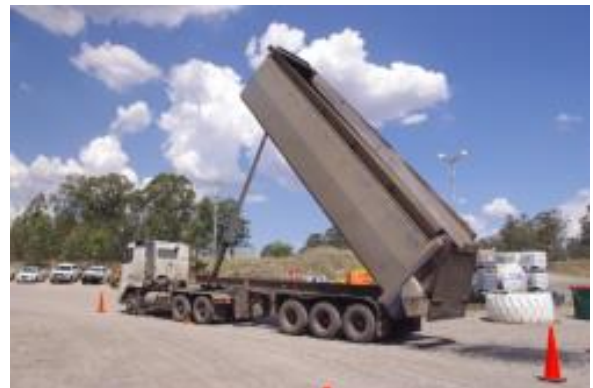
The Muscat trailer did not have the hoist intruding into the trailer whereas the Marlin trailer did.
