REPORT | RESOURCES REGULATOR

Investigation report

**Report into the incident involving a worker at Ulan
West Operations on 26 November 2015**

First published: June 2017

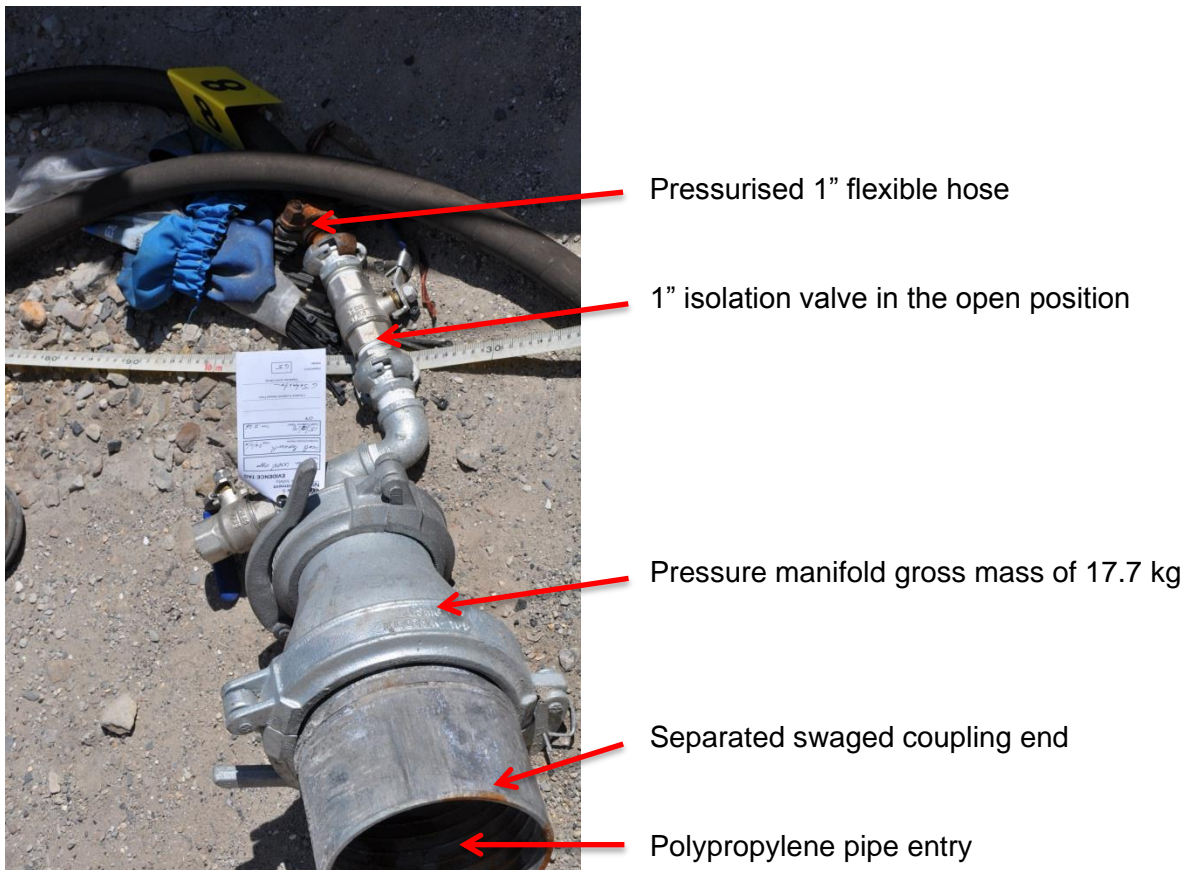
Figure 1 - Photograph of pressure manifold and swaged pipe end.

Figure 1 shows the pressure manifold and swaged end fitting.

After the incident, the pressure manifold and swaged end fitting were found separated from the pipe end and both were about 6 metres apart.

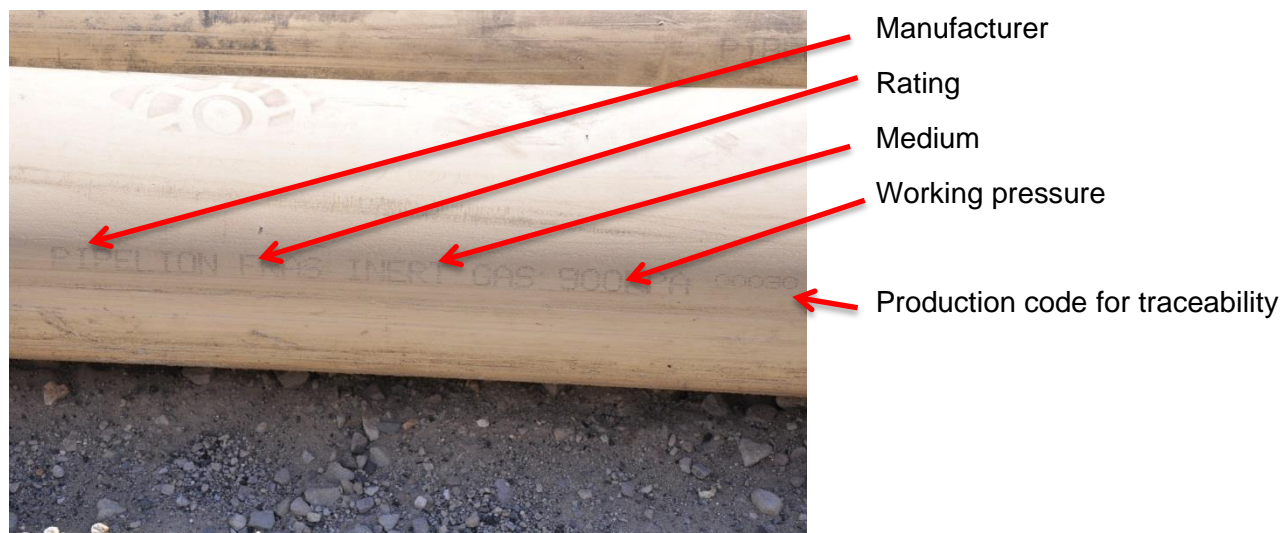
Figure 2 – Pipelion specification marking.

- e. Information supplied by the mine indicates the pipe would have been subjected to a maximum working pressure of 870 kPa at Ulan West Mine.

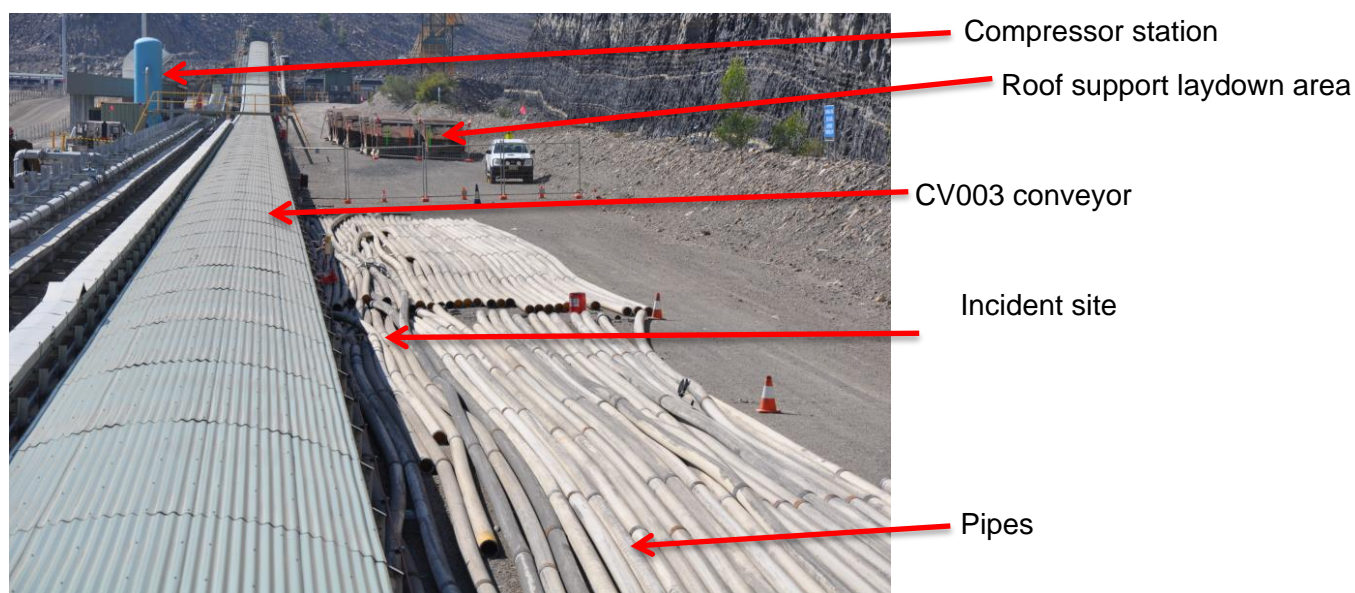
Figure 3 – Photo showing the pipeline lay down area adjacent to conveyor CV 003.

- ii. was not applicable for pressurised leak testing of many polypropylene pipes at ground level when stacked alongside each other, refer to Figure 3. The SWP was for pressurised leak testing polypropylene pipes when installed and hung from the roof underground.

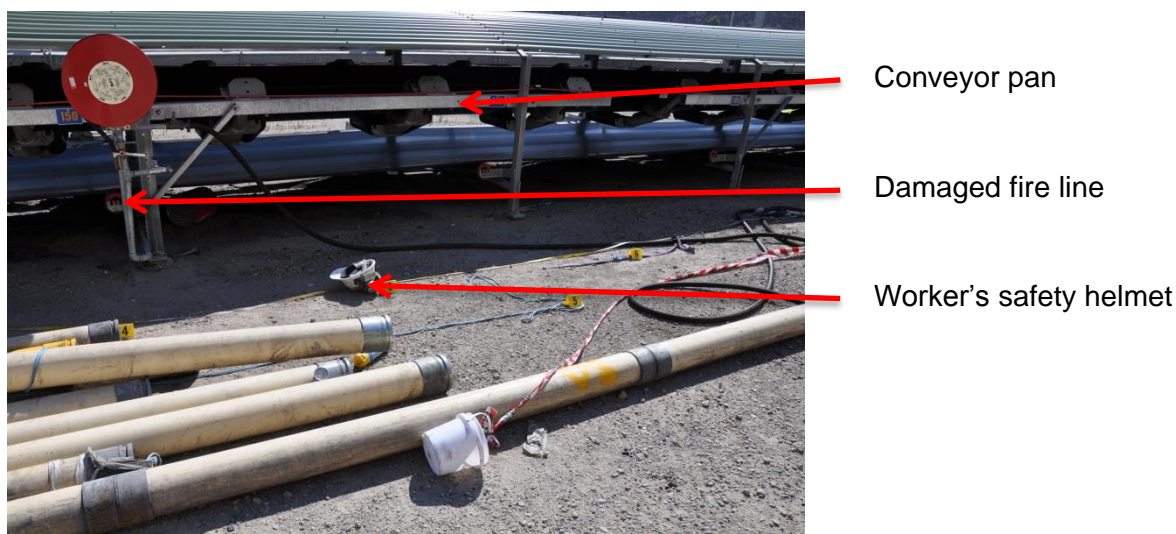
Figure 4 – Photo of incident area adjacent to CV003 conveyor.

Figure 4 shows the incident area between 149 pan and 150 pan of CV003 conveyor. The photograph also includes shows personal items belonging to the injured worker.

- a) Figure 4 shows how closely workers were positioned to CV003. It was reportedly running at the time of the incident.
- b) There were areas where pipes were packed on top of each other, creating potential trip hazards.

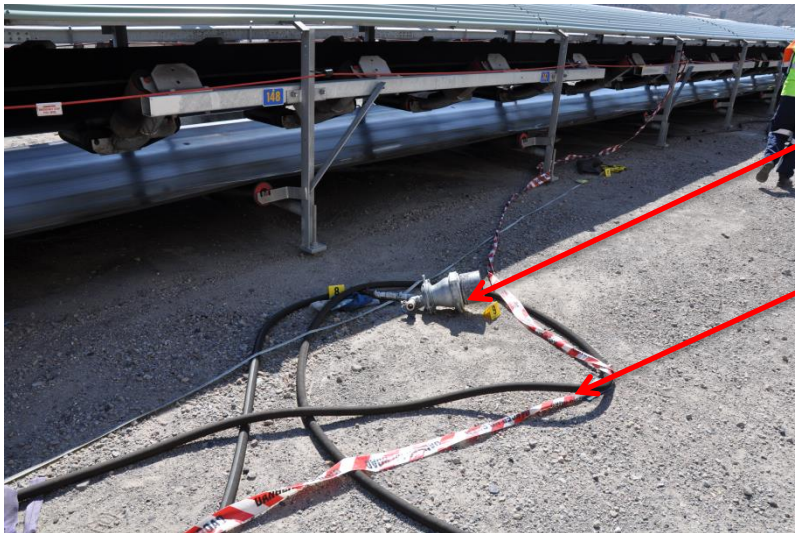
Figure 5 - Incident scene adjacent to conveyor CV003 at pan 148.

The pressure manifold pipe end complete with the pipe swaged end was found about 6 metres from the pipe end (refer to figure 5).

Pressure manifold and pipe swage end about 6 m from pipe end

Flexible 1" compressed air supply line

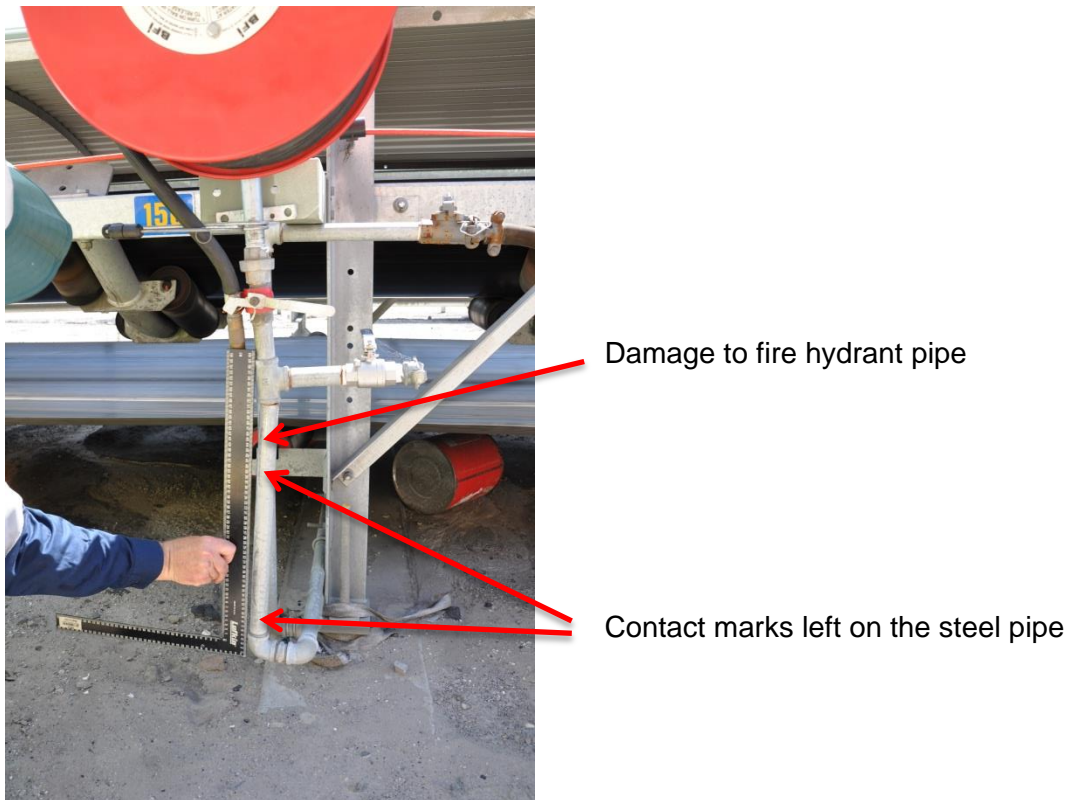
Figure 6 – Damaged fire hydrant at pan 150 CV003 conveyor.

A 1" fire hydrant line at CV003 pan 150 was also damaged. Marks on the pipe and damage to a screwed joint were evidence of it being hit by a solid object and with sufficient force to fracture a threaded joint. This, in turn, released pressurised water into the working environment.

The fire hydrant at 150 pan on CV003 was marked from an impacting object (refer to figure 6).

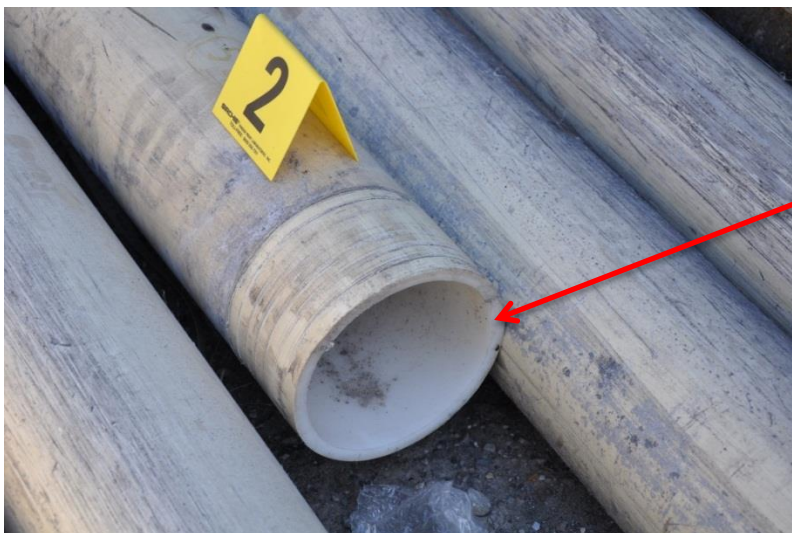
Figure 8 – Incident pipe end

- o) The shouldered end of the incident pipe had separated from the end of the polypropylene pipe (refer to figure 9).

Pipe #52 (incident pipe, exhibit 2)

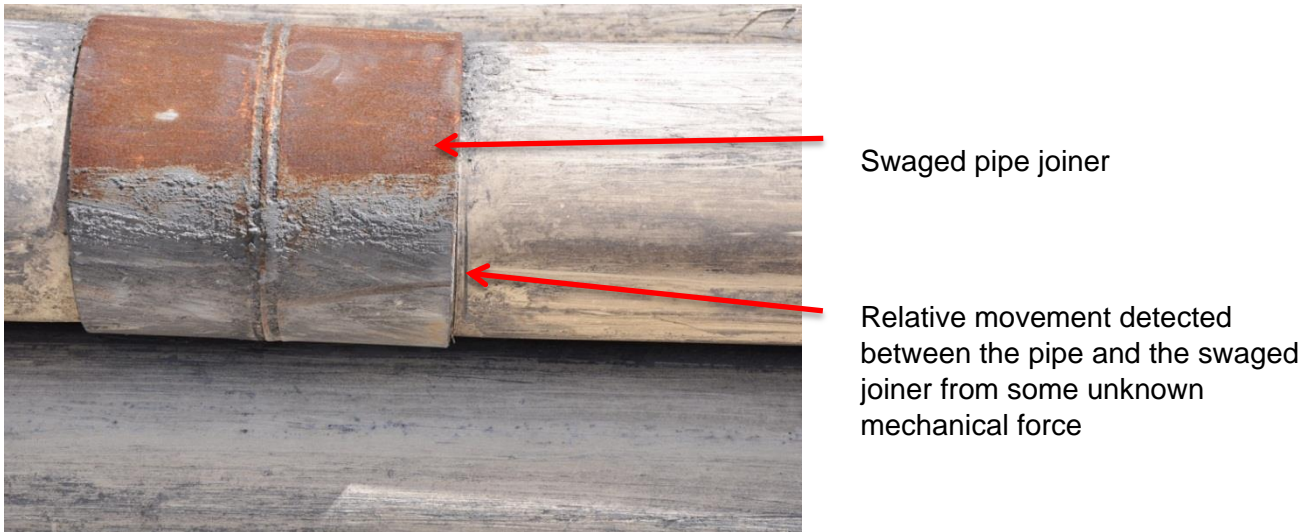
Figure 9 - Swaged pipe joiner

- u) A number of swaged joiners showed evidence of wear and corrosion possibly from the transportation and/or recovery process (refer to figure 10). A swaged pipe joiner is used to couple multiple pipes together to form one long pipe assembly.

- v) Some of the joiners showed evidence of movement, possibly caused by acute bending during the transportation and recovery process.

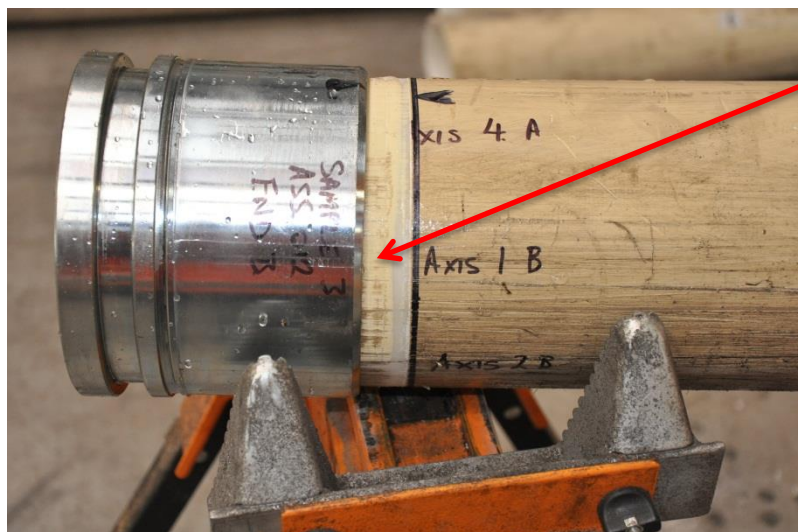
Figure 10 – Ass 012 showing swaged end separation

Pipe ass 012 was assembled from a section of incident pipe called exhibit 10 and was fitted with two ends swaged to a dimension of 170.5 mm. The purpose of this test was to try to replicate the failed incident pipe.

Swaged end has begun to separate from the polypropylene pipe during hydrostatic testing

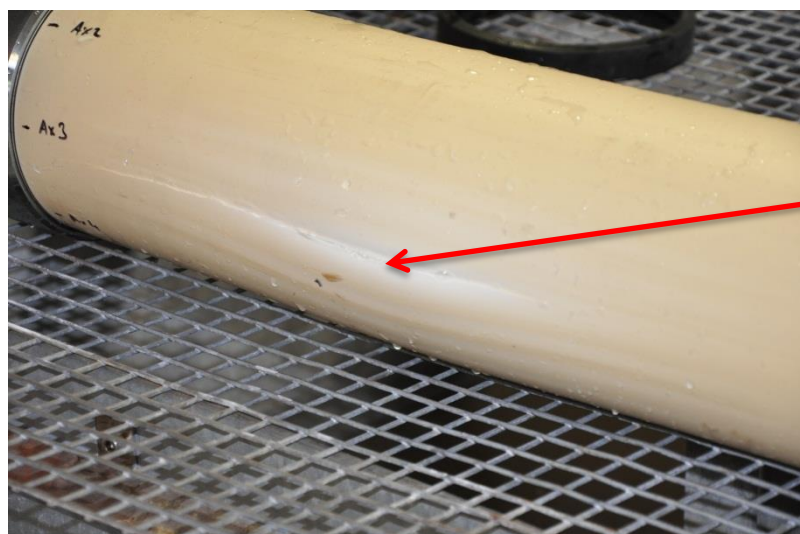
Figure 11 – Control pipe tested to failure.

These tests were recorded using a GoPro camera that clearly shows the pipe failing. The pipe material progressively failed without swaged end separation (refer to figure 12).

Failure point of pipe material

The control pipe testing supports the original designer's assertion that the pipe material would fail gradually with no pipe end separation, providing the pipes were manufactured and assembled in accordance with the original designer's specifications.

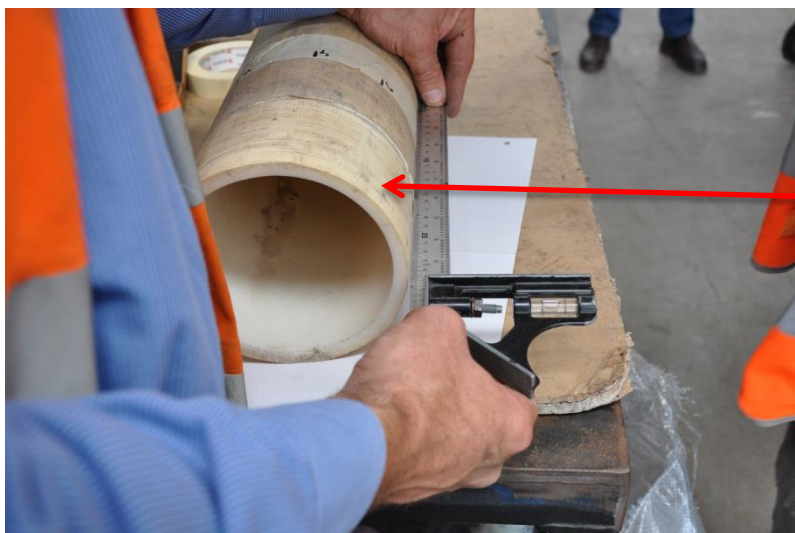
Figure 12 – Pipe #52 (exhibit 2) being checked

- a) The towing method was determined to have been the most likely and major contributing factor to the failure because:
 - i. the failure occurred on an end coupling
 - ii. the aforementioned end coupling was connected to the LHD
 - iii. there was no control on the quantity of pipes connected to the end coupling acting as the towing connection
 - iv. the combination of load and impact (caused by intermittent resistance with varying ground conditions) could result in 'spikes' in tension loading at the end coupling
 - v. bending at the end coupling, especially under load and impact, can cause separation between pipe end and coupling.

Destructive tests showed joints to be sound and failure would only occur if subjected to 'longitudinal forces' greater than 3 tonne. The tractive effort of modern LHDs exceeds 7 tonne. In the absence of suitably rated and flexible towing attachments, damage will occur.

Deep impression where the back of the swaged fitting was pushed into the polypropylene pipe from an undetermined mechanical force.

- c) Dragging of pipes should be avoided where possible as this can lead to joints being stressed and resulting in sudden failures when pipes are placed into service.

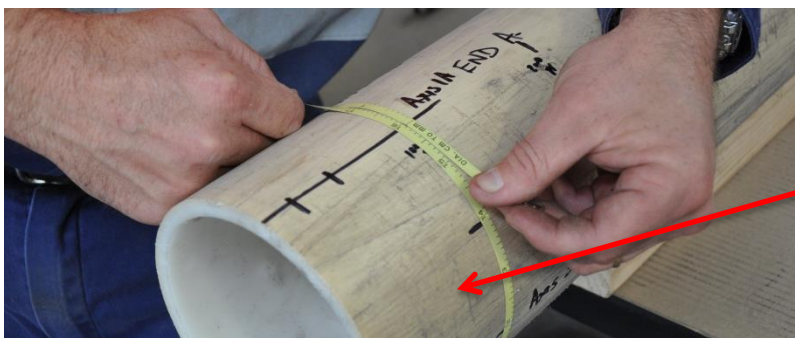
Figure 13 – Pipe diameter measurement

- g) The method for measuring the critical dimensions of outside diameter, ovality and wall thickness may not have been performed in accordance with the Pipelion R&D plan version 1.2. The R&D plan version 1.2 required outside dimensions to be measured using outside micrometres in four places and the wall thickness measured using Vernier callipers. During sample testing on 5 April 2016, 6 April 2016, 20 May 2016 and 13 July 2016, it was identified that UGM Mining Solutions was measuring the pipes outside diameter and ovality with a non-calibrated, non-graduated circumference (Pi) tape (refer to figure 13).

Circumference (Pi) tape measure, non-calibrated and non-graduated.

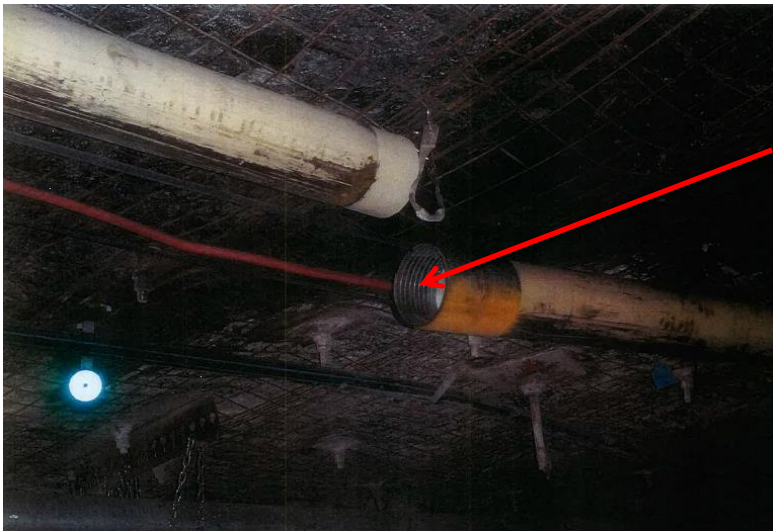
Figure 14 – Swaged joiner separation.

In February 2015, after being leak pressure tested with compressed air, a swaged joiner separated (refer to figure 14).

Swaged joiner separated from polypropylene pipe end

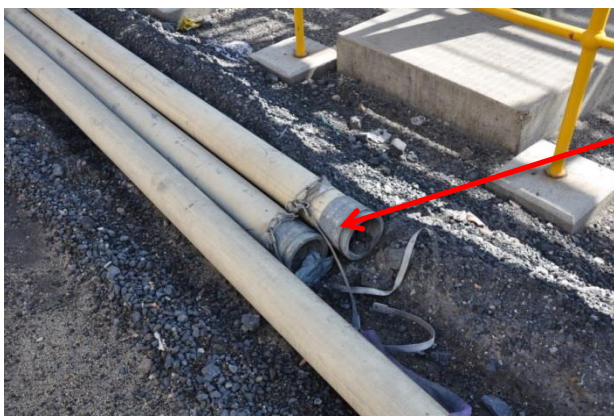
Figure 15 – Recovered poly pipes towed out of the mine.

- iii. consideration for alternatives to leak testing with compressed air.
- b) Changes to the method of towing (refer to figure 16). This was not the recommended procedure for the recovery and towing of polypropylene pipes.
- c) Recommendations that all previously swaged pipe ends would need to be re-swaged to a new revised dimension of 168.5 mm.

Stainless steel tether straps are designed to support the pipe line when being suspended from the mine's roof support structure.
