Investigation report

Investigation into the serious injury of a mine worker at the Perilya Broken Hill Southern Operations Mine, Broken Hill, NSW on 8 June 2012.

Report prepared by the NSW Mine Safety Investigation Unit

23 May 2014

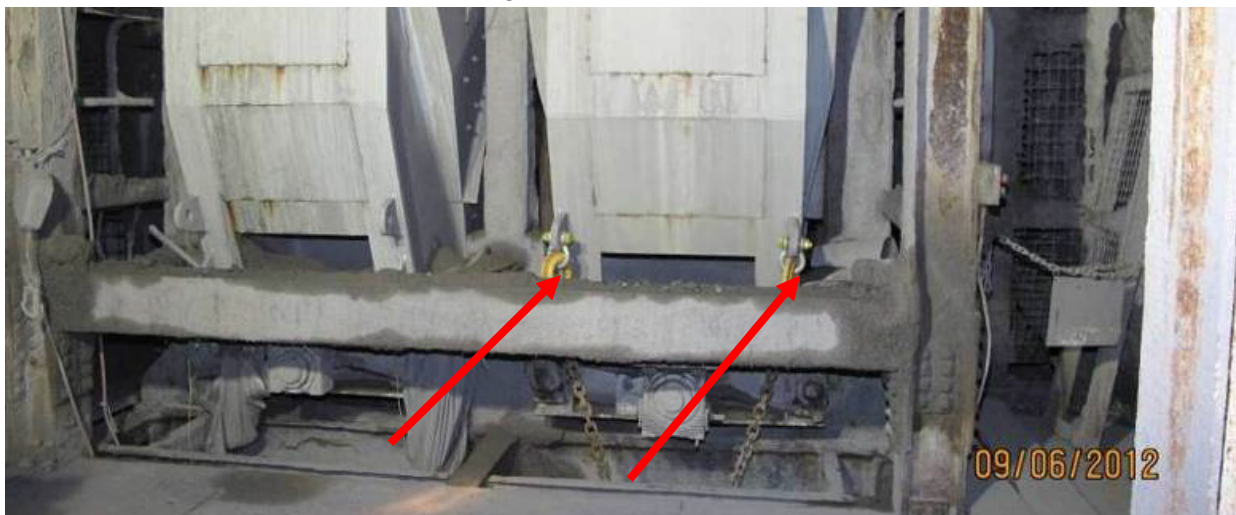
Figure 6: Two yellow chain hooks attached to the lugs on the weigh flask.

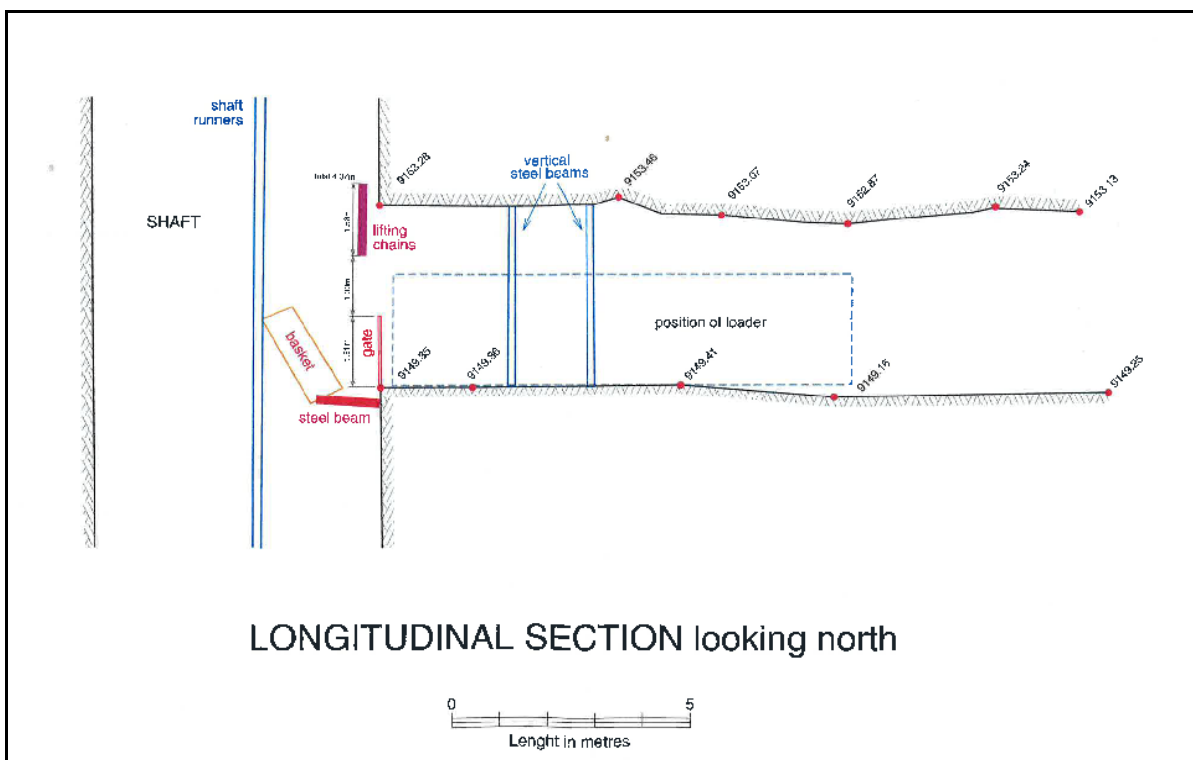
The weight basket with three weight blocks (9.8 tonne) lodged on steel work in the shaft. One of the blocks, weighing 3 tonnes fell from the basket to the base of the shaft (see Figure 7).

Figure 7: Incident plan showing the position of the loader in relation to the final position of the weight basket, the closed access gate and the lifting chains hanging from the weigh flask.¹⁵

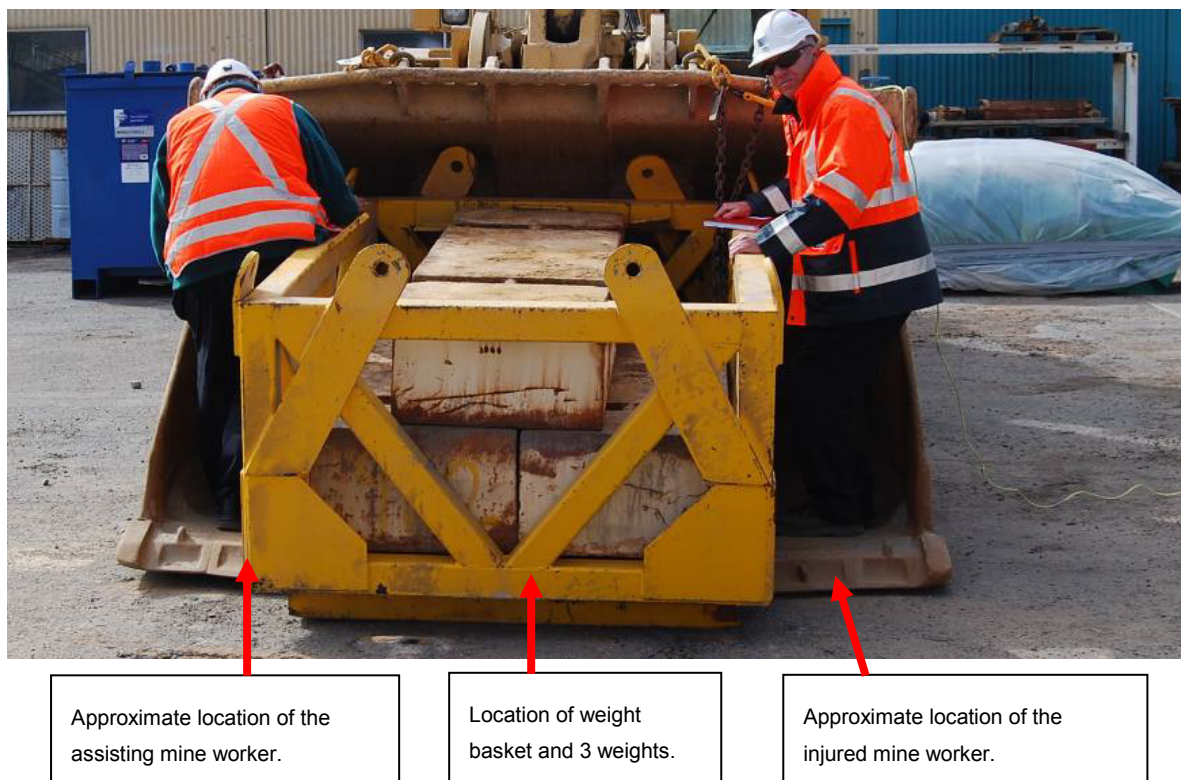
The incident occurred when two mine workers were working inside a loader bucket with an untethered 9.8 tonne weight basket (see Figure 8).

Figure 8: Incident simulation conducted on 28 June 2012 showing the approximate positions where the two mine workers were standing in relation to the untethered weight basket in the loader bucket.¹⁶ Note: The two mine workers were both wearing full body harnesses individually attached by a rope lanyard back hooked to the top of the bucket. The synthetic fibre slings around the base of the weight basket at the time of the incident are not shown in this simulation.

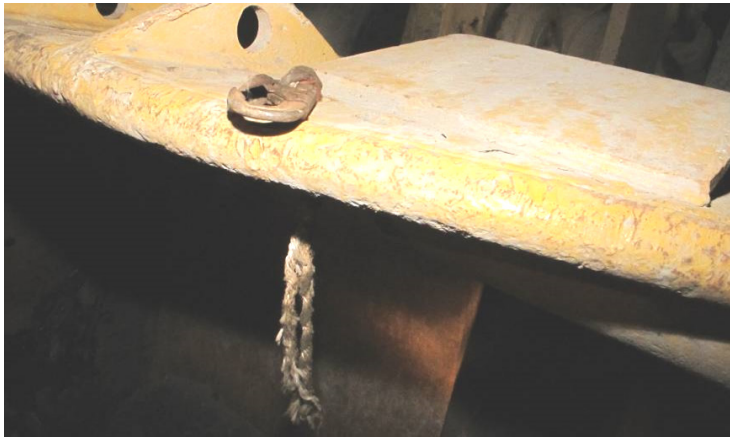
The mine workers' lanyards were back hooked (choked) around a hole cut in the top of the bucket and a steel double action snap hook clipped back onto the lanyard rope. When the rigger fell from the bucket the rope lanyard failed to restrain him.¹⁷ It is not known what load was placed on the rope lanyard. It is not known if the rigger's clothing or harness was caught by the weight basket as it fell from the loader bucket, nevertheless, the lanyard broke.

Figure 9: The rigger's rope lanyard end as found reeved onto a hole in the loader bucket.¹⁸

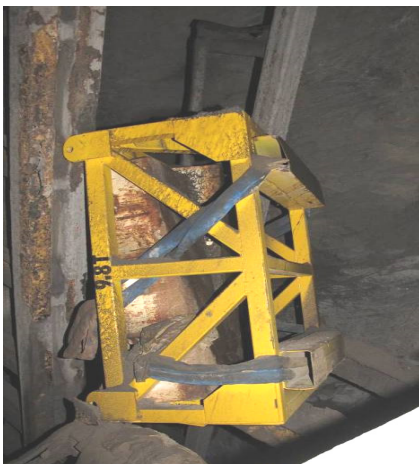
Figure 10: The weight basket lodged vertically on its end on the steel RSJs at the shaft access level. There were only two 3 tonne weights remaining in the weight basket

One of the three metal weights in the basket ejected from the weight basket and fell 14 metres down into the shaft along with the mine worker.

Blue coloured fibre slings are observed slung through the fork lift slide steels on the upturned base of the weight basket and located over the remaining weight blocks.¹⁹

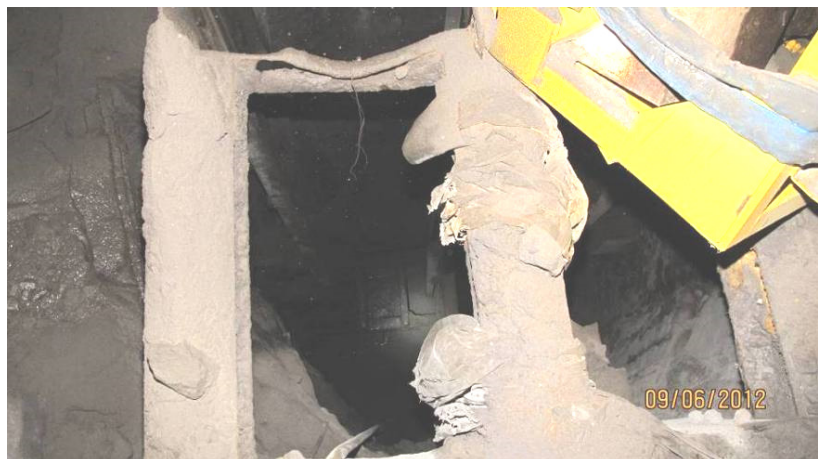
Figure 11: The steel RSJs protruding at shaft access level and the gaps with the view to the base of the shaft 14 metres below. The end of the yellow steel weight basket is visible lodged on steel RSJs and one of the blue coloured fibre slings.

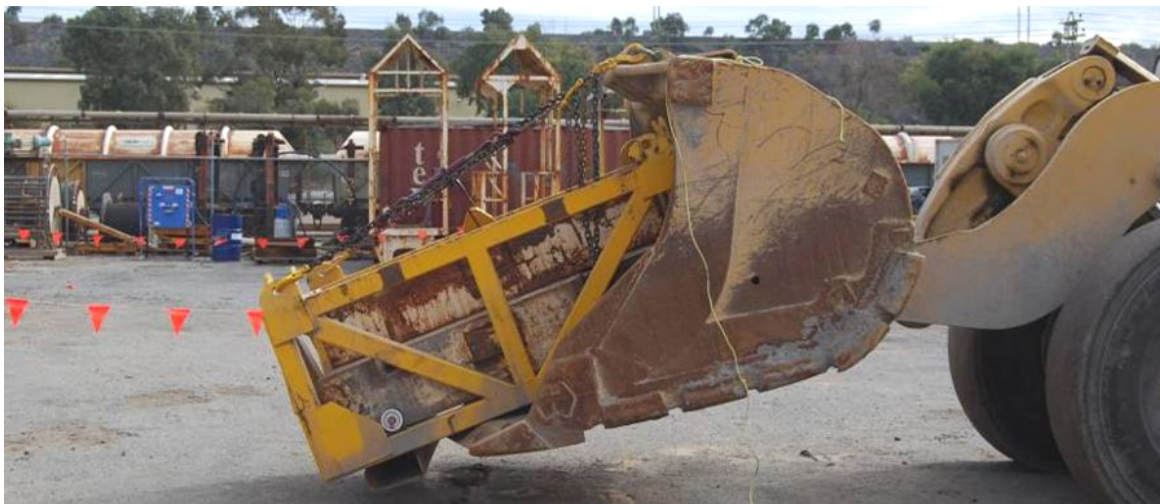
During the tests, investigators were able to recreate the slippage of the basket from the loader bucket. The angle at which the weight basket slipped from the bucket was observed to be approximately 15° from the horizontal (see Figure 12).

Figure 12: The angle of the bucket required for the weight basket to slide from the bucket. Note the weight basket was tethered by a chain for the purpose of the test.²⁰

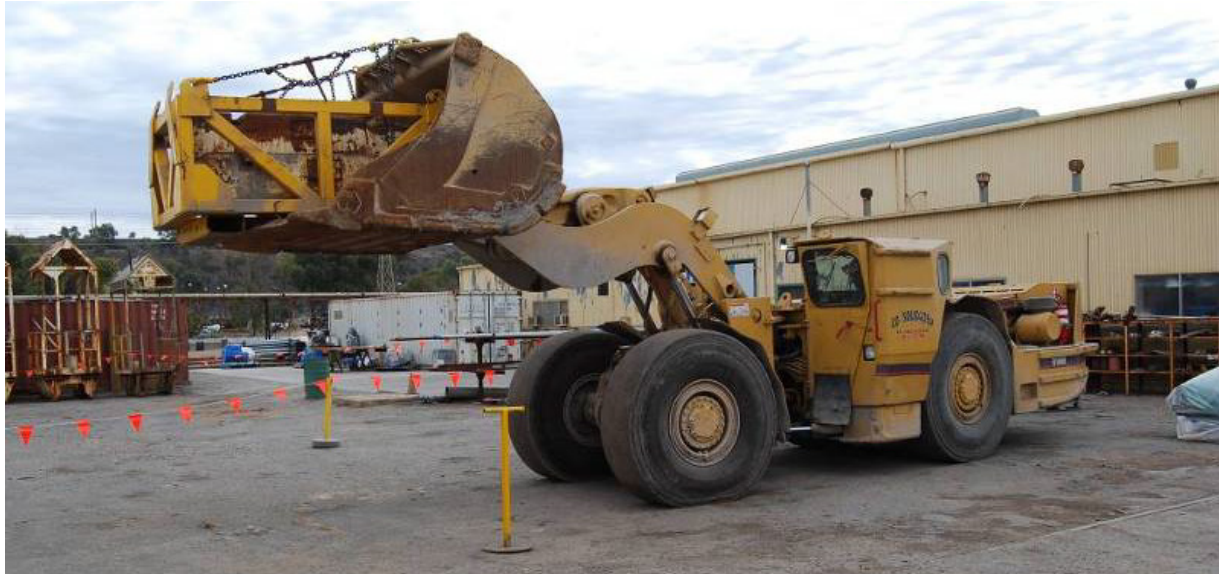
8. The base of the loader bucket was visible when the bucket was elevated (see Figure 13).

Figure 13: The loader bucket in a raised position on 28 June 2012. The yellow marker post in front of the loader represents the height of the shaft gate.²¹

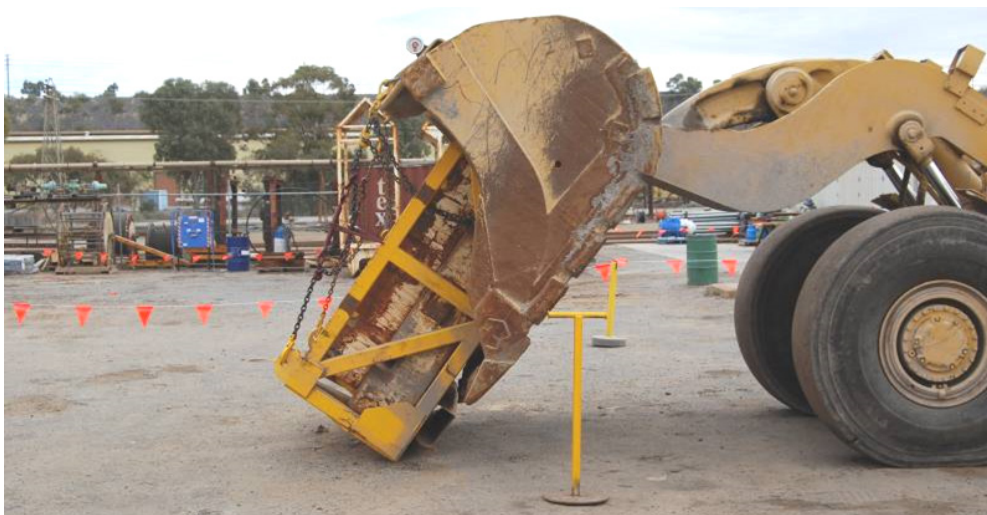
9. The weight basket slipped from the loader bucket at approximately 15° from the horizontal.
10. The rated maximum load for the loader bucket was 10.2 tonne.
11. The estimated load in the bucket, including the 9.8 tonne weight basket, chains and two people (estimated total weight of 170kg) equates to approximately a 10 tonne load.
12. The 10 tonne load was close to the maximum payload of the loader.
13. When the loader bucket was in a fully elevated position the load could not be controlled by the operator of the loader. At this height the bucket and load tilted forward and could not be controlled (see Figure 14).

Figure 14: Observation made on 28 June 2012 showing the final resting position of tethered basket and bucket following the loss of control of the load by the operator during the operation of the load at full elevation.²²

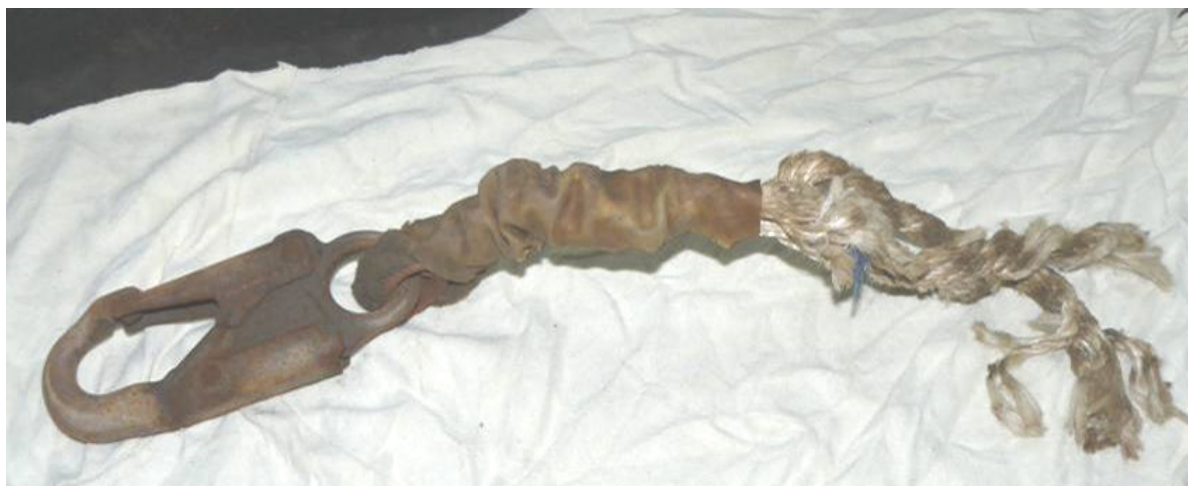
Figure 17: Remnant of the injured rigger's fall arrest lanyard as found on the loader bucket. Note the remaining components of the failed lanyard have not been recovered from the base of the shaft.¹

The three strand 12mm diameter (measured 14.7mm diameter due to grit and moisture content) rope has been broken. The breaks in the strands occurred at different distances from the splice. The ends show signs of failing under load.

Some fibre ends on strand 'C' are 'balled' indicating melting - fail.

No sharp cuts are visible at the failure site. The spliced eye of the rope shows significant wear and grit build up – fail.

The lanyard is four years old and extensively worn and so is unlikely to have had the required strength of 15kN.

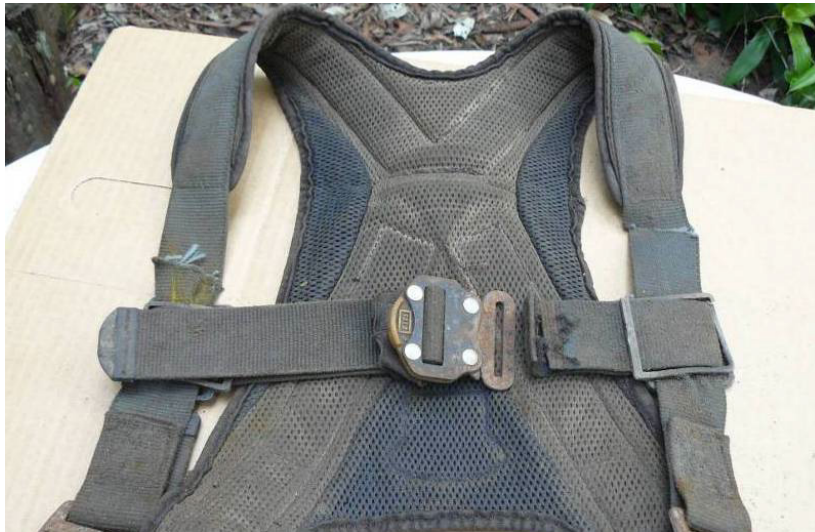
The consultants identified that the rigger's fall arrest equipment (harness and lanyard) and the second mine worker's lanyard would not have passed fit for purpose inspection if the equipment had been subjected to inspection in accordance with manufacturer's user guides and guidelines published in Australian Standards (see Figure 18).²⁹

Figure 18: The condition of the rigger's harness (taken post incident) laid out in an as-worn configuration. Note some of the visible damage to the harness was sustained as a result of the recovery of the injured mine worker.³⁰

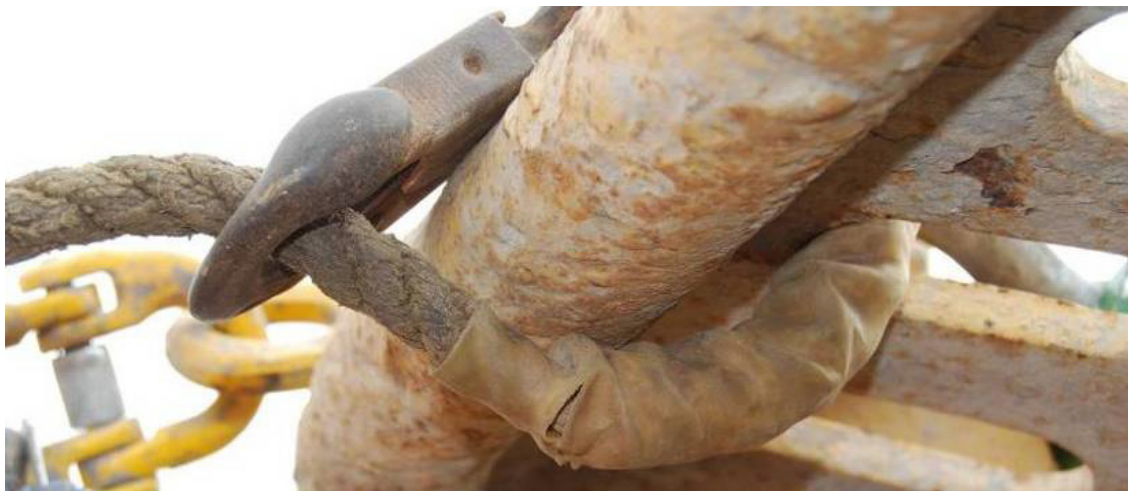
The rigger's fall arrest equipment lanyard was back hooked (choked) around a hole in the bucket and the Pensafe steel double action snap hook clipped back onto the lanyard rope (see Figure 19).

Figure 19: A simulation of the lanyard reeving method back hooked around the sharp edge hole in the loader bucket. The simulation used by the assistant mine worker's rope lanyard, which was similar to the lanyard that the rigger used.³¹

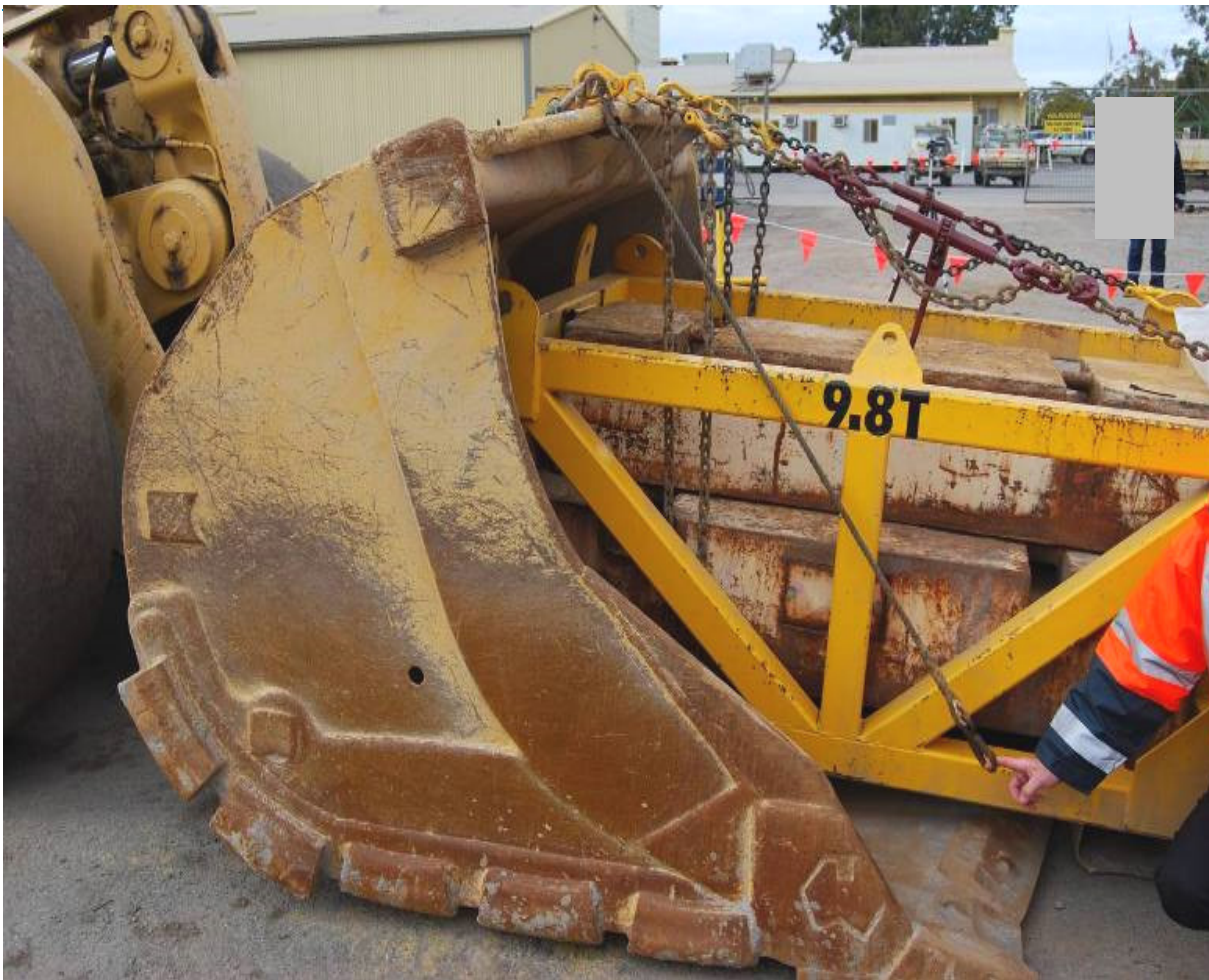
It was observed that in the scenario using a 2 metre lanyard back-hooked around the top of the bucket and a person falling over the front lip of the bucket would result in the harness and upper body of the person striking the front edge of the bucket during the fall.

The angle of the rigger's lanyard at the instant the lanyard failed is not known (see Figure 22).

Figure 22: The distance that a 2 metre lanyard would extended laterally and vertically towards the tip edge of the bucket when the lanyard was back hooked to the top of the bucket. It was observed that the lanyard end would not reach to the front tip edge of the bucket.³³
