Fires on mobile plant

July - September 2018

Title Safety ancillary reports - fires on report date mobile plant

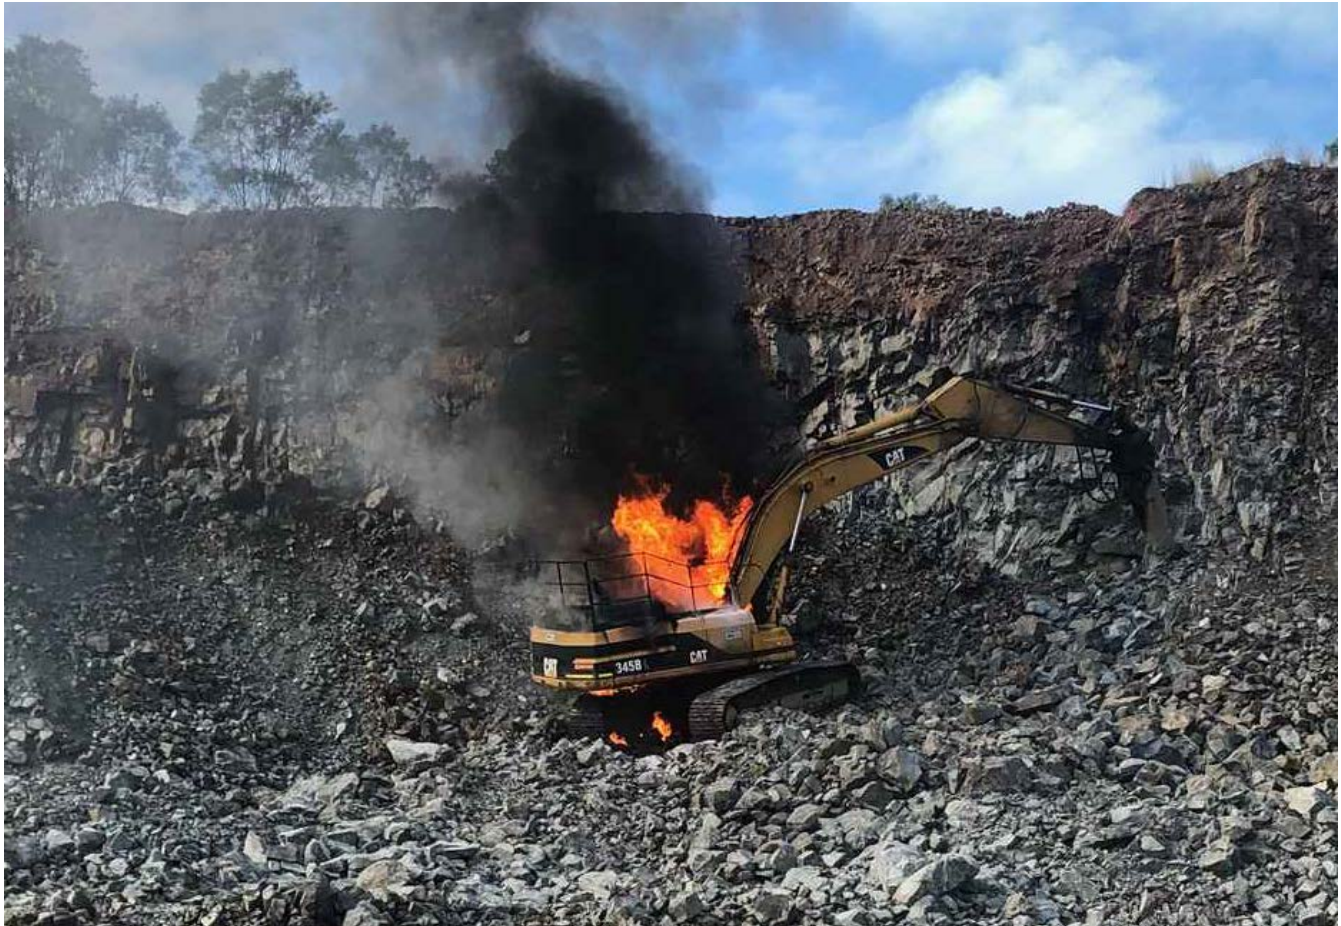
Photo1: Quarry fire.
