# QUARTERLY REPORT

## Fires on mobile plant

October – December 2018

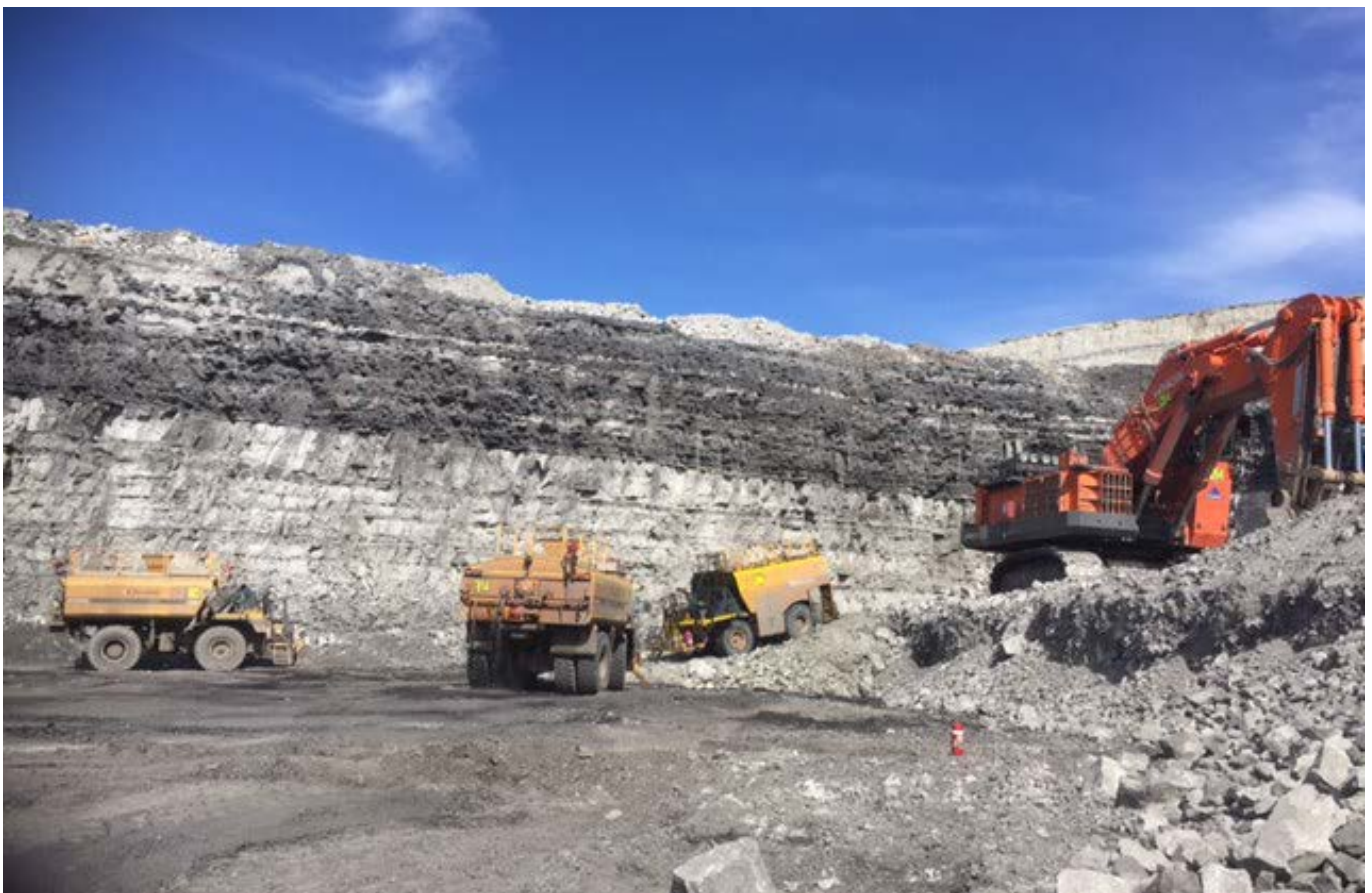
*Photo1: Fuel truck fire – fuel spill from tank onto engine surface when reversing up grade*
