Investigation Report

Fatality involving
David Hurst Oldknow
Ravensworth Underground Mine
Coal Preparation Plant
Reject bin 802
18 February 2009

Mine Safety Investigation Unit

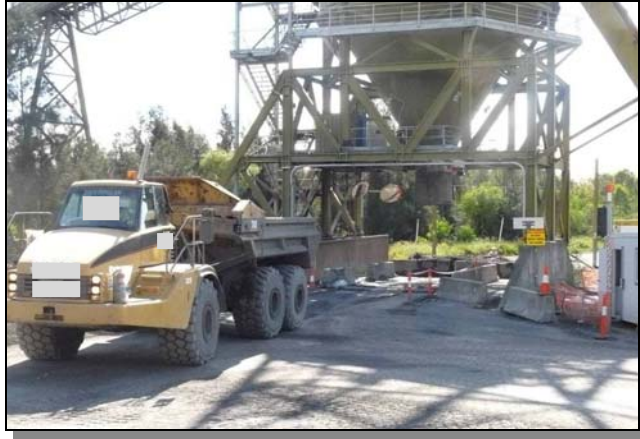
The loading area showing barriers preventing front and side entry, and an off-road haul truck with cabin FOPS reversing under the Reject Bin

- New procedure and maintenance system implemented.
- Isolation devices provided for the hydraulic circuit.
- Installing holder in truck cabins for the remote control unit.

- Retraining of supervisors and operators.
