REHABILITATION INFORMATION RELEASE

DATE: 1 JULY 2020

Rehabilitation of part of Horsley Park Quarry to industrial land use

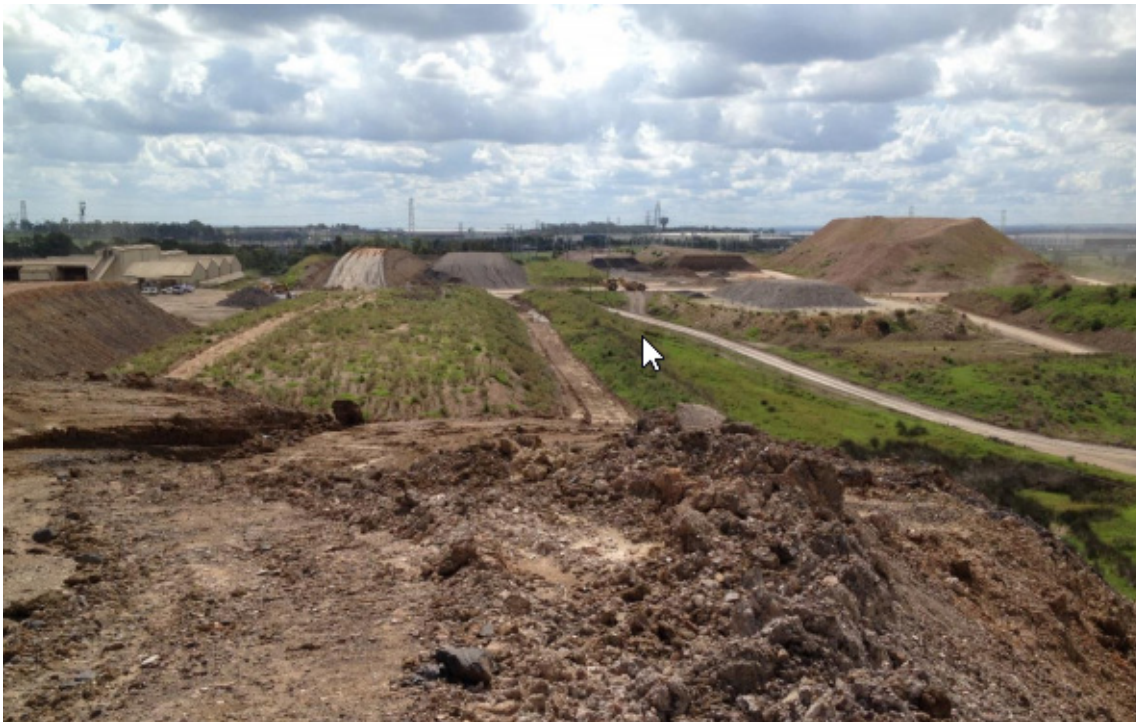
Figure 4 Stockpiles on the land in 2018 before rehabilitation

- the removal of existing stockpiled raw materials to elsewhere within the operating quarry
- the removal of waste material that was identified in the historic fill. The materials that were contaminated with asbestos were sent to a designated containment cell outside of the mining lease area in accordance with the approved RAP and local and state planning requirements.
- commencement of cut and fill works and compaction to create the various levelled building pads and road alignment associated with the proposed industrial development.

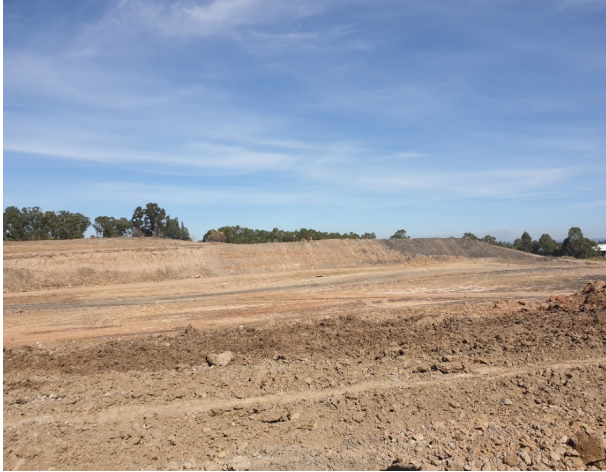
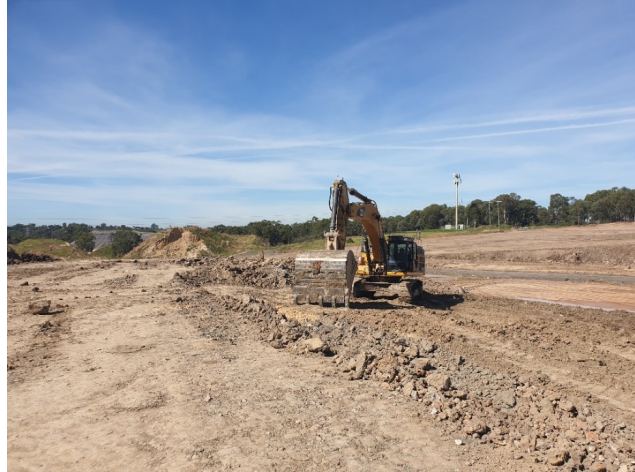
Figure 5A & 5B Earthworks in April 2019 preparing the land for industrial use

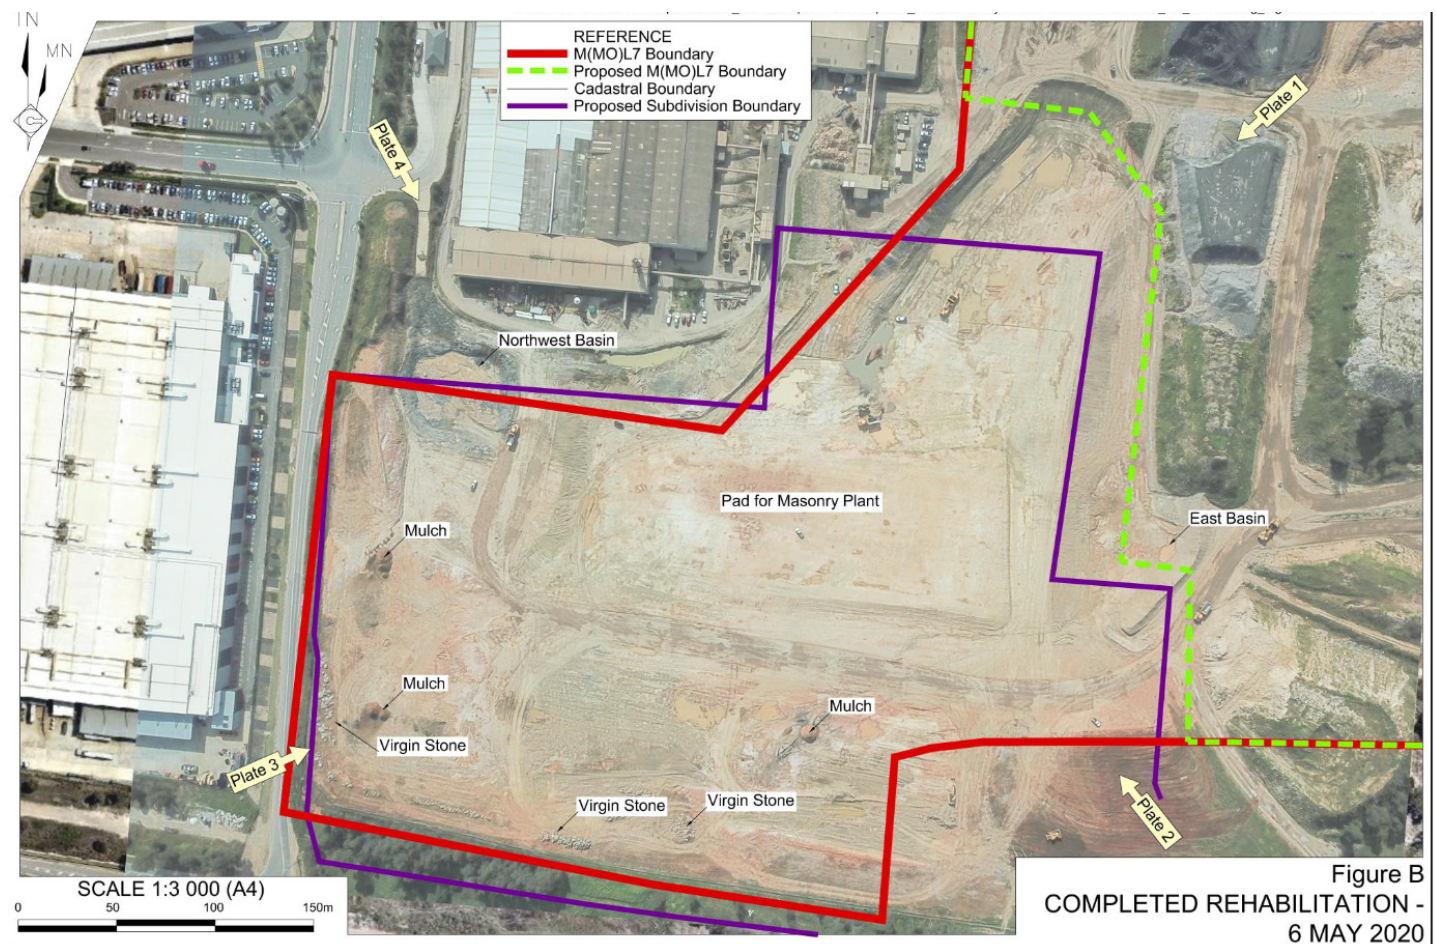
This assessment determined that rehabilitation obligations were fulfilled in accordance with the approved rehabilitation objectives and completion criteria included in the MOP.

Figure 6 Rehabilitated site ready for industrial development – May 2020
