# SAFETY ALERT

## Truck tailgate hits worker's head

This safety alert provides safety advice for the NSW mining industry.

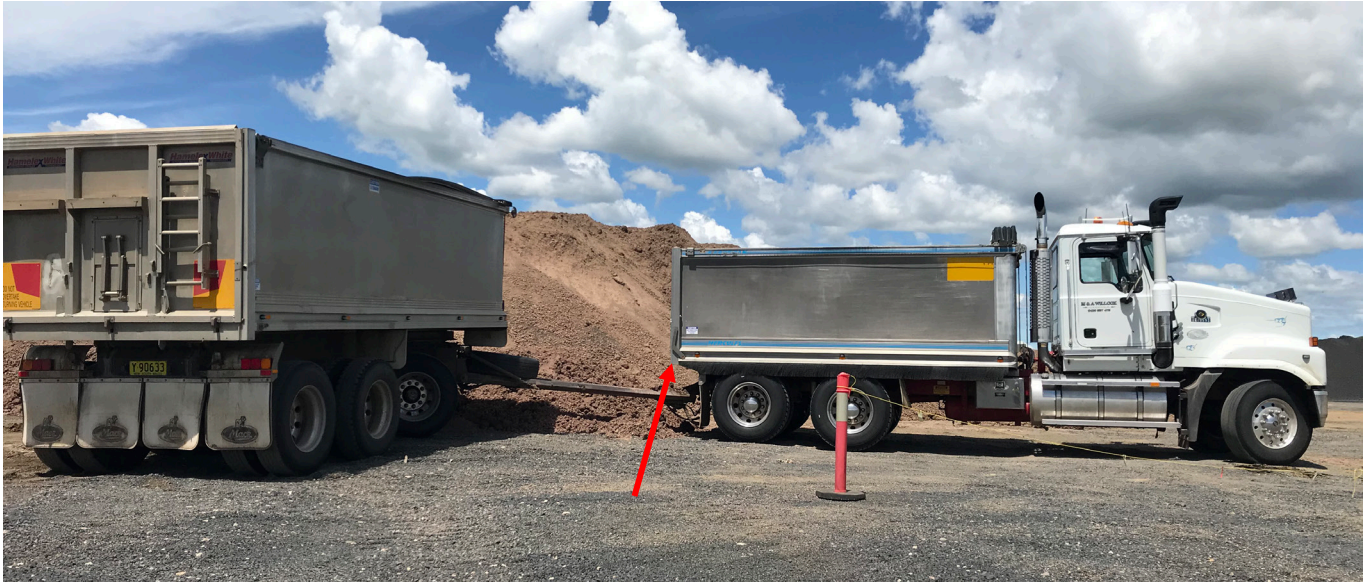
The driver saw that the tailgate was stuck open on the tipped material and put his head between the tailgate and truck body to check the truck body for hung up material.

At this point, the tailgate released, hitting him on the head.

Figure 1 The red arrow shows where the truck driver's head was when it was hit. Note: the tray was in a raised position when the incident occurred.

- Mine operators must carry out risk assessments regarding all haulage and dumping activities undertaken onsite. The risk assessments must include inspecting truck bodies for hung up materials and cleaning out truck bodies and drawbars.
- In carrying out risk assessments for haulage and dumping activities, mine operators must implement controls in accordance with the hierarchy of control measures as required in clauses 35 and 36 of the Work Health and Safety Regulation 2017.
- Consideration should be given to a latch and lock mechanism designed into the truck body to prevent the tailgate closing if there is a need to access the body via the tailgate.
- Fit-for-purpose access and egress points should be installed on all plant and equipment.
- Mine operators must provide training to all workers (including contractors) about the dangers of working under suspended and unsecured loads.
