SAFETY ALERT

Hydraulic injection near miss

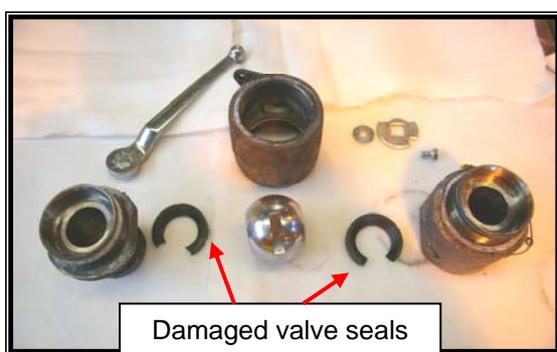
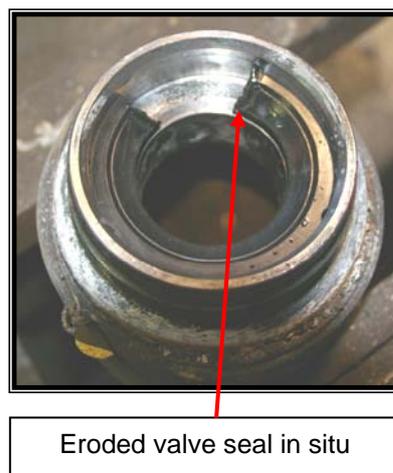
The investigation found that the second isolation valve ball valve seat had failed and had allowed the pressure to build up in the circuit.

1. The wear on the valve seal was probably caused by the slow activation of the ball valve when restoring pressure, thus eroding the seal on the ball valve.

2. The isolation ball valve was left in a partially open / closed state, thus eroding the seat away during normal longwall operation.

Stripped isolation valve

1. Investigate alternative isolation and restoration of pressure to save wear and tear on ball valves and seals.
2. Review isolation procedures and training to ensure there is no stored pressure in hydraulic circuits before commencing work.

3. Review the installation of pressure gauges at isolation points to ensure all the pressure is dissipated.
4. Investigate an alternative method of slow filling hydraulic circuits to prevent shock loading.
5. Review the mine's maintenance schedule to check, inspect and test the isolation valves at periodic intervals.
6. Consider a double block and bleed¹ arrangement for the main hydraulic isolation points in the hydraulic system supplied on longwalls.
