SAFETY ALERT

Fatality – Repairs to Shearer

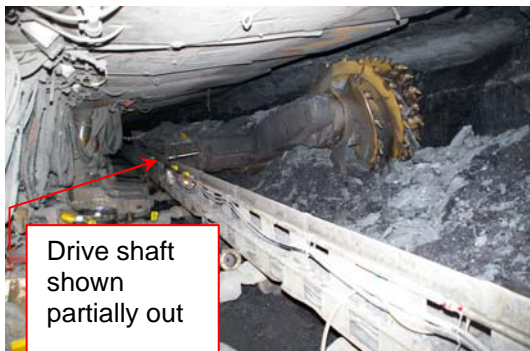
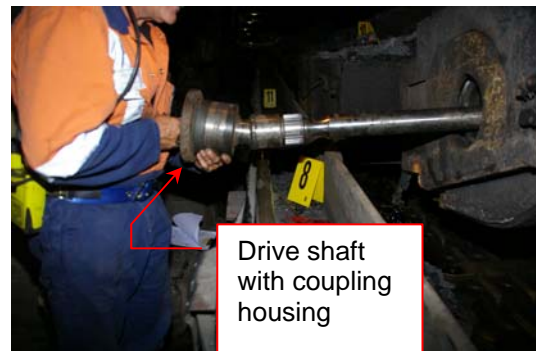
A longwall crew was replacing a broken drive shaft on the ranging arm of a longwall shearer. The drive shaft had a spline on each end and required alignment of the splines to be completely installed.

It appears that the drive motor rotated under power, catching and forcibly ejecting the shaft. A coupling housing was flung from the end of the rotating shaft, striking the victim.

- Maintenance procedures include sufficient safeguards to control all energies present during each phase of the task.
- All employees involved in a particular maintenance job are instructed and trained to understand the safe guards built into the maintenance procedures for that job.
- Maintenance safe work procedures are available in the workplace.
- Maintenance work is carried out as specified in safe work procedures.
