SAFETY ALERT

Crane A-frame mast falls on rigger

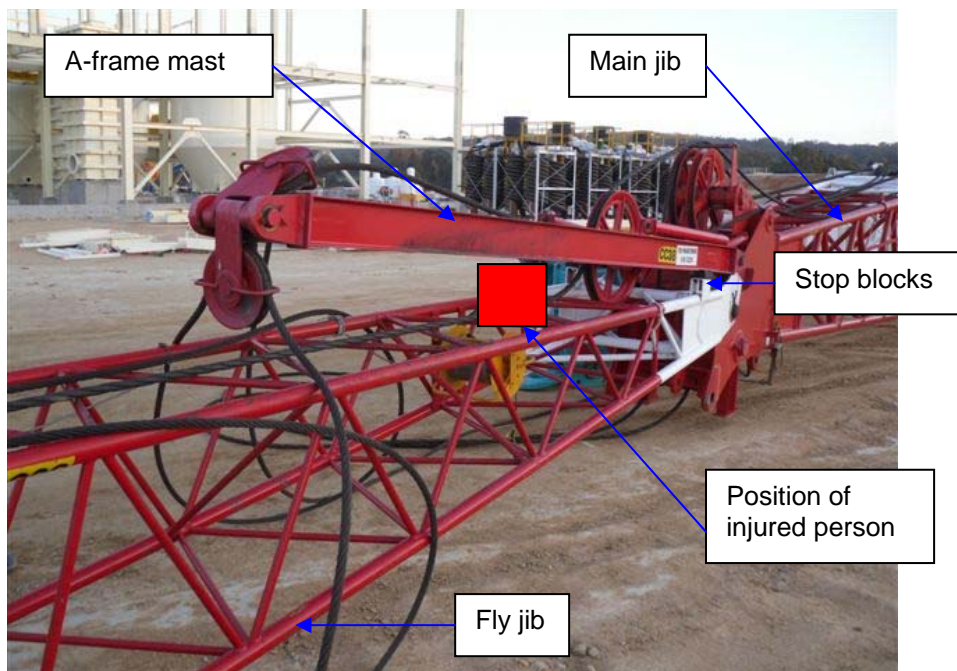
Crane operators were making changes to the crane fly jib configuration in preparation for the next series of lifts. The crew had shortened the fly jib and were preparing to shorten the pendent wires from jib to fly. This required the pendent wires to be disconnected, which left the A-frame mast in an unsecured vertical position. As the rigger lent over the fly jib to couple up the overwind electrical sensor, the A-frame mast fell forward, landing on his upper torso and causing injuries, including rib fractures.

A photograph showing the location of the A-frame mast after the fall.

- failure to follow the original equipment manufacturer's documented procedures
- failure to isolate gravitation energy
- the workgroup made an incorrect assumption that the tube on the A-frame mast was a double-acting retainer, which they believed secured the A-frame mast in position. This allowed them to disconnect the pendent ropes
- people being placed in pinch point areas.

- when hiring or dry hiring plant, ensure documentation that details safe operation of the plant is provided by the plant owner or hirer
- when supplying operators to operate hired plant, ensure the operators are competent to operate the plant safely
- ensure all lift studies are documented and communicated to those involved in the lifting process
- ensure lift studies which require configuration changes to the crane jib, fly jib or other parts make reference to safe work procedures for the task
- review documented procedures for the safe operation of plant prior to the commencement of unfamiliar tasks
- identify site-specific hazards which must be assessed and controlled.
