SAFETY ALERT

Unattended haul truck rolls 65 metres

CM9 reference	DOC21/35815
Mine safety reference	SA-21-02
Date published	2/02/2021
Authorised by	Acting Chief Inspector Office of the Chief Inspector

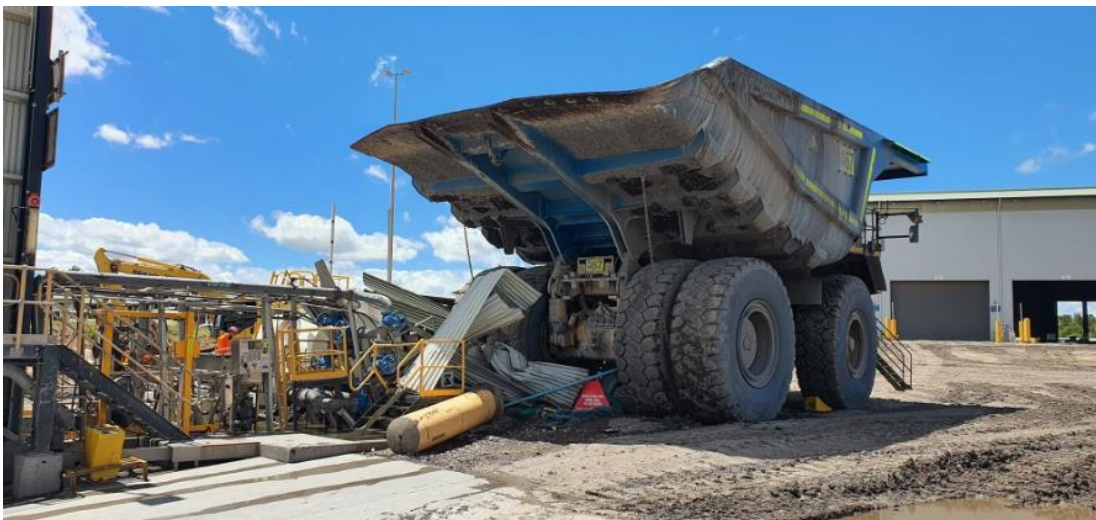
An operator parked a CAT793D haul truck on the workshop deadline for a defect repair. The truck was parked across a parking hump and the engine was switched off. Soon after the operator disembarked from the vehicle, it started rolling backward. The operator unsuccessfully attempted to stop the runaway vehicle. After rolling 65 metres, the truck collided with a pump and associated infrastructure at the heavy vehicle wash bay.

Figure 1 Truck collision with wash bay pump

Further investigation on the vehicle found that a solenoid on one of the park brake valves failed and the air pressure did not bleed from the park brake circuit. This resulted in the park brake not being engaged automatically. The remainder of the fleet onsite was inspected and the same fault was also identified on another vehicle.

- All mobile plant park-up areas are designed, constructed and maintained to enable safe and stable parking.
- Work area inspections verify that mobile plant park-up areas are constructed and maintained to the standard.
- Brake testing regimes on mobile plant includes testing fail-safe mechanisms and interlocks.

Mine workers must ensure they apply the park brake prior to exiting mobile plant and must not rely on safety interlocks or other means of application of the park brake.

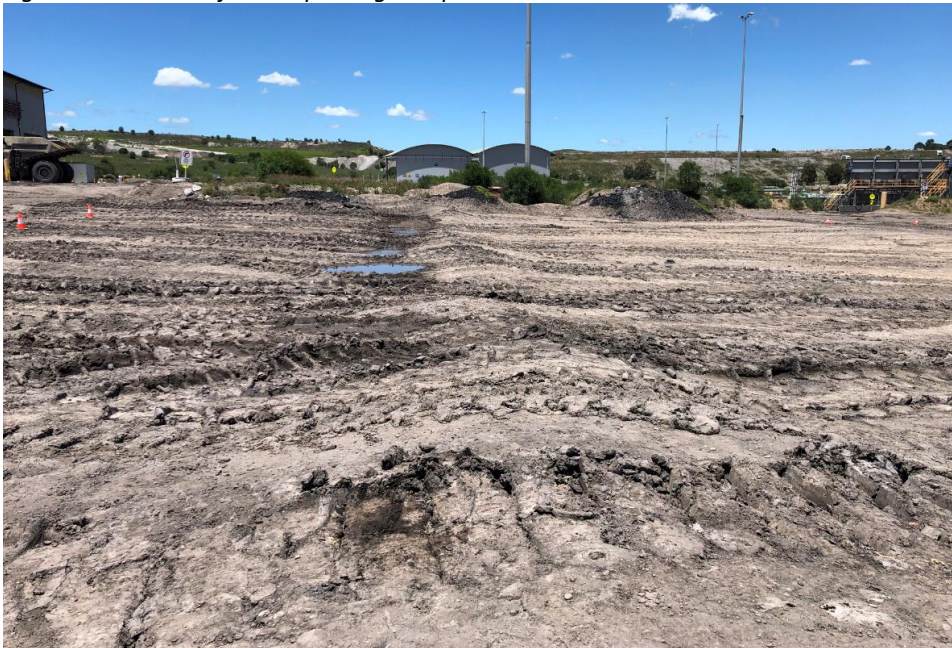
- The park-up hump at the workshop deadline was not constructed to the site standard.
- The post-incident inspection of the truck cab found that the park brake had not been selected.
- The fail-safe park brake mechanism did not activate when the truck's ignition was switched off.

Figure 2 Condition of stable parking hump
