SAFETY ALERT

UNPLANNED MOVEMENT CAUSED BY FAULTY TRANSMITTER

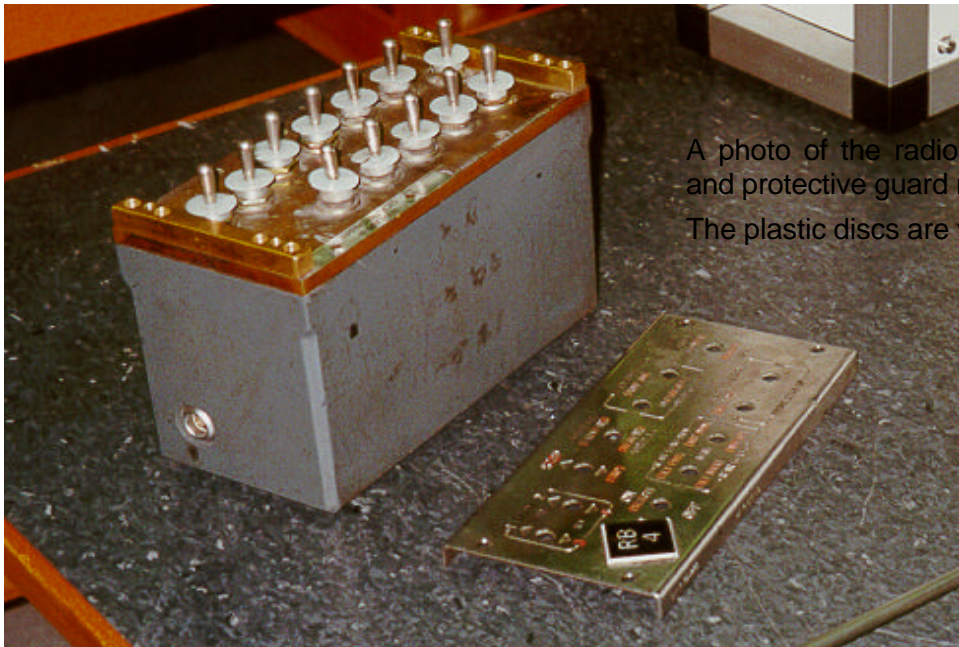
Small plastic discs were recently added to the transmitter between the toggle switches and the top cover to lessen dirt getting into the switch to minimise switch damage. The top cover on the transmitter was slightly indented from a recent impact. The plastic discs on some of the switches were trapped tightly between the top cover and the toggle switch body, effectively anchoring the toggle switch actuator in any position, preventing the spring return to "off" position.

A photo of the radio transmitter with the top cover and protective guard removed.

The plastic discs are visible on the toggle switches.

End users should carefully examine transmitters for impact damage before issue.

Operators should check transmitter switches prior to use.

Mine managers should satisfy themselves that remote controlled mining equipment complies with Australian Standard AS 4240 "Remote Controls for Mining Equipment" and MDG 5001.
