SAFETY BULLETIN

DATE: NOVEMBER 2019

Rapid face bolters incidents

This safety bulletin provides safety advice for the NSW mining industry.

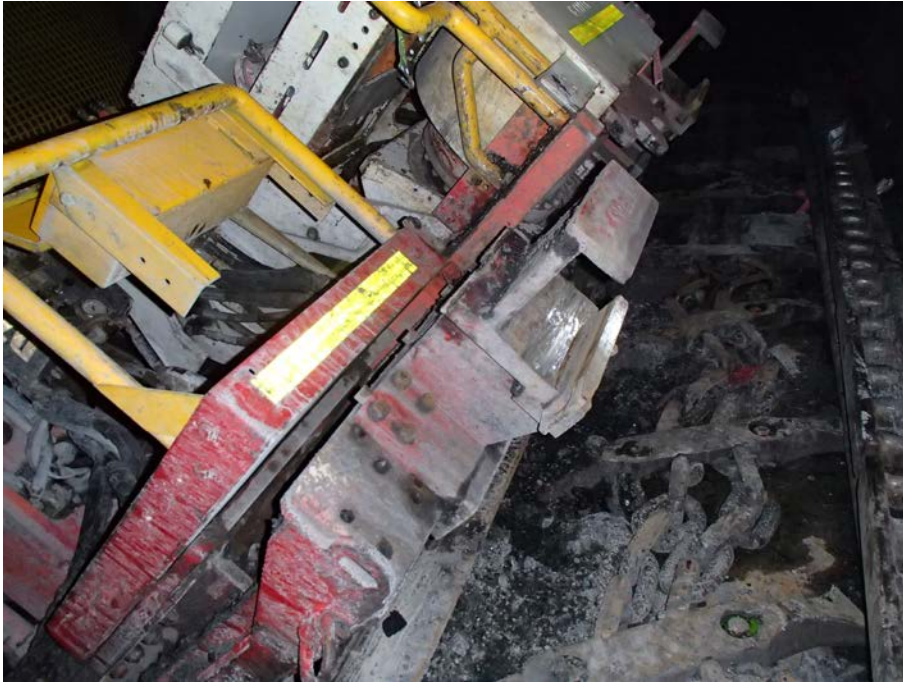
A rapid face bolter was positioned on an AFC near the tailgate drive. The operator extended the platforms and positioned the rigs, then identified the bolter was in the wrong location. The bolter was then trammed towards the maingate when it unexpectedly stopped. The worker assumed it was jammed and reversed towards the tailgate, freeing the bolter. The worker then started tramming the bolter towards the maingate. The bolter then disengaged from the AFC rack bar and tipped 45° towards the face (as shown in figure 1). The worker was ejected off the bolter, landing in front of the bolter between the two drill rigs. The worker suffered minor injuries requiring first aid treatment on site.

An investigation identified that when the rigs and platforms were extended, the centre of gravity shifted close to the skid shoe. As the rack bar position moved on the ramp pans, this shifted the bolter forward, tipping the bolter.

Figure 1 Rapid face bolter tipped 45° towards the face

1. Conduct an engineering review of the compatibility with the panline, rack bar and rapid face bolter. Ensure the trapping shoe engagement is sufficient to retain the bolter in all foreseeable operating configurations.
2. Verify that rack bar engagement with the trapping shoe is sufficient to retain the bolter as part of commissioning checks.
3. Repeat the above checks for any non-standard sections of the panline such as transitions and ramp pans.
4. Update operating procedures and training material to require that rigs are parked and platforms are retracted as specified in the original equipment manufacturer (OEM) requirements when rapid face bolters are trammed.
