# WEEKLY INCIDENT SUMMARY

Week ending Friday 1 May 2020

This incident summary provides information on reportable incidents and safety advice for the NSW mining industry. To report an incident to the NSW Resources Regulator: phone 1300 814 609 24 hours a day, 7 days a week.

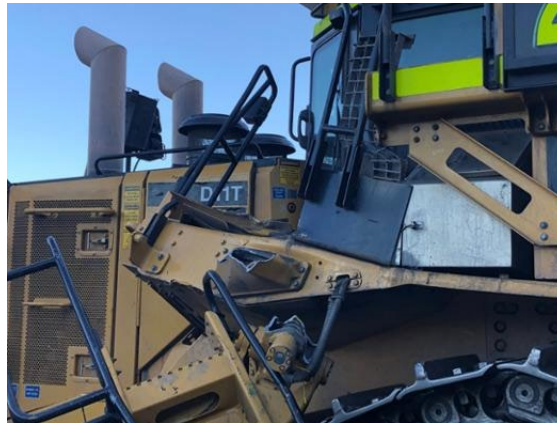
INCIDENT TYPE	SUMMARY	RECOMMENDATIONS TO INDUSTRY
Dangerous Incident IncNot0037230 Open cut coal mine

Roads or other vehicle operating areas	<p>Two dozers collided when preparing coal. One dozer was ripping when it hit the side of the other dozer, that was pushing. The operator of the dozer that was ripping was looking backwards, away from the other dozer, at the time the incident occurred.</p> <p>The blade of the ripping dozer was raised, damaging the access platform and ladder assembly of the other dozer.</p>	<p>Mines must conduct risk assessments on dozer operations and identify, document and implement effective controls for all risks, including risks associated with dozers operating perpendicular to one another.</p> <p>Supervisors must be able to determine that controls are in place and that dozer operators are using them effectively.</p> <p>Dozer operators should always maintain situational awareness and pay attention to the movement and proximity of other</p>

machinery. Ground implements (blades and rippers) should be kept as low to the ground as possible during operation.

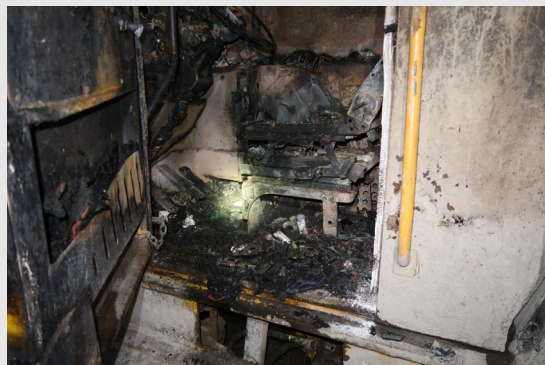
Dangerous incident  
IncNot0037233  
Underground  
metals mine

The operator of an underground dump truck saw flames coming from an engine bay. He tried to activate the fire suppression system, but was unsuccessful. He immediately exited the cabin and retreated to the crib to report the incident. Two other workers in the area tried to extinguish the fire with hand-held fire extinguishers but were unsuccessful.

The mine initiated its emergency response procedures, and all workers retreated to fresh air bases. All workers were subsequently withdrawn to the surface.

The mine's fire and rescue team members re-entered the mine and successfully extinguished the fire.

Vehicles used in underground mines must be rigorously assessed regarding the risk of fire.

An assessment program undertaken by the Regulator in 2019 focused on the contribution of maintenance practices to plant fires. The program identified significant deficiencies regarding fire risk assessments.

This incident also highlights the importance of emergency response procedures and their timely activation.

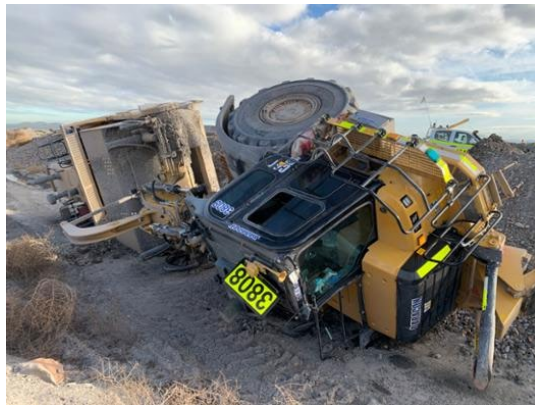
Dangerous incident  
IncNot0037234  
Open cut coal mine

The operator of a scraper was trying to get a load of gravel off a stockpile when the vehicle rolled onto its side over a narrow windrow. The driver was not injured.

Equipment operators must maintain situational awareness and remain vigilant to manage the risk of machine rollovers.

The circumstances of this incident underpin the importance of wearing seatbelts as a mitigating control.

When planning tasks and travel paths, supervisors must consider rollover hazards.

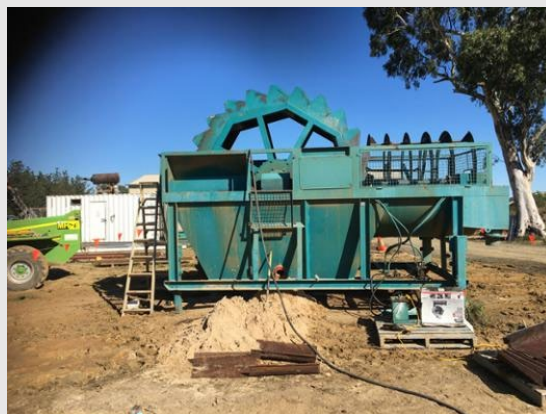
Dangerous incident  
IncNot0037239  
Quarry

An operator was working on a bucket wheel when the wheel moved unexpectedly, trapping the operator in the machine. The operator sustained an injury to his leg that required stitches.

When isolating any equipment to work on gravitational energy must be considered. All equipment should be assessed to determine the best way to isolate against gravitational energy.

Mine operators must have systems in place for workers to contact others in the case of an emergency when working alone.

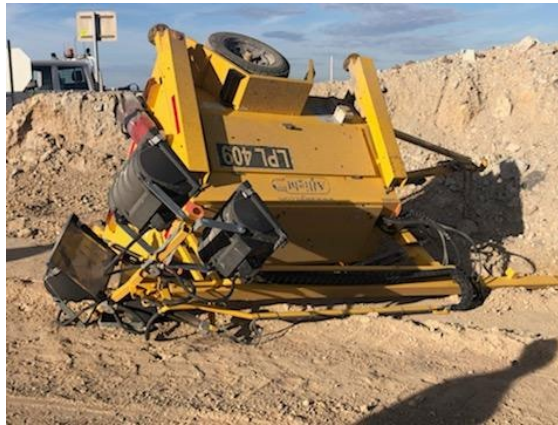
Dangerous incident  
IncNot0037256  
Open cut coal mine

A light vehicle was towing a lighting tower to a workshop when the tower separated from the vehicle and travelled about 60 metres before overturning.

Mine operators and contract companies should review their procedures to determine if their

training includes the potential hazards associated with towing.

When connecting a trailer to a vehicle's tow ball ensure that the trailer is securely on the tow ball and locked in position. Safety chains must be attached between the trailer and the towing vehicle.

In the instance where a person other than the vehicle operator attaches a trailer to the vehicle, the vehicle driver should ensure that the trailer has been securely attached before towing the trailer.

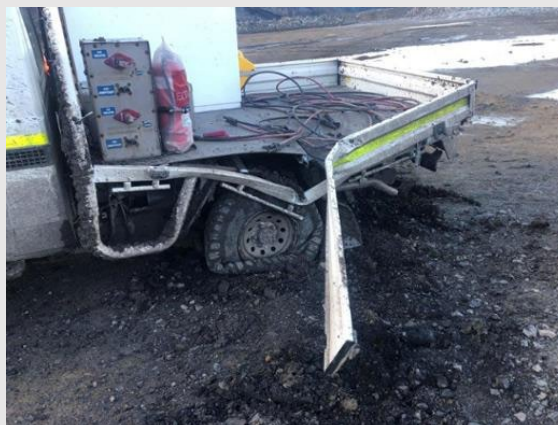
Dangerous incident  
IncNot0037265  
Open cut coal mine

An electrician was called to work on an excavator. He parked on the bench about 30 metres away from the excavator. While he was on the excavator, a dozer entered the area and parked about 20 metres in front of the light vehicle. The dozer driver and the excavator operator had a conversation and when the dozer driver re-entered the cab to drive away, he reversed into the light vehicle.

The dozer operator was unaware that he had hit the light vehicle, and left the work area.

Mobile plant interactions in mines, particularly between light vehicles and heavy mobile plant such as dozers, are a well-known risk.

Mine operators must identify, implement and maintain appropriate no-go zones and separation areas between light vehicles and heavy mobile plant.

Mine operators should consider applying engineering controls such as proximity detection, collision avoidance systems and cameras to assist in managing the risks associated with light vehicle and mobile plant interactions.
