WEEKLY INCIDENT SUMMARY

Week ending 2 May 2019

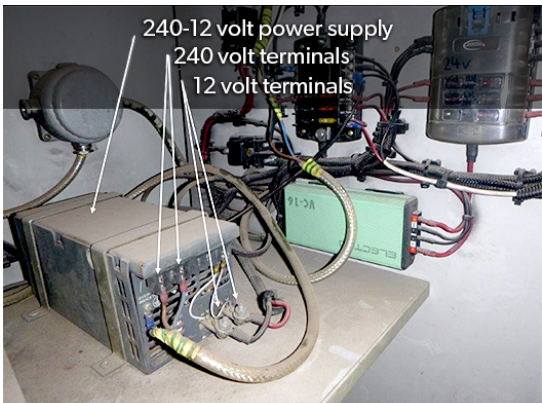
| INCIDENT TYPE | SUMMARY | RECOMMENDATIONS TO INDUSTRY |
|---|---|--|
| Dangerous incident IncNot0034469 | <p>A fitter suffered an electric shock in an underground metalliferous mine while trying to identify a fault in a tele remote loader hut. The fitter's hand contacted the 240-volt terminals on a power pack.</p> | <p>Mine operators must ensure only suitably qualified personnel work on electrical apparatus. Isolation and testing for dead are critical to ensure electrical safety. Terminals are to be appropriately labelled and suitably shielded for their environment.</p> |

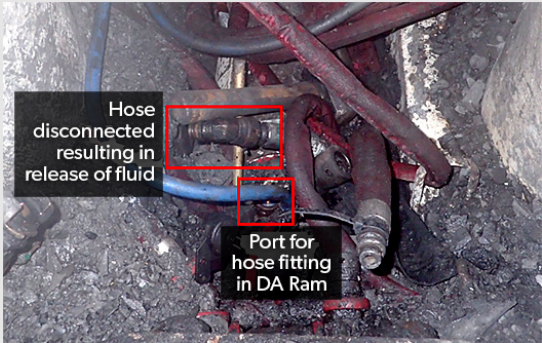
| INCIDENT TYPE | SUMMARY | RECOMMENDATIONS TO INDUSTRY |
|---|--|--|
| <p>Dangerous incident IncNot0034473</p> | <p>A release of under pressure fluid occurred on a longwall face. A fitter was replacing a hydraulic hose on a roof support which had been damaged by stone. The fitter had isolated and dissipated system pressure. When the staple was removed from the hose, it whipped, striking the fitter in the hand. The fluid stream sprayed the fitter, dislodging his hard hat and safety glasses. The fitter was taken to hospital as a precaution and was cleared of injury.</p> | <p>Where stored pressure can remain in a circuit (such as check valves and load lock valves), appropriate methods must be available to safely dissipate pressure.</p> <p>Mine risk assessment on hydraulic systems must identify and provide effective controls for areas of trapped pressure.</p> |

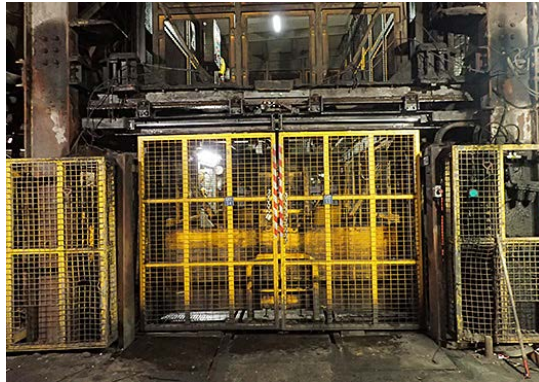
High potential incident
IncNot0034489

A mine reported the gates on a winder at a coal mine opened without the cage being docked. The shift supervisor was investigating a control system fault on the winder when a worker heard the seam level western material gate operate. The worker investigated and found the gates had operated and opened, leaving a fall risk into the shaft sump. The winder cage was parked on the surface at the time. The gates were manually driven closed to make the area safe and the winder tagged out of service.

Mine operators must ensure appropriate controls are implemented to prevent unsafe situations occurring whenever maintenance or fault finding is being undertaken on mine winders.

Seam gates require two independent controls: an electrical interlock and a mechanical gate lock. Routine schedules must be implemented for the proof testing of all primary and secondary safety circuit functions.

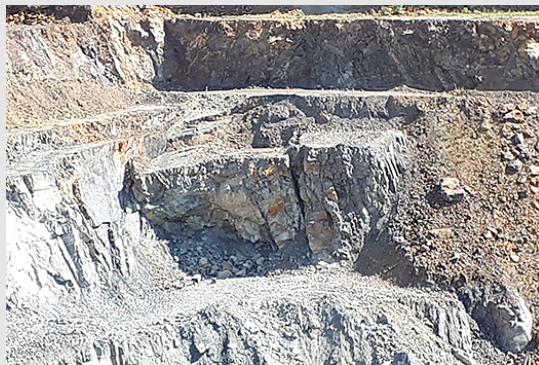
Dangerous incident
IncNot0034478

A large fall of ground, measuring approximately 10 metres by 10 metres, occurred in a quarry when a wedge, within a working face, slipped approximately 1 metre. There were no workers at the mine when the event occurred.

All mines with highwalls should complete geotechnical assessments to determine the design of the highwall. All geological and geotechnical issues need to be considered and highwalls designed accordingly.

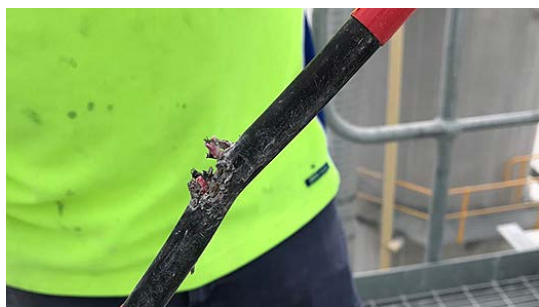
Dangerous incident
IncNot0034514

A worker in a quarry suffered an electric shock while a fitter was operating a 240-volt winch. While using the winch, the worker's hand contacted a damaged section of the power cord, resulting in an electric shock.

Mine operators must have systems and checks in place for workers to complete pre-use inspections of portable electrical hand tools and monitor worker compliance. Workers must inspect any tools and equipment being used to ensure they are fit for purpose and free from damage.
