WEEKLY INCIDENT SUMMARY

Week ending Friday 02 October 2020

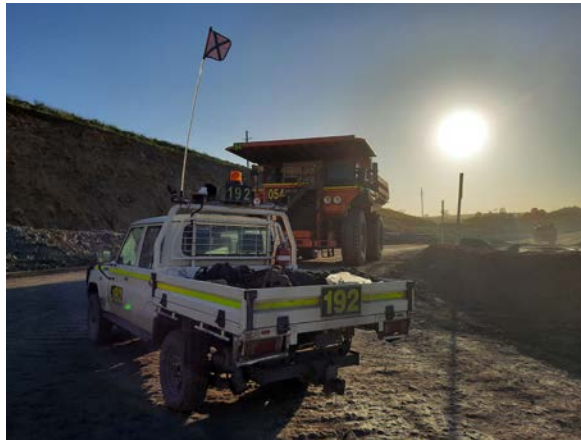
INCIDENT TYPE	SUMMARY	COMMENTS TO INDUSTRY
Dangerous incident IncNot0038360 Open cut coal

<p>A haul truck and a light vehicle had a near miss at an open cut coal mine. The empty haul truck approached a corner where a grader was working on the inside of the curve.</p> <p>The haul truck moved to the wrong side of the road to pass the grader and did not see any approaching vehicles. Both operators saw each other in time to stop their vehicles and avoid a collision.</p>	<p>The risk of collision when vision is restricted is well documented and reasonably foreseeable. Windrows should be constructed and maintained at heights that maximise visibility for all road users and maintain the effective delineation of roadways.</p> <p>Mines should review procedures and warning systems when road maintenance is being undertaken and when part of the road has been closed. When visibility is restricted, vehicle operators should only proceed when they are satisfied the roadway is clear.</p>

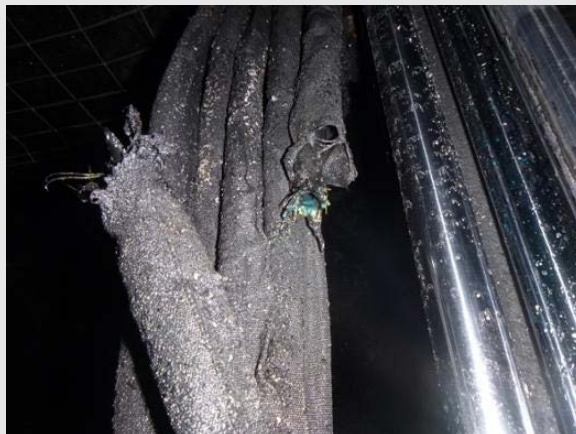
Dangerous
incident
IncNot0038356
Underground
coal

A continuous miner operator was sprayed with hydraulic oil from a damaged hose on a roof bolt hose pack. It appears the hose pack return hose was damaged by a piece of coal as the roof bolter head extended.

Mines should ensure all employees working around equipment with high-pressure hydraulic systems are fully aware of the dangers of fluid injections entering the body and the damage they can cause.

Cut out distances need to be reviewed and changed in different geological conditions in order to minimise the accumulation of stone in the working area. Excessive build-up of material around hoses should be avoided, inspected and cleaned prior to operating bolting rigs. Operators need to maintain situational awareness in relation to hoses contacting sharp edges.
