WEEKLY INCIDENT SUMMARY

Week ending Friday 09 October 2020

This incident summary provides information on reportable incidents and safety advice for the NSW mining industry. To report an incident to the NSW Resources Regulator: phone 1300 814 609 24 hours a day, 7 days a week.

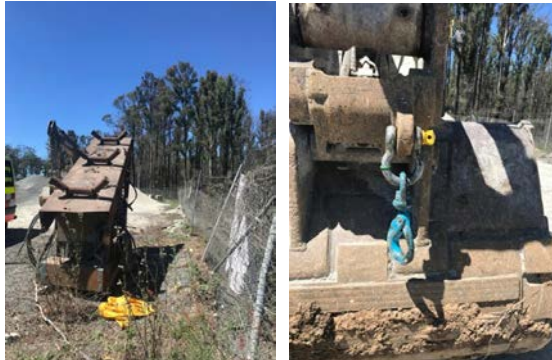
| INCIDENT TYPE | SUMMARY | COMMENTS TO INDUSTRY |
|--|--|---|
| Dangerous incident IncNot0038433 Open cut construction materials | <p>A worker climbed onto a redundant item of plant to attach a set of lifting slings to the excavator hook with the intention to lift and move the item. A decision was then made to remove the bucket from the excavator prior to the lift.</p> <p>Before the worker had removed the slings from the hook, the excavator moved causing the item of plant to shift. The worker attempted to jump from the item of plant but caught his foot and fell to the ground.</p> <p>The worker suffered a broken wrist.</p> | <p>Mine operators must have safe systems of work to protect workers from the risk of falls.</p> <p>Workers should remain situationally aware and not put themselves in a position where they are at risk of falling from a height. Appropriate work platforms should be considered when working at height.</p> <p>Methods of communication between workers must be clear, agreed upon and understood before the task is undertaken.</p> |

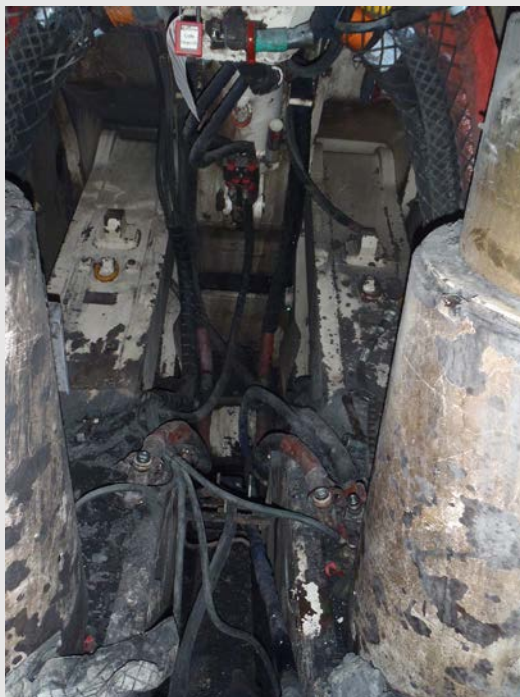
A longwall fitter was replacing hoses on roof supports as part of a maintenance program. He removed the staple from a DA Ram POCV and was applying some force to remove the hose when he was struck on the palm of his hand by fluid under pressure.

Initial investigation indicates that residual pressure was retained in the circuit. The bleed point was potentially contaminated with dirt which prevented full dissipation of fluid pressure.

Although procedures for the task were followed in this instance, the tool for the job was not functioning properly which put the worker at risk.

Failure to identify residual pressure, and to bleed this pressure off appropriately is failure of a critical control.

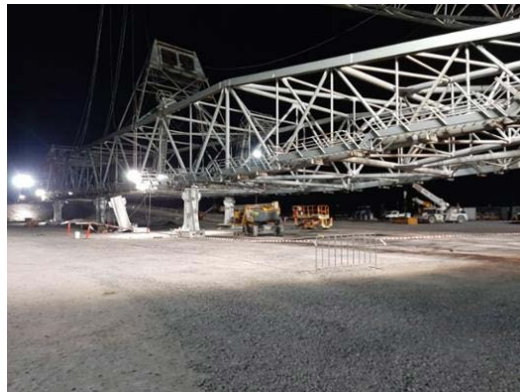
During a shutdown, workers were removing stands from underneath the boom of a dragline when the boom moved approximately 300 millimetres.

The task was to remove the stands under the boom between the dragline house and the end of the boom.

The incident occurred when workers were lowering the hydraulic cylinders on the third last stand located between B2 location and the dragline cabin.

The B2 left stand fell over and the B2 right stand lost packing between the stand and the boom.

It is essential that a task such as this have a documented procedure.

The risk assessment for this task must be thoroughly undertaken and include all hazards, including detail about the removal of boom stands.

All personnel involved in the task must understand the procedures and sign on to the JHA.

Ensure there is enough packing between the ground and the base of the stand, and at the interface between the hydraulic cylinders and the boom.

The boom should be monitored for movement during the build.

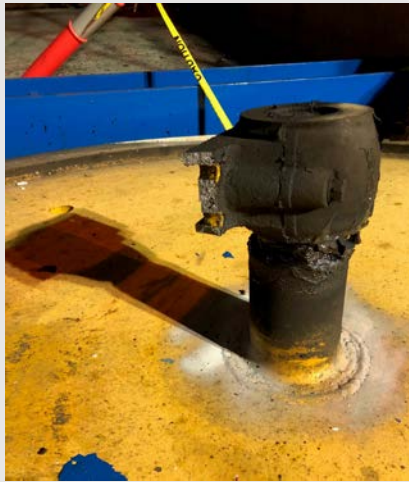
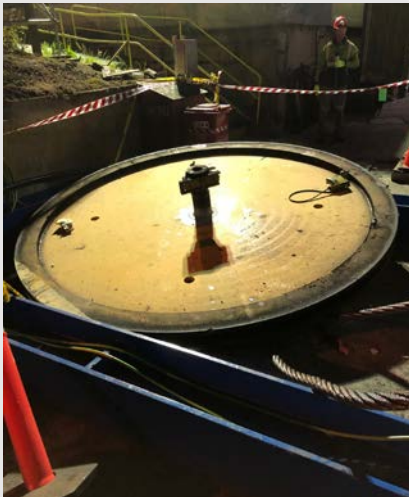
While removing a drift winder rope, the head sheave plumber blocks failed, resulting in the head sheave falling to ground level from its position on the gantry, a vertical distance of approximately 15 metres. The sheave wheel fell into a demarcated no-go zone. A person was positioned in the line of fire when the pulley fell, but was not injured.

Initial investigation indicates that the method of rope removal, using the mobile friction winder, inducted a horizontal load on the plumber blocks. This resulted in the plumber block feet failing and the head sheave working free.

Safe systems of work must be documented and provided by mine operators. Supervisors must ensure that the systems of work are understood and implemented by workers.

Engineering design and expected forces must be calculated for all parts of the task to ensure equipment is designed for the expected duty.

The risk of falling objects and the positioning of workers must be considered in the work methods.

Established no-go zones must be adequately sized to ensure workers are not put at risk from falling objects.
