REPORTABLE INCIDENTS | WHS MINES LEGISLATION

Weekly incident summary

Publication Date: 13 January 2016

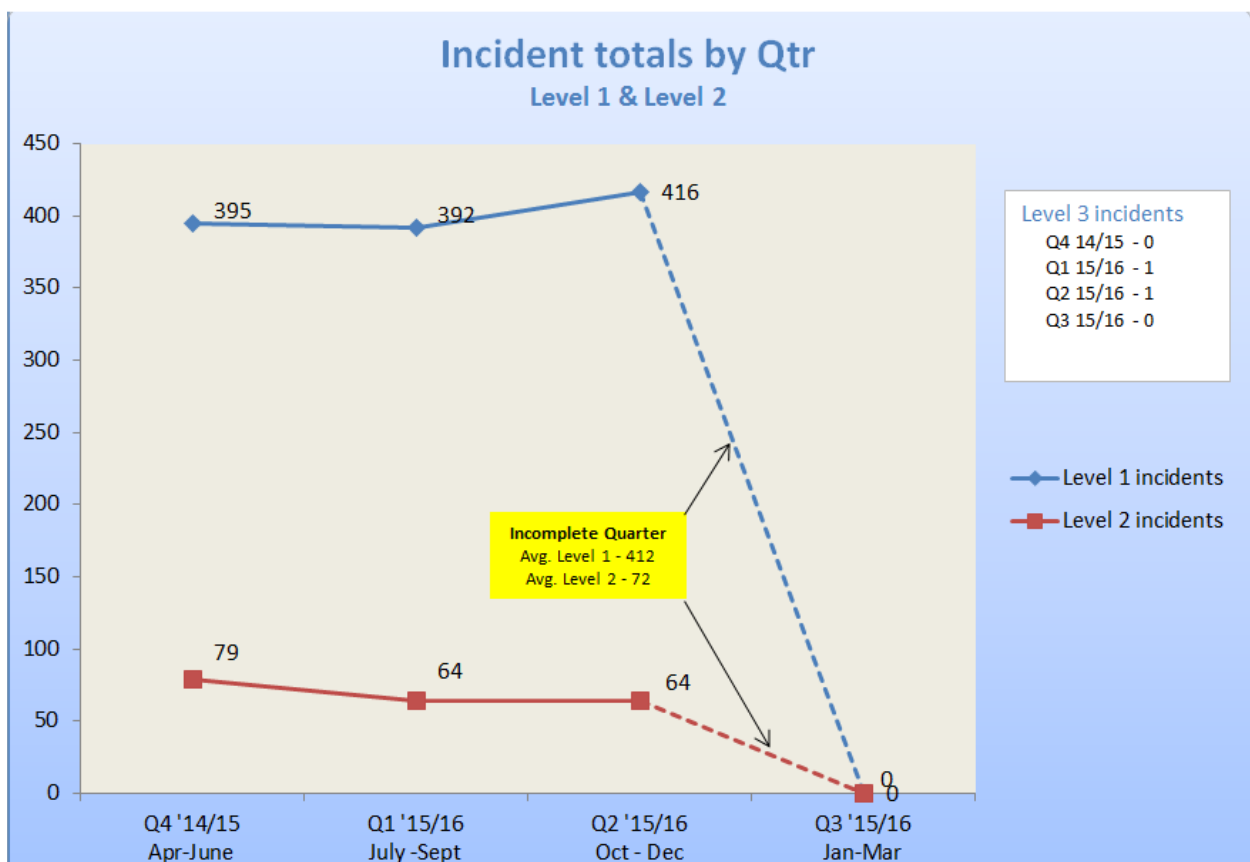
Level	Incident type	Summary	Comment to Industry
2	Mech Equip 317657777001	The bucket of a front end loader impacted with the cabin of a gravel truck while loading when the loader toppled over. The loader was working across a slight slope and was partially articulated while discharged into the truck.	A risk assessment of all loading/tipping operations must be carried out that includes, but is not limited to, potential toppling of the loader through loader articulation while the bucket is elevated, the slope of the work location and fit-for-purpose truck/loader configuration.
2	Elect Energy 317657883001	Starter motor failed causing a direct earth to short. Resulting fire in engine was extinguished by operator.	A missing cover plug on the starter motor allowed dust and dirt ingress which caused the electrical fault and subsequent fire. Such plugs should be in place and effective.
2	Mech Equip 317657883001	Operator noticed timberjack lowering while attempting to drill a hole for roof bolt even though the timberjack 'down' function had not been activated.	It has been identified that the spool monitoring was out of adjustment after reassembly of the rig and control bank. Spool proximity sensor calibration to OEM specifications is now on the commissioning check sheet.
