WEEKLY INCIDENT SUMMARY

Week ending Friday 10 April 2020

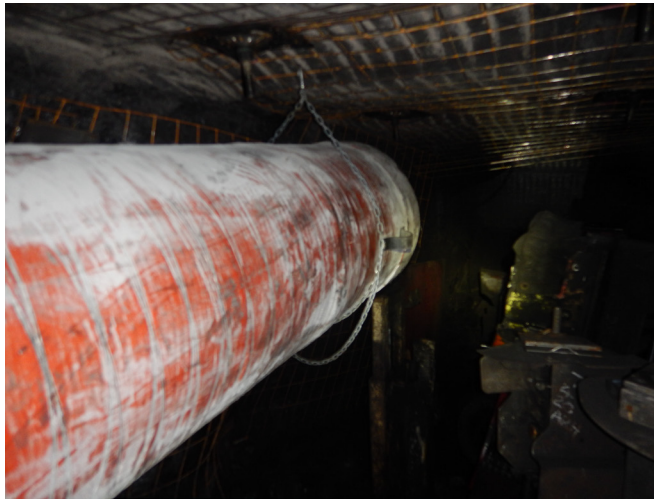
INCIDENT TYPE	SUMMARY	RECOMMENDATIONS TO INDUSTRY
Serious injury IncNot0037143 Underground coal mine	<p>While installing a ventilation tube, a worker was sucked into the tube and briefly lost consciousness. Two other workers were unable to remove the worker from the tube until an auxiliary fan was shut down.</p> <p>The auxiliary fan's variable inlet vanes were set to 13 cubic metres per second and the ventilation tubing was about 90 metres to the face via a 90 degree elbow and a T-piece.</p>	<p>Control measures and procedures in relation to installing ventilation tubes while auxiliary fans are in operation should include identifying:</p> <ul style="list-style-type: none"> ■ safe operating ranges for workers installing ventilation tubes ■ the sequence of steps to take, in order to safely add ducting inline

- guards on the most inbye tube, to minimise the risk of workers being sucked into or against the ducting while working adjacent to it (e.g. on continuous miner platforms).

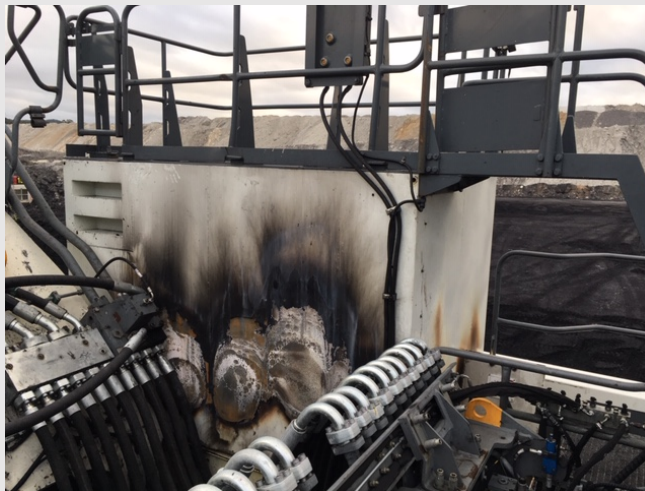
IncNot0037126

A worker saw smoke coming from a sound suppression box on top of a hydraulic cooler room on an excavator. The worker manually activated the fire suppression system and a water cart was also used to extinguish the fire.

The excavator had undergone maintenance earlier in the day, and fish plates had been welded onto the bottom of the sound suppression box. The excavator had been idle for about an hour before starting up.

Inspections conducted after maintenance, particularly when hot work has been undertaken, should identify new hazards that may have been inadvertently introduced as a result of that task. Appropriate controls should be put in place to manage the risks.

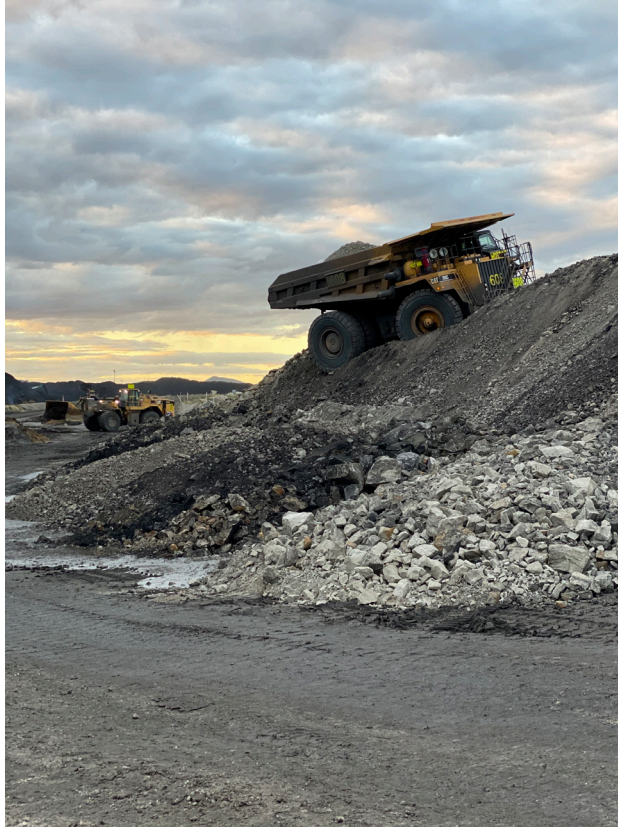
A dump truck was reversing to a tip head when it breached a windrow, with two wheels going through the windrow. No-one was injured.

Mines should have systems in place to ensure windrow standards are regularly verified and maintained. Ground stability should be considered when planning a dump site.

Mine operators should review how their supervisors monitor critical controls and determine what actions to take when critical controls are identified as being inadequate.

Tipping procedures should be reviewed to ensure that dump trucks do not tip close to edges.

Dumps should be maintained in a straight line, with windrows constructed of predominantly dry, competent material to a specified height.
