WEEKLY INCIDENT SUMMARY

Week ending Friday 14 February 2020

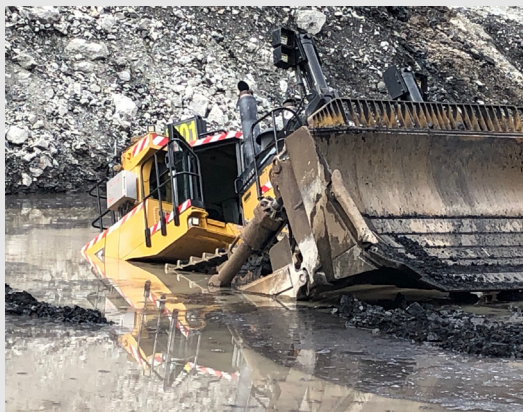
Serious injury
IncNot0036687
Open cut coal

An operator's wrist was cut while trying to get out of a partially submerged, bogged dozer. The operator lost footing, reached out and grabbed the dozer blade. A burr on the blade caused the cut, which needed four stitches.

The area where the incident occurred was very confined, and the site had received about 160 millimetres of rain overnight.

Operators should review and update site procedures for managing bodies of water on site.

Geotechnical consideration should be given to the potential for voids, slumping and subsidence areas to form, particularly following significant rainfall.

The potential for drowning in a submerged vehicle must be considered in such circumstances.

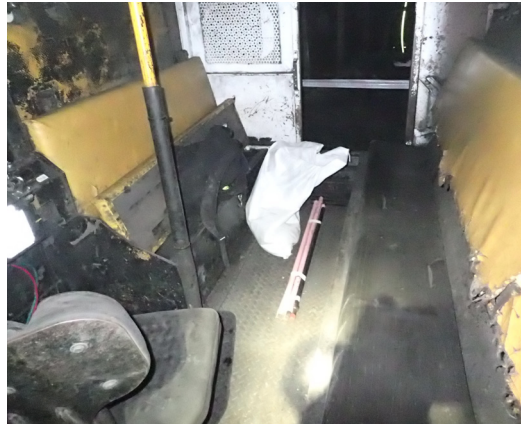
Dangerous incident
IncNot0036709
Underground coal

An operator of a diesel man car (DMC) stopped and reportedly activated the dump valve. The operator exited the DMC and turned to switch it off, but it began to roll forward.

The operator activated the intake emergency shut-off valve, but the machine continued to roll downhill.

The DMC travelled about 17 metres to a set of catch points that were closed and travelled a further 23 metres before hitting another parked DMC.

There was no-one in either DMC. The catch points were closed due to excessive build-up of coal and fines.

Operators should review the risks associated with parking machinery on inclines and should implement suitable procedures to eliminate the risk of unattended machines rolling away.

Catch points should be maintained and form part of rail maintenance plans.
