WEEKLY INCIDENT SUMMARY

Week ending Friday 15 January 2021

Mine safety reference ISR21-02

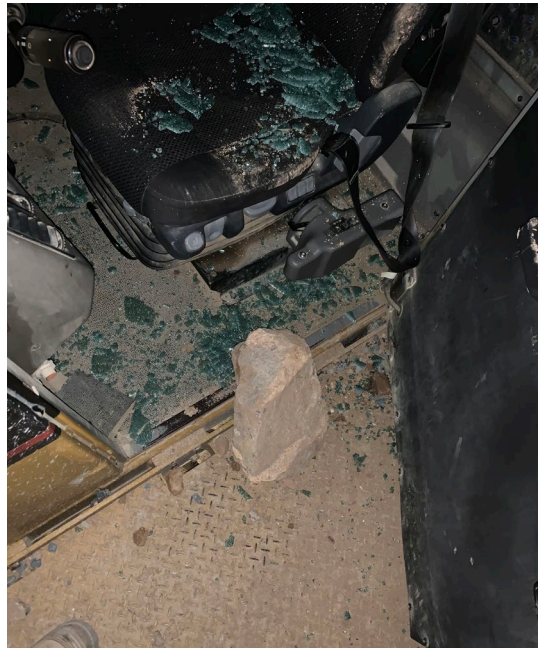
INCIDENT TYPE	SUMMARY	COMMENTS TO INDUSTRY
Dangerous incident IncNot0038985 Underground metal mine	An operator was loading a truck at the oxide stockpile when a rock, weighing approximately 20 kilograms, came off the bucket and bounced through the truck side panel window, making contact with the operator. The operator received bruising to the upper arm.	Mine operators should ensure loader operators are trained in correct bucket loading practice and techniques, including loading perpendicular to the truck where appropriate. Mine operators should ensure that the most suitable plant is used to complete the loading. Introduction to site processes must be in place to ensure the correct equipment is used for each particular application.

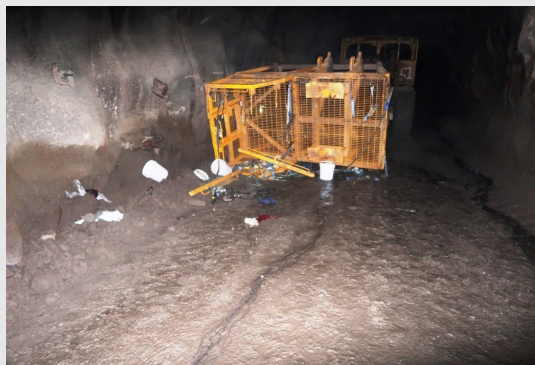
Dangerous incident
IncNot0038987
Underground metal mine

A work box detached from an integrated tool carrier and fell approximately two metres. It hit the ground and rolled 90 degrees onto its side, partially ejecting two mine workers who had been inside the work box.

Mine operators must ensure that locking pins are in place on mobile plant used for work boxes. The locking pins should be used to give a positive/secure attachment. Mine workers involved in the task must verify that all locking pins are correctly engaged prior to use.

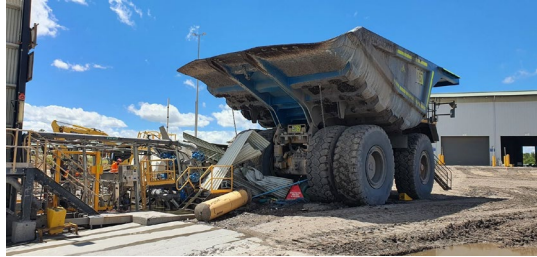
Dangerous incident
IncNot0038989
Open cut coal mine

A truck was on the workshop deadline for a defect repair. After parking the truck, the operator exited the machine and the truck rolled backwards approximately 65 metres and collided with the pump at the wash bay.

It has been identified that the park brake had not been applied. The mine also identified that the park up hump standard had deteriorated from recent

wet weather events and failed to prevent the truck from rolling away.

Where the ground is contoured to make vehicles fundamentally stable, mine operators must ensure the contours are to standard as per the procedure and are remediated if required.

Park brake safety interlocks should be checked as part of pre-operational inspections and should never be used as the

primary means of applying the park brake.

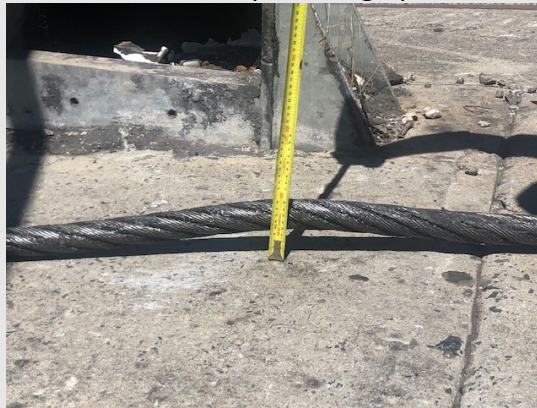
Dangerous incident
IncNot0038998
Underground coal mine

A winder rope kinked approximately eight metres from the man car attachment point. The man car operator noticed the rope kink and the buildup of mud/dirt on the rope during operations.

From the primary investigation it was identified that the rope may have been run over by a vehicle with rubber tyres. Mines operating winders should have exclusion zones clearly defined. Workers must report damage to plant and equipment when it occurs.
