WEEKLY INCIDENT SUMMARY

Week ending Friday 16 August 2019

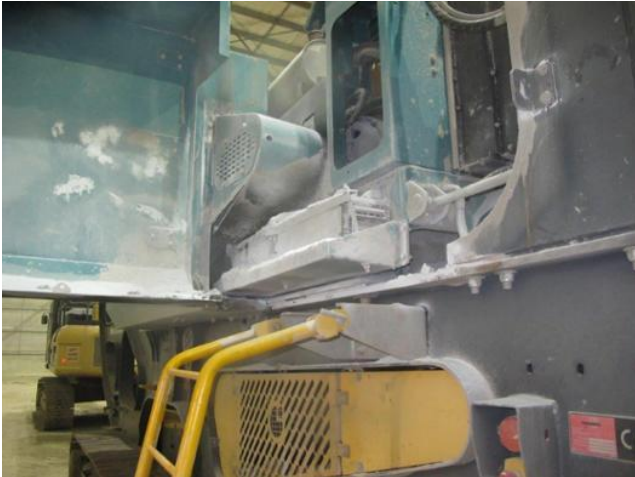
INCIDENT TYPE	SUMMARY	RECOMMENDATIONS TO INDUSTRY
<p>Dangerous Incident IncNot0035336</p>

<p>The operator of a mobile crushing unit smelled smoke. On further examination, the operator observed flames coming from the battery compartment. The operator shut down the unit and used a single hand-held extinguisher to put out the fire.</p> <p>Initial investigation indicates that a belt guard had become loose and contacted the battery terminals, causing a fire.</p>	<p>Plant that is subject to constant, heavy vibration must be appropriately inspected and maintained.</p> <p>Mine operators should consider all risks associated with the placement and guarding of lead acid batteries fitted to such plant.</p>
