WEEKLY INCIDENT SUMMARY

Week ending Friday 17 April 2020

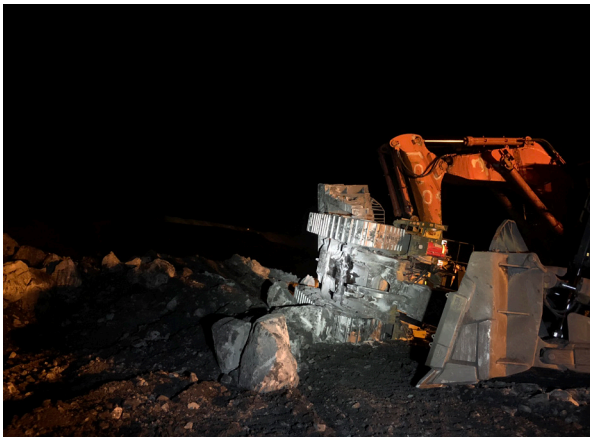
INCIDENT TYPE	SUMMARY	RECOMMENDATIONS TO INDUSTRY
Dangerous incident IncNot0037148 Open cut coal mine

Roads or other vehicle operating areas	A dozer operator was cleaning up a bench floor at night when it backed over some large rocks and rolled onto its side. The operator was not injured.

Following the investigation of several incidents in which tracked dozers overturned, the NSW Resources Regulator identified a range of contributing factors and published a safety bulletin. Recommendations on managing risks to dozer operators can be found in safety bulletin SB19-01 Rise in dozer incidents putting operators at risk

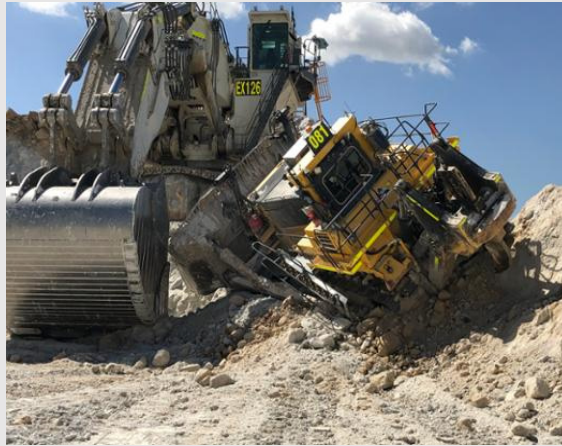
Dangerous
Incident
Open cut coal
mine
IncNot0037158

A dozer carrying out preparation work slid off a walk back and working bench near an excavator. The dozer operator appears to have misjudged the corner and driven off the edge. The dozer operator was not injured.

Refer to the recommendations provided in the previous dozer rollover incident above.

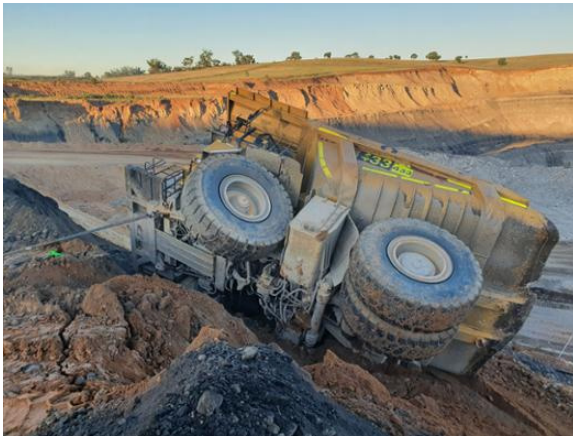
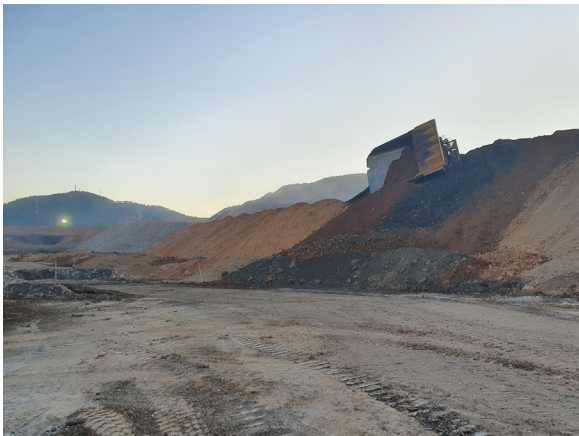
Dangerous
Incident
IncNot0037154

A dump truck went through a windrow when backing into a corner of the dump. The ground failed, causing the truck to overturn.

Preliminary investigations suggest that the controls identified to manage the risks associated with using weathered material at the dump may not have been adequate and some of those controls were not implemented.

While 10 metre lifts were planned for the dump, on the outside edge where the tip head failed, the rill face was approximately 20 metres high.

Mines must have systems in place to ensure dumps are operated and maintained as per the original design with adequate TARPs in place if circumstances change.

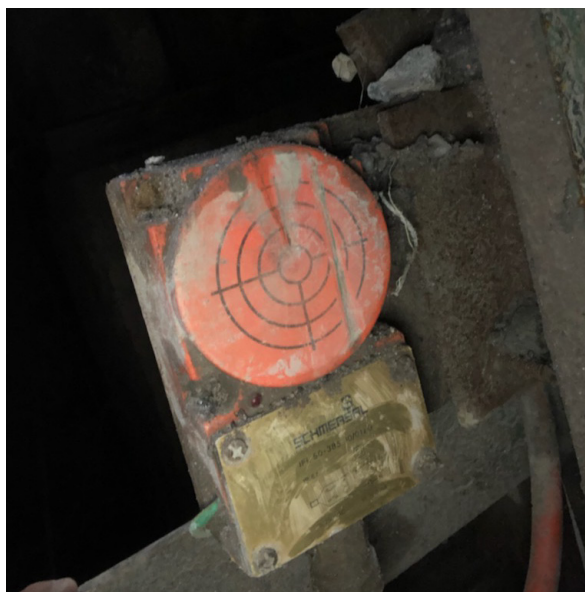
Dangerous
Incident
IncNot0037185
Underground
metals mine

A mill operator suffered an electric shock when opening a door at a surface crusher building. He made contact with the door's proximity switch and suffered an electric shock to his left hand.

A preliminary investigation suggests a diminished ingress protection (IP) rating of the proximity switch, together with the fact the area was wet, allowed the operator to be shocked when he touched the switch.

Electrical equipment that has an IP rating is critical in wet areas and should be maintained as fit-for-purpose throughout its life cycle. Mines that have control voltages to field devices above extra low voltage (ELV) should review how they manage the risk of electric shock, including the modification of field control circuits to ELV.
