Week ending 21 November 2018

This incident summary provides information on reportable incidents and safety advice for the NSW mining industry. To report an incident to the NSW Resources Regulator: phone 1300 814 609 (24 hours a day, 7 days a week).

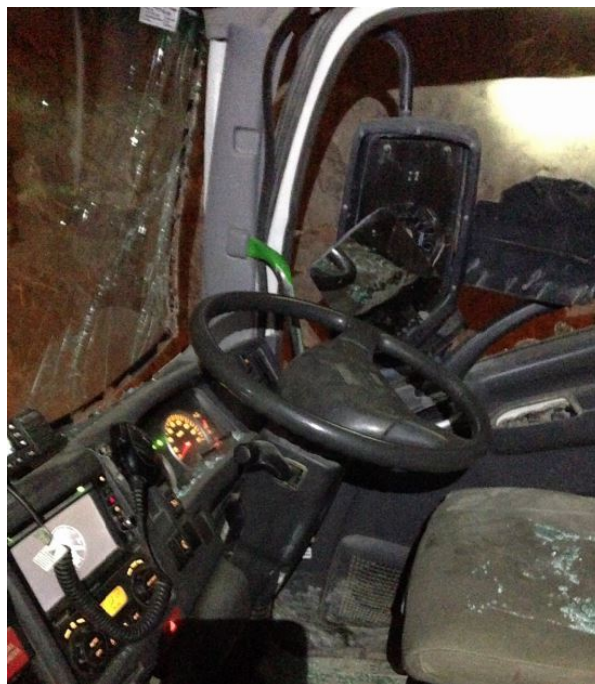
Dangerous incident SinNot-2018/01916	<p>A worker was injured while trying to stop a runaway vehicle in an underground metalliferous mine. The worker parked a truck and got out of the vehicle. The truck moved forward unexpectedly. The worker</p>	<p>When accessories are fitted to a vehicle (such as bull bars, custom trays/bodies, fire suppression systems, vehicle loading cranes) the</p>

tried to get back into the truck but was pinned between the door of the truck and the wall of the mine. The worker suffered injuries to the foot and ankle.

An investigation identified that the truck was overloaded at the time.

load carrying capacity is reduced. This should be clearly marked on the vehicle and communicated to operators.

When determining locations for parking vehicles at log on points and tag boards, areas on grades such as drifts or declines, should be avoided.

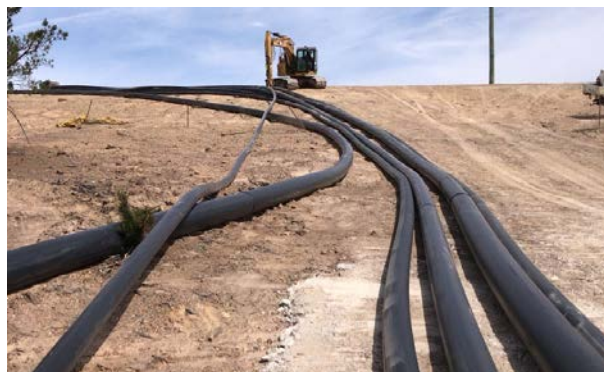
A worker was injured when poly pipe hit him. The poly pipe was being lifted and dragged into position using excavators. After moving three pipes, the fourth pipe being moved hit the worker. The worker's knee and shoulder were injured when he fell to the ground.

When poly pipe is being moved, the stored energy and potential for sudden release (spring back) must be taken into account in task procedures. Clear and defined 'no-go' zones must be developed to protect workers from sudden releases of energy.
