WEEKLY INCIDENT SUMMARY

Week ending Friday 27 November 2020

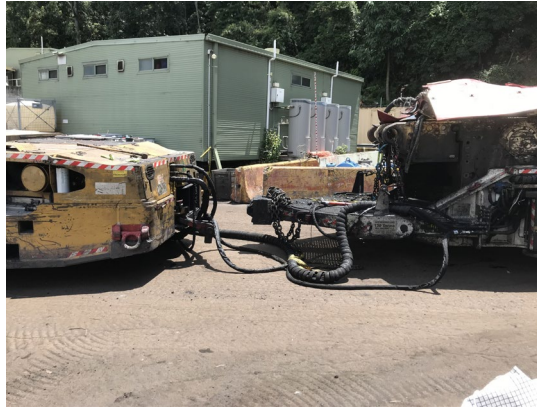
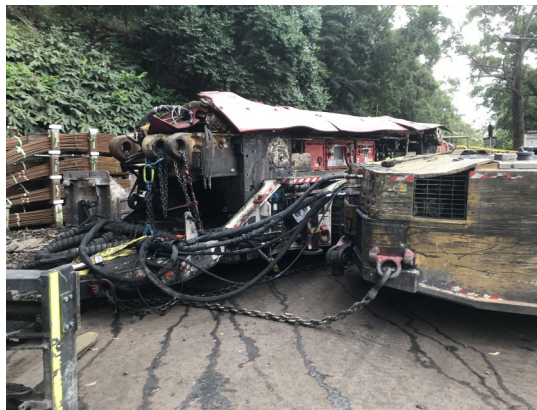
INCIDENT TYPE	SUMMARY	COMMENTS TO INDUSTRY
Dangerous incident IncNot0038712 Underground coal mine	<p>An operator was using a heavy lift loader to move a loaded shearer transporter a short distance. When negotiating a slight decline, the shearer transporter jack-knifed and snapped the tow hitch on the heavy lift loader.</p> <p>Preliminary investigation suggests that speed was a factor, as well as lack of knowledge/experience in moving heavy machinery on a decline. The investigation will determine if there was a delay in the shearer transporter brakes engaging, following application of the brakes on the heavy lift loader and if there was a requirement for a tow vehicle to assist braking.</p>	<p>It is imperative that operators have a procedure for towing heavy loads, including the weight of loads and the vehicle/s to be used.</p> <p>These procedures must refer to the OEM specifications of the towing vehicle and include road grades, road surfaces and vehicle to road surface contact.</p> <p>Operators should be trained in the requirements for towing heavy equipment, particularly in the effects of braking when on a decline and when the towed load is turning.</p>

Refer to:
[MDG 1009 - Managing road and vehicle operating areas in underground coal mines.](#)

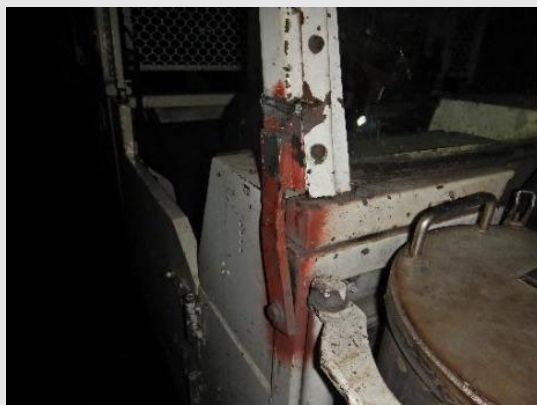
Dangerous incident
IncNot0038720
Underground coal
mine

A load haul dump vehicle (LHD) and PJB collided in an underground coal mine. Two PJBs were travelling in convoy passing the LHD that was in a cut through. The first PJB passed safely, but the LHD pulled out and collided with the second PJB. The bucket of the LHD contacted the frame of the windscreen of the PJB on the driver's side. Nobody was injured.

Lack of positive communications continues to be an issue throughout the industry.

Mine operators, supervisors and vehicle operators all have a role to play in ensuring effective communications between vehicle operators.

Mine operators must have protocols and procedures documented and implemented, including signalling when entering a roadway, and should consider proximity detection and collision avoidance technologies.

Supervisors must ensure that vehicle operators comply with the protocols and procedures.
