REPORTABLE INCIDENTS | WHS MINES LEGISLATION

Weekly incident summary

8 February 2017

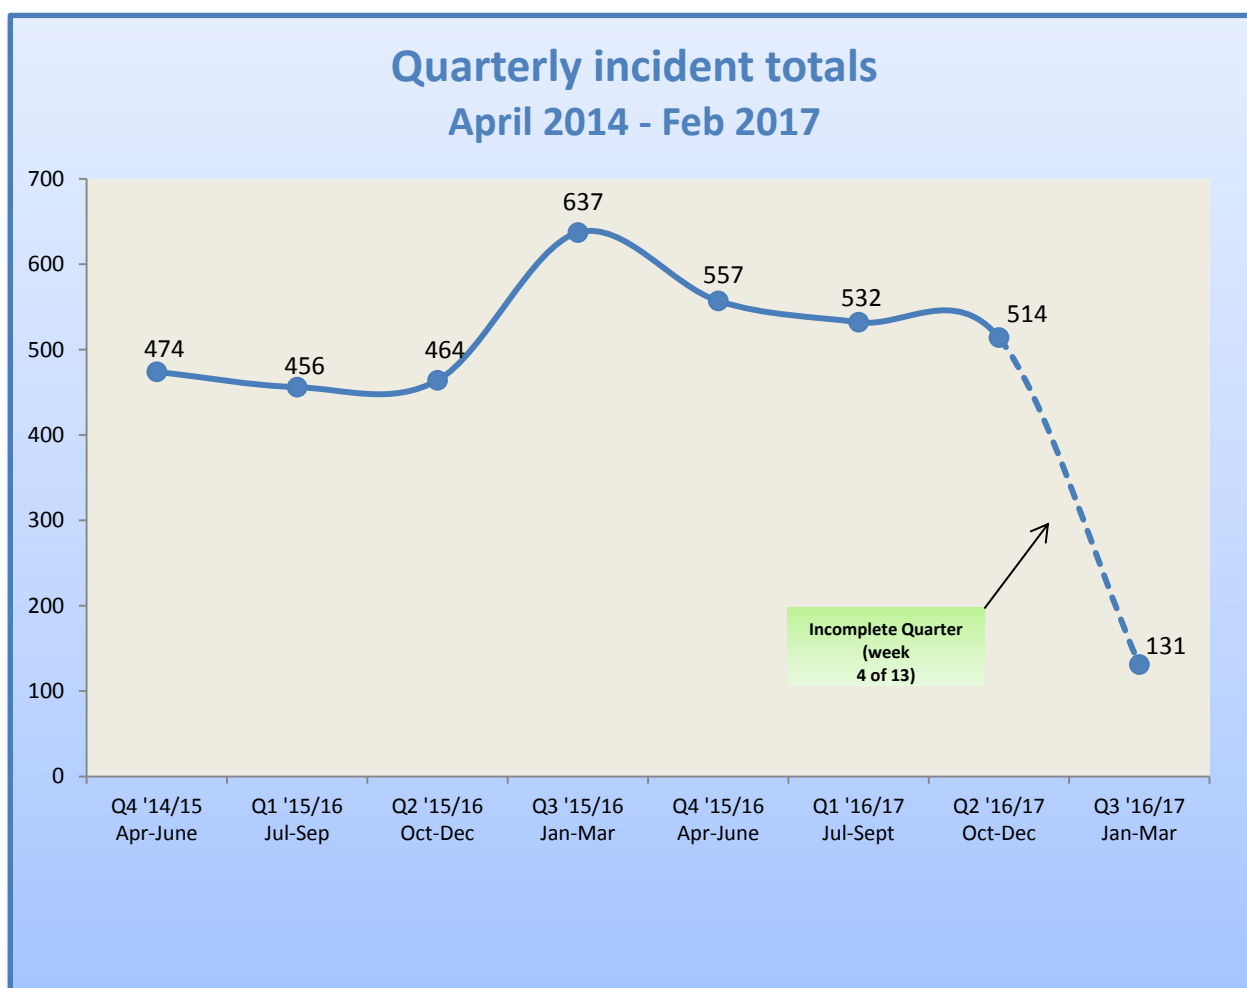
Incident type	Summary	Comment to industry
Dangerous incident SInNot 2017/00141	On night shift, the driver of a DT771 dump truck was reversing into the work area of an excavator when it struck the D10 dozer that was cleaning up the area. No workers were injured.	Investigation of this incident should highlight to mine operators that traffic management plans should include: <ul style="list-style-type: none"> • Positive communications process at the mine for all vehicle interactions • Lighting requirements for night shift operations • Allocation of who controls the loading/work area • Fatigue management • Adequate supervision arrangements to verify controls are being maintained
